Yamhill-Carlton School District

Building Assessment

Carlton Elementary School

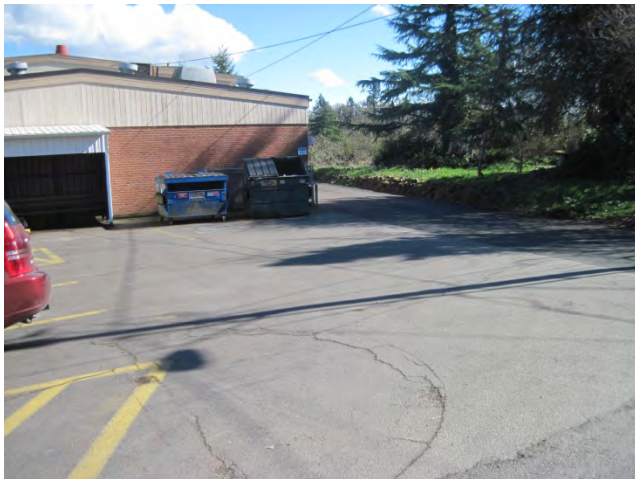
Elementary School – Area-A, Southwest Parking Lot Area; Note, this area is in fair to poor condition with the need for selective removal, replacement, and overlay. In addition, it is showing signs of excessive wear and cracking

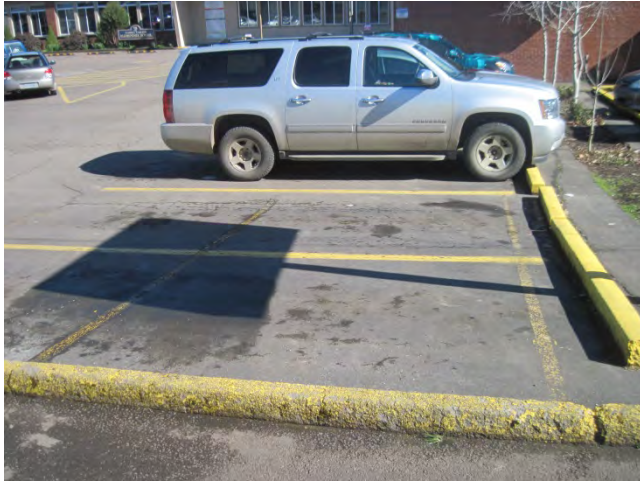
Elementary School – Area-A, Southwest Parking Lot Area; Note, this area is in fair to poor condition with the curbing showing signs of severe degradation and damage over time.

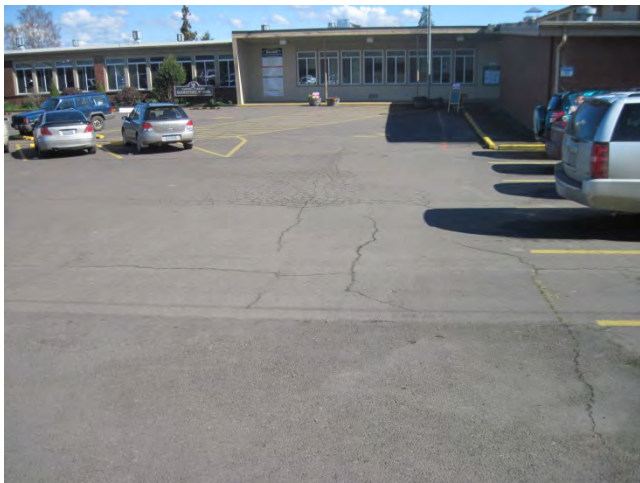
Elementary School – Area-A, West Main Parking Lot Area; Note, this area is in fair to poor condition overall. A complete overlay is recommended for this area in addition to the complete removal and replacement of severely damaged areas in select locations of heavy use.

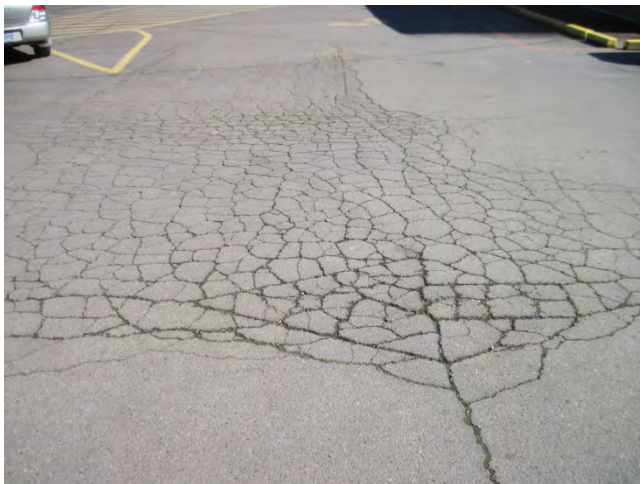
Elementary School – Area-A, West Main Parking Lot Area; Note, severely damaged areas in select locations due to heavy use and bus traffic.

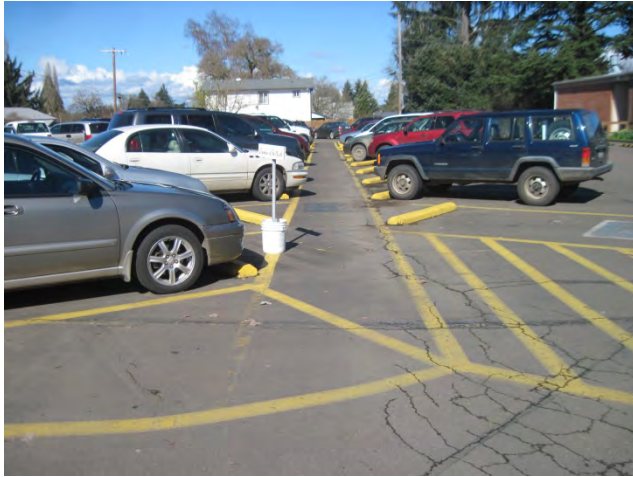
Elementary School – Area-A, West Main Parking Lot Area; Note, severely damaged areas indicated by surface cracking.

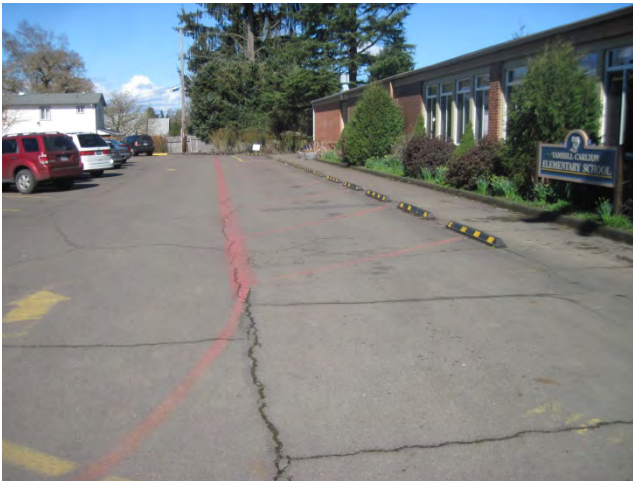
Elementary School – Area-A, West Main Parking Lot Area; Note, severely damaged areas in select locations due to heavy use and bus traffic.

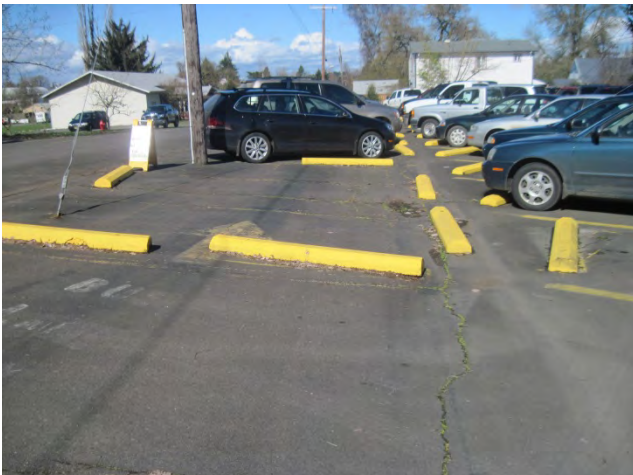
Elementary School – Area-A, West Main Parking Lot Area; Note, signs of base failure and areas with inadequate or misplacement of wheel stops. This picture also depicts areas of worn or faded striping and demarcation.

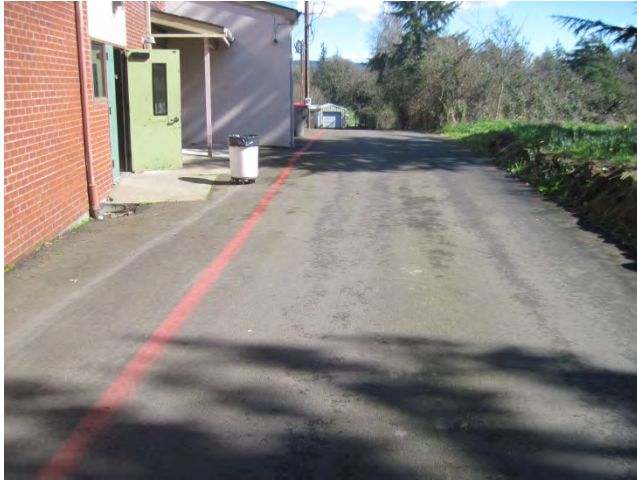
Elementary School – Area-B, North Perimeter Emergency Lane Area; Note, this area has signs of surface wear and minor cracking.

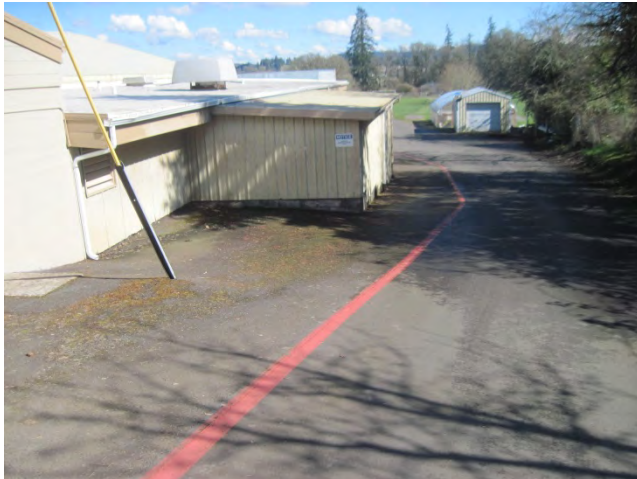
Elementary School – Area-B, North Perimeter Emergency Lane Area; Note, additional paving with signs of surface wear and minor cracking.

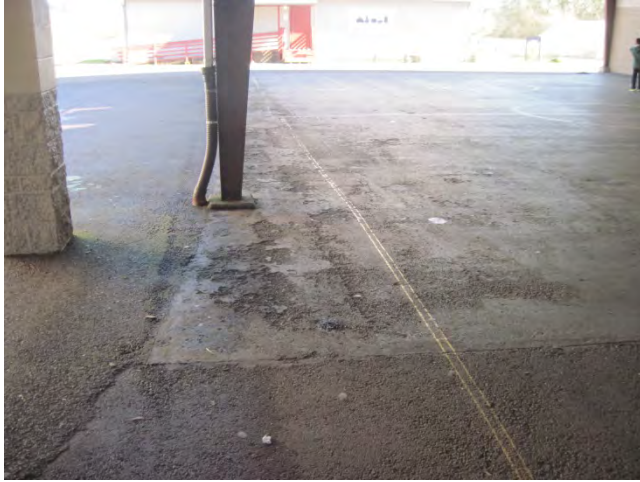
Elementary School – Area-C, Northwest Covered Play Area; Note, this area is in poor condition due to severe surface pitting and is recommended for overlay of new asphalt.

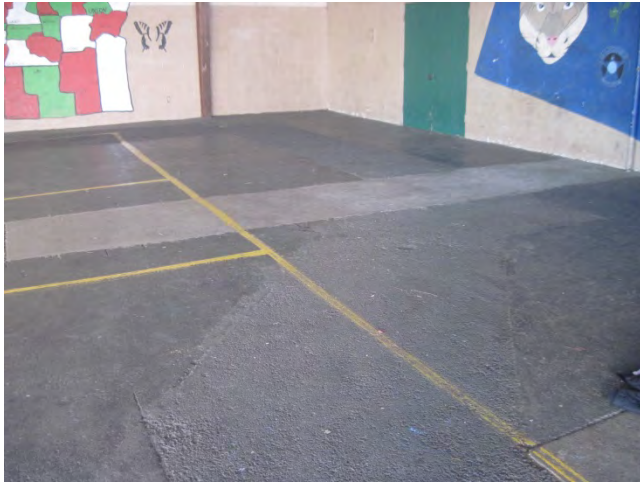
Elementary School – Area-C, Northwest Covered Play Area; Note, additional view showing severe surface pitting and wear.

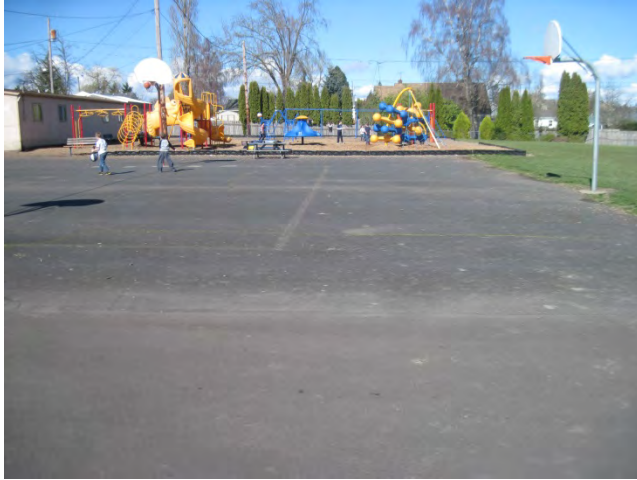
Elementary School – Area-D, West Play Area;
Note, minor cracking and surface degradation,
worn and faded playground striping.

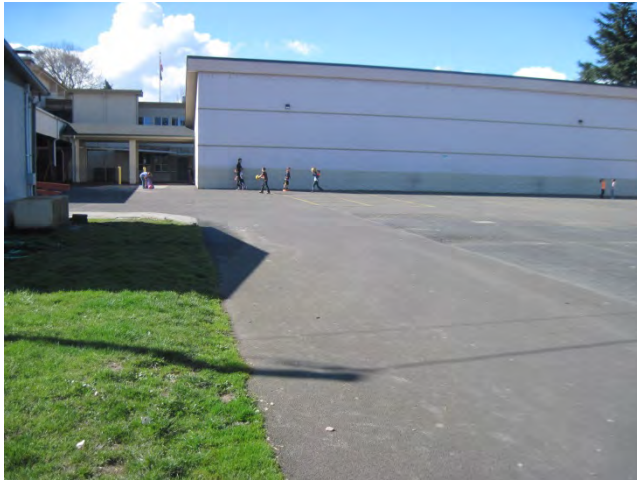
Elementary School – Area-D, West Play Area;
Note, minor surface degradation, worn and faded
playground striping.

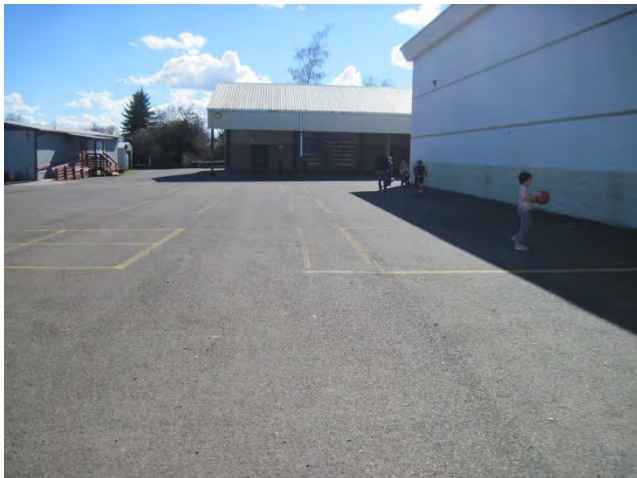
Elementary School – Area-D, West Play Area;
Note, minor surface degradation, worn and faded
playground striping.

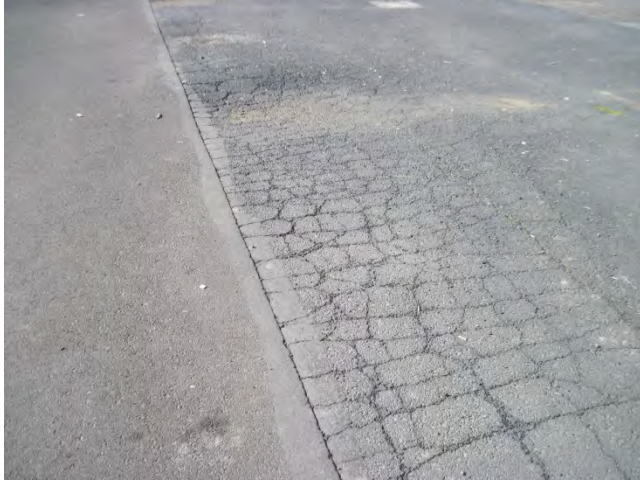
Elementary School – Area-D, West Play Area; Note, selective areas of base rock and surface failure in need of replacement.

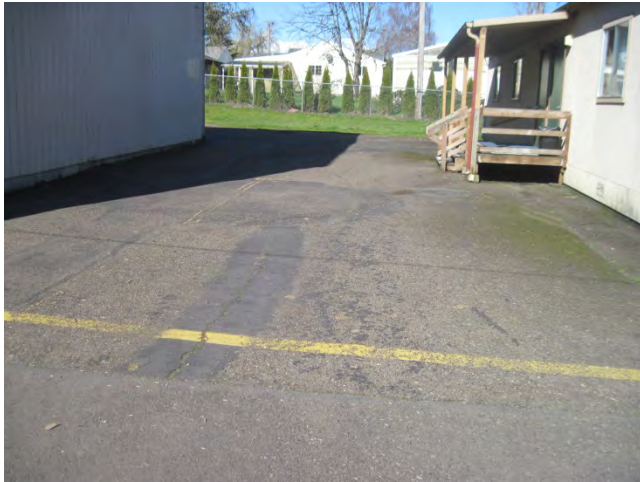
Elementary School – Area-D, Southwest Play Area; Note, selective areas of base rock and surface failure in need of replacement.

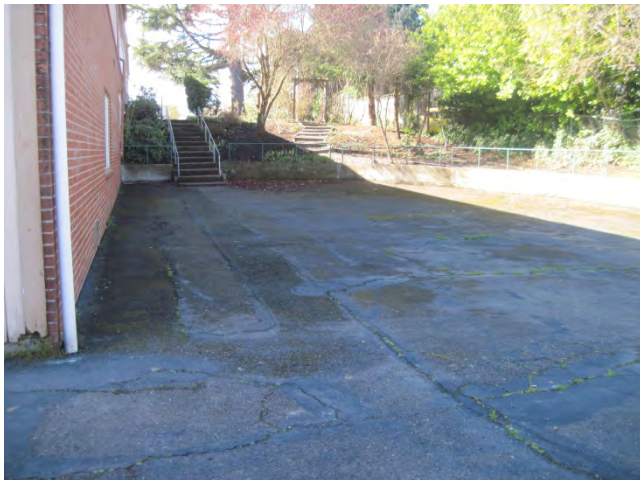
Elementary School – Area-D, South Courtyard Area; Note, this area indicates a complete failure of the base rock and surface asphalt in need of complete replacement.

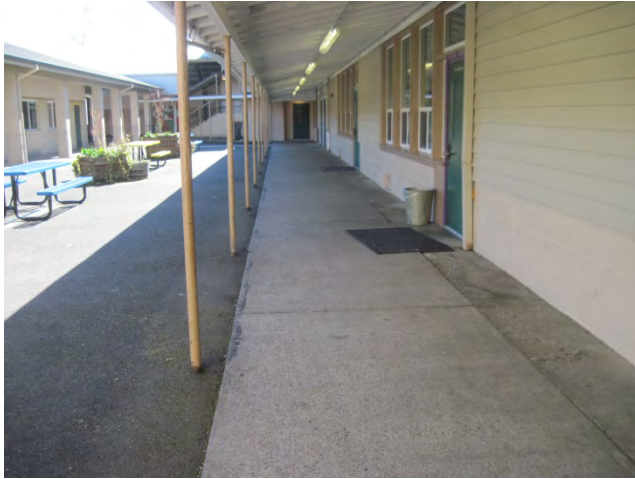
Elementary School – Area-E, Central Courtyard Play Area; Note, minor surface wear

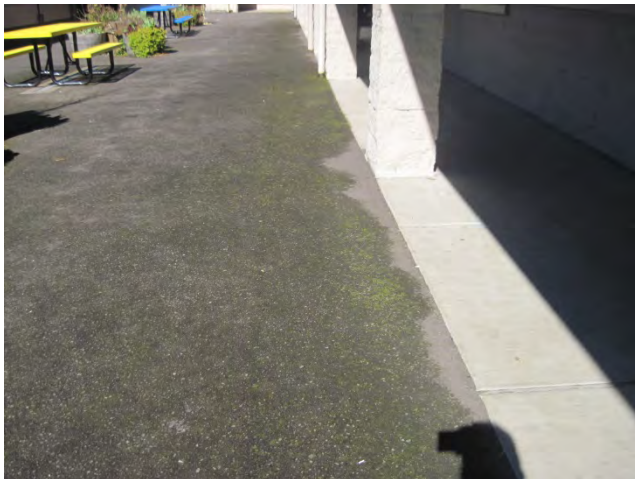
Elementary School – Area-E, Central Courtyard Play Area; Note, minor surface wear and moss growth.

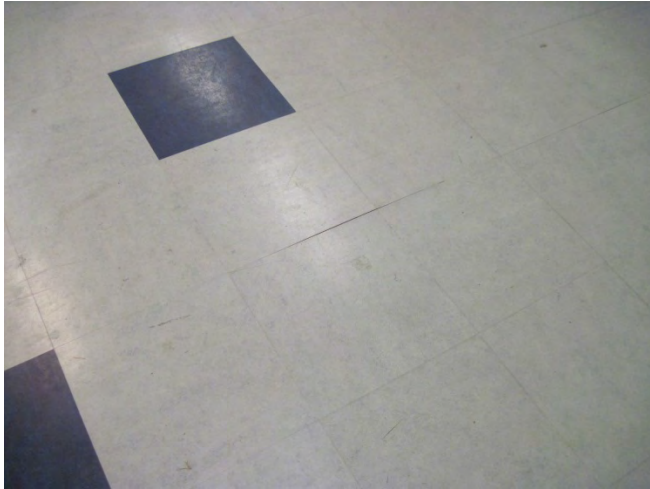
Newer 12'x12' Vinyl Floor Tile showing separation, Main Floor Corridors

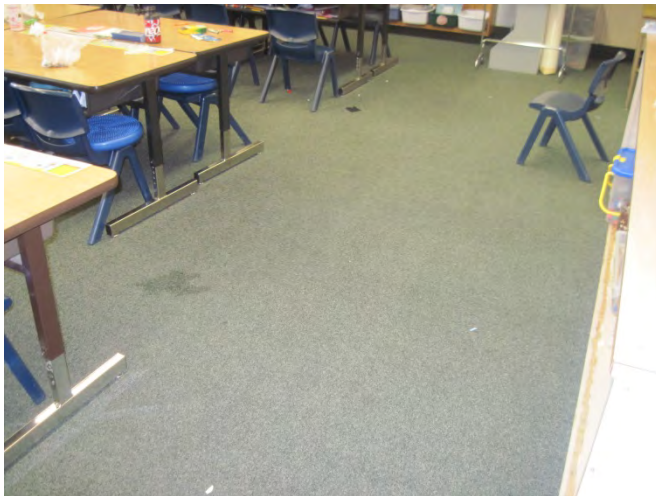
Worn and outdated carpeting Main Floor Classroom

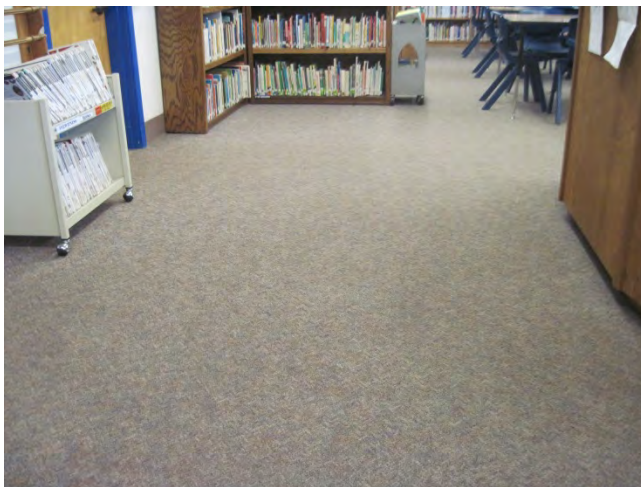
Worn and outdated carpeting, Main Floor Library

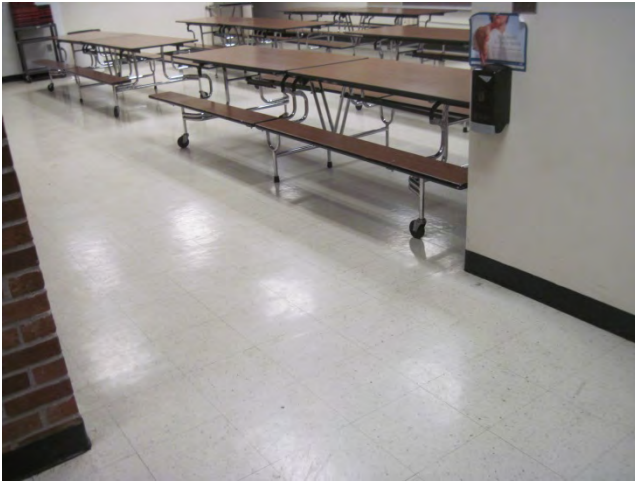
Older 12'x12' Asbestos Floor Tile, Cafeteria,
Main Floor

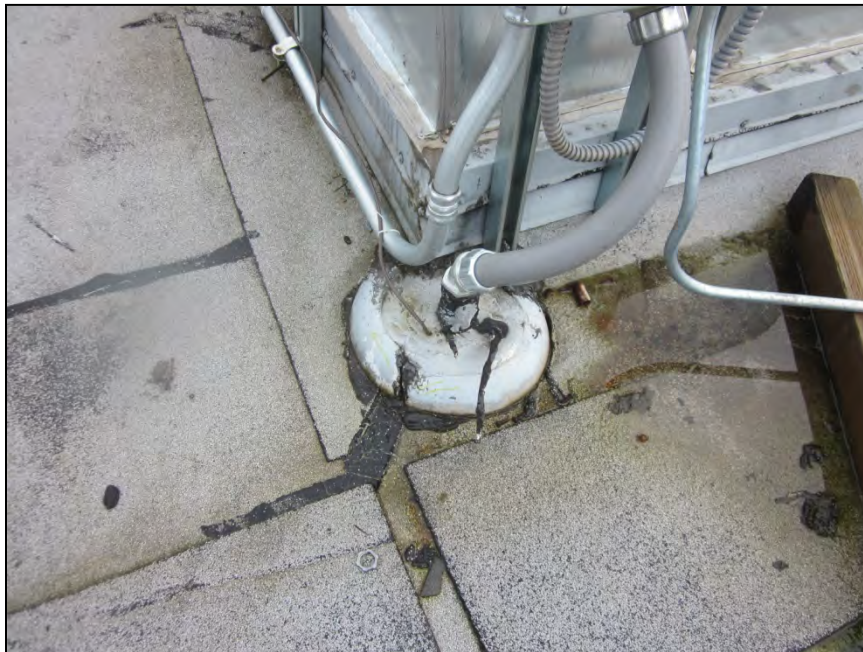
Sec. 1.04 – Roof A: View of voids in sealer at Chem-curb near AC at west section of the roof.

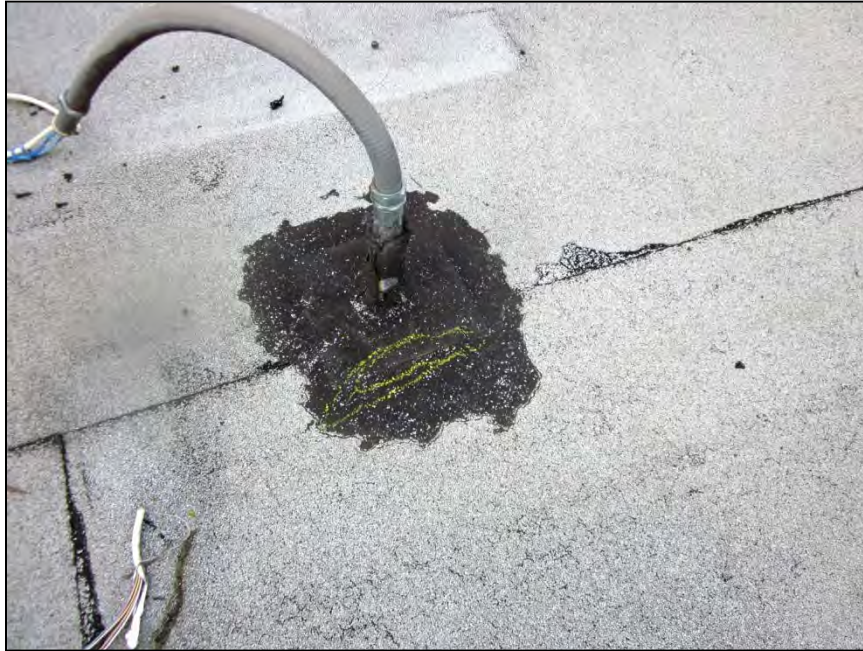
Sec. 1.05 – Roof A: View of splits in mastic at abandoned pipe penetration near AC at west section of the roof.

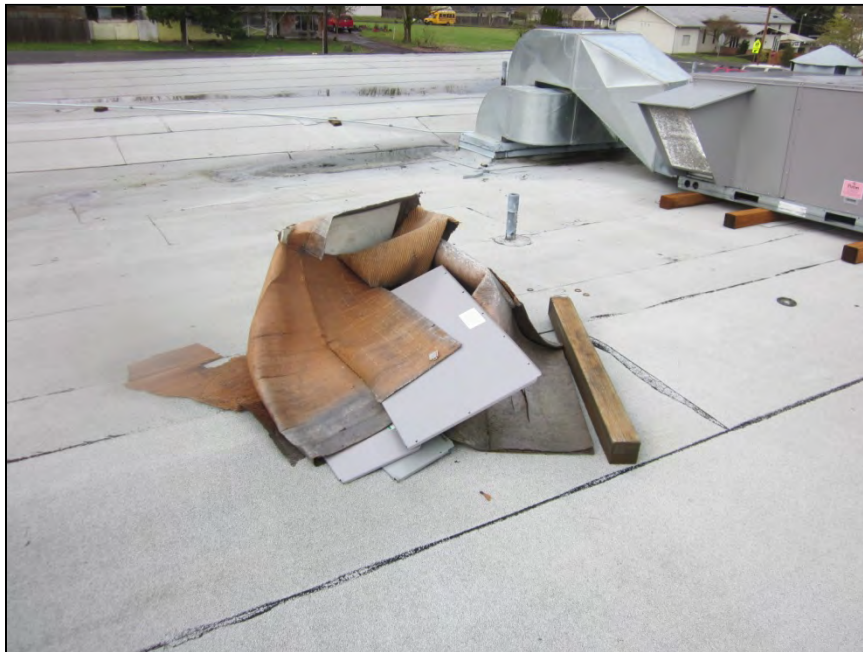
Sec. 1.06 – Roof A: View of debris on roof at south section of the roof.

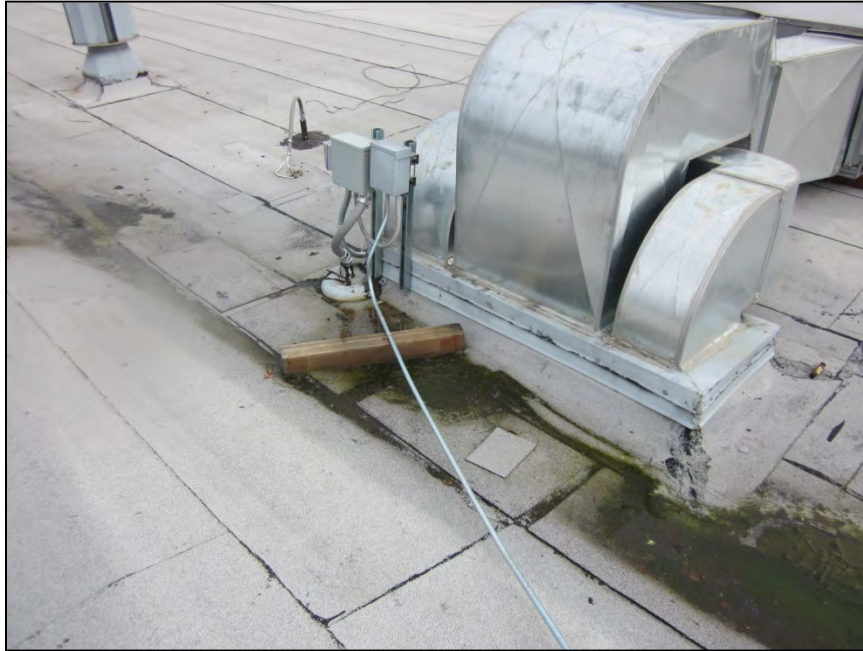
Sec. 1.07 – Roof A: View of wood support that is blocking water flow in valley at west section of the roof.

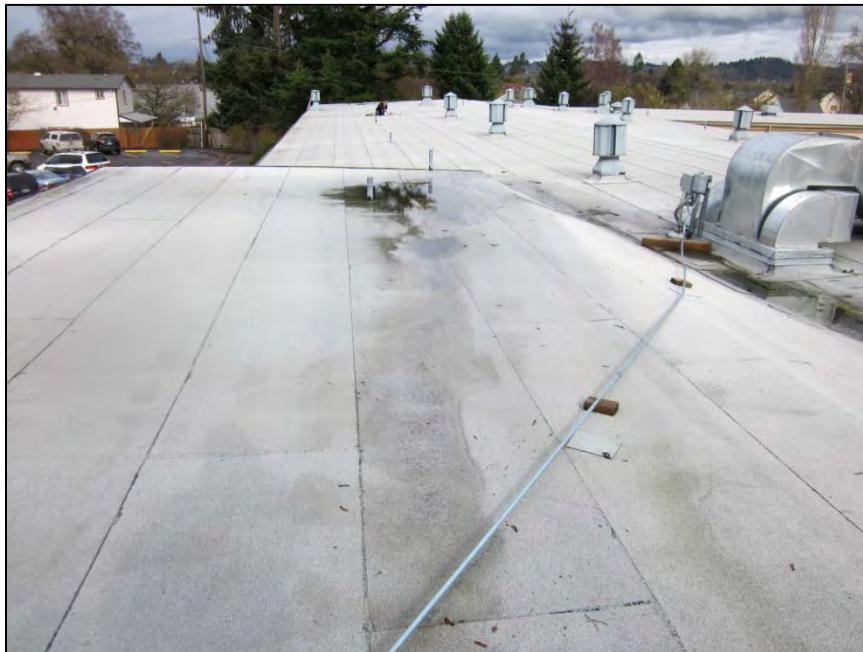
Sec. 1.08 – Roof A: View of ponding at west section of the roof.

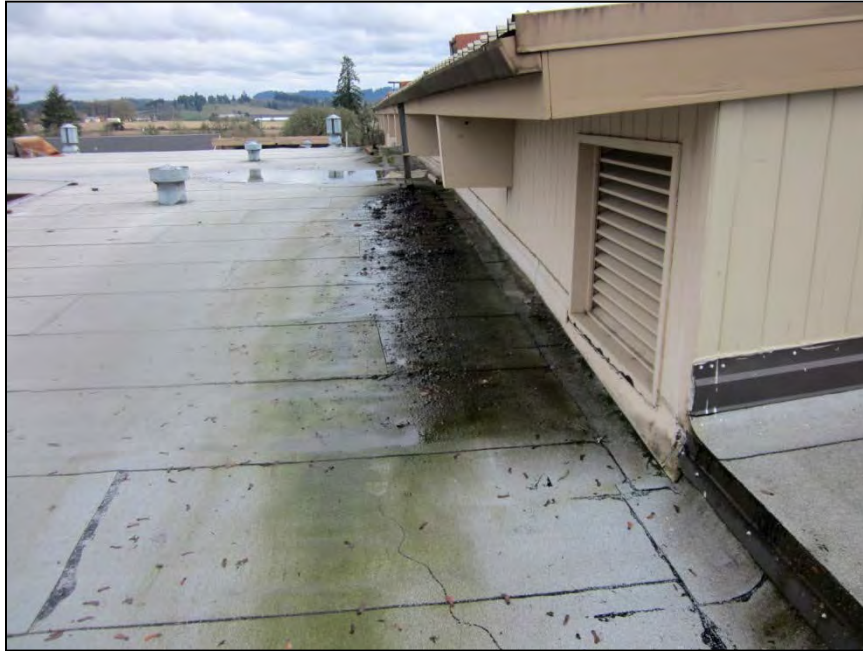
Sec. 1.09 – Roof A: View to east of organic debris at south section of the roof.

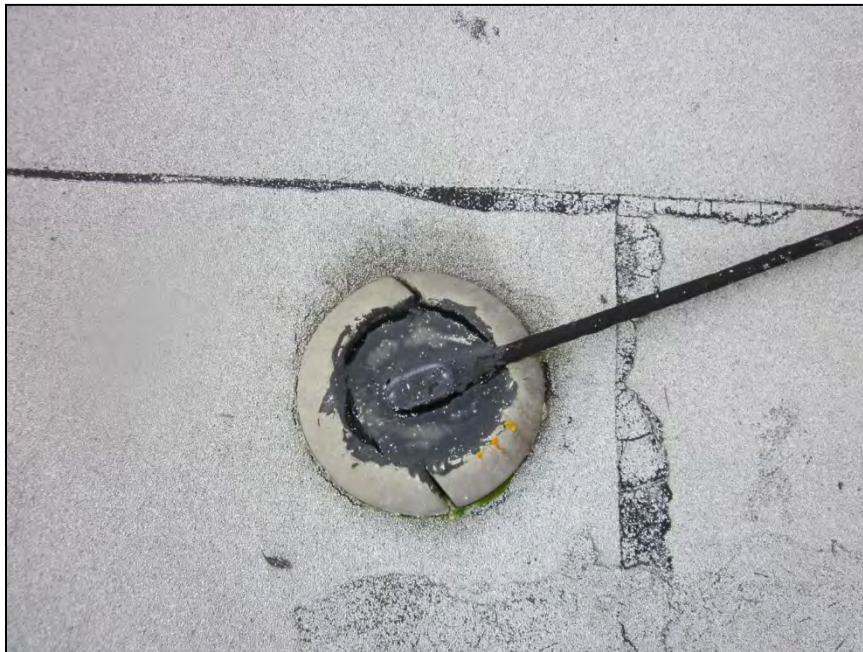
Sec. 1.10 – Roof A: View of voids in Chem-curb sealer at south section of the roof.

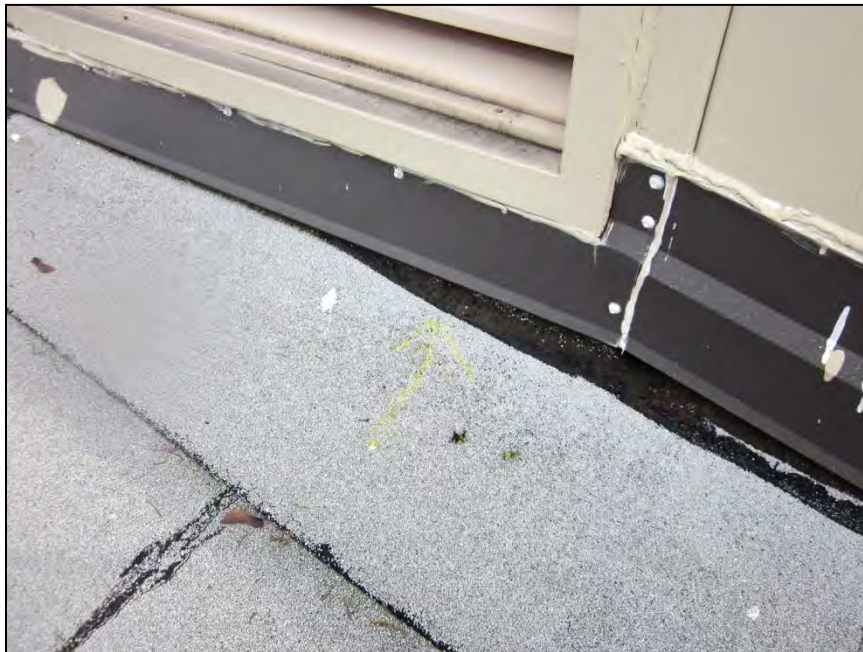
Sec. 1.12 – Roof B: View of base flashing that is not tight at east parapet at center section of the roof.

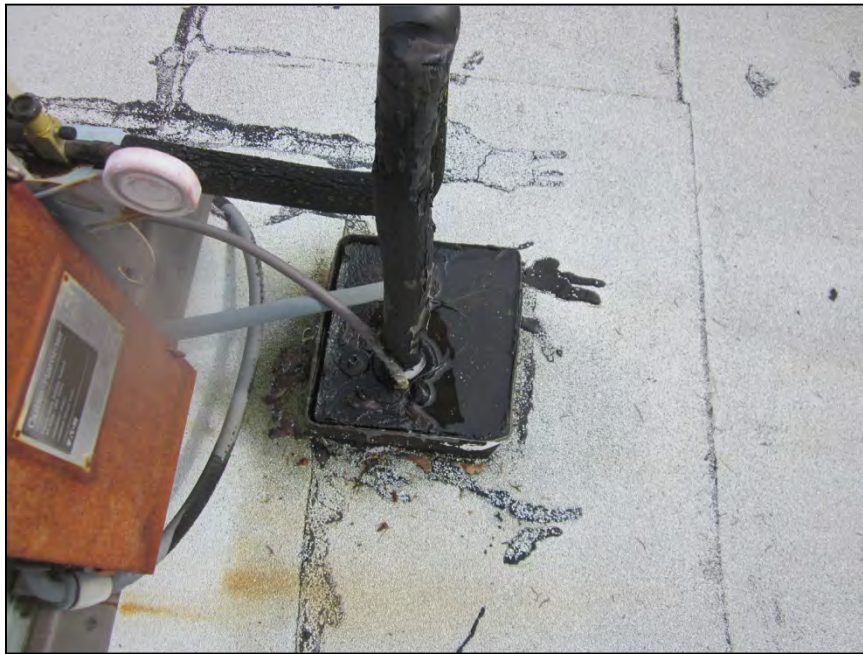
Sec. 1.13 – Roof B: View of water in voids in pitch pan sealer at southwest section of the roof.

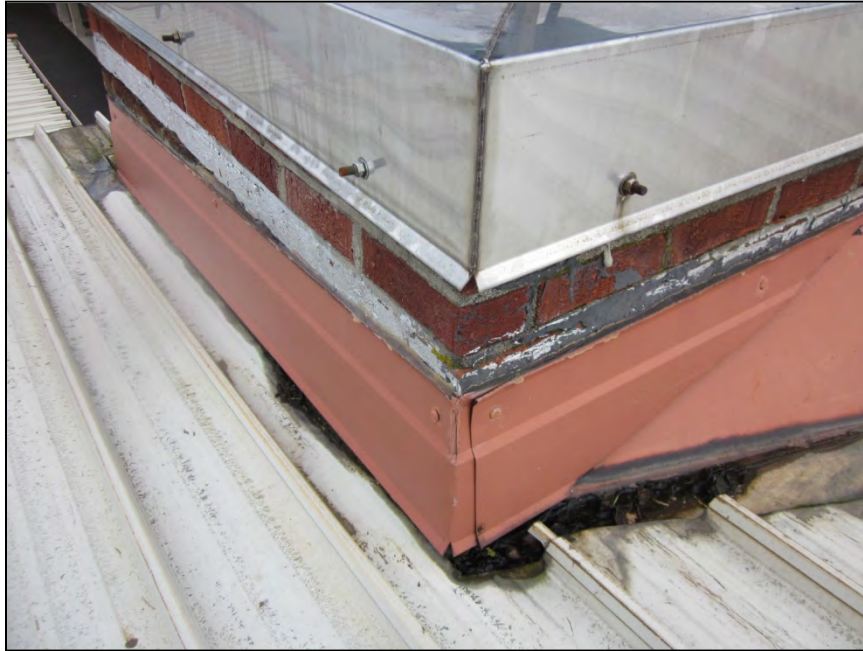
Sec. 1.17 – Roof D: View of voids in caulking at chimney at northeast corner of the roof.

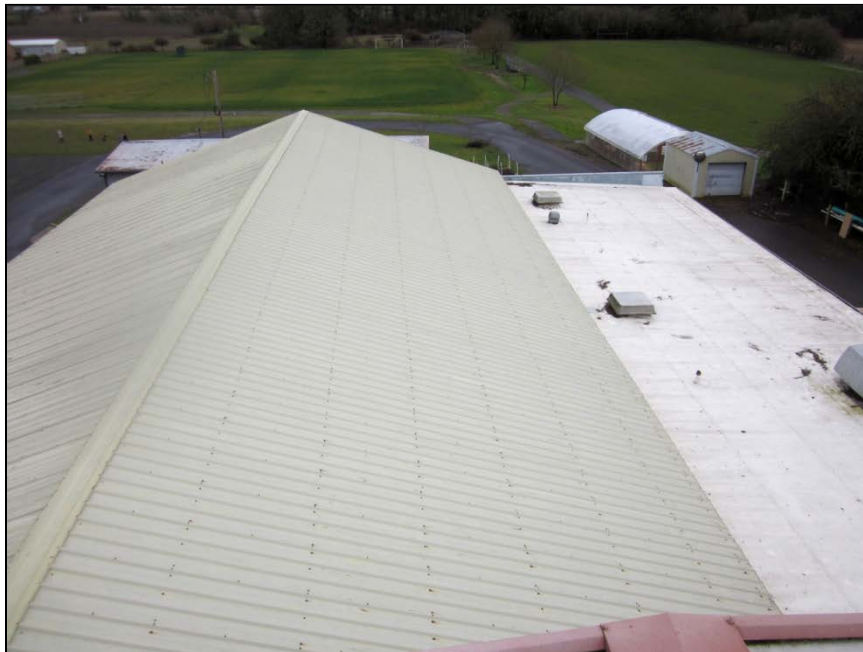
Sec. 1.18 – Roof E: View to east across roof field at south section of the roof. Note some staining at screws.

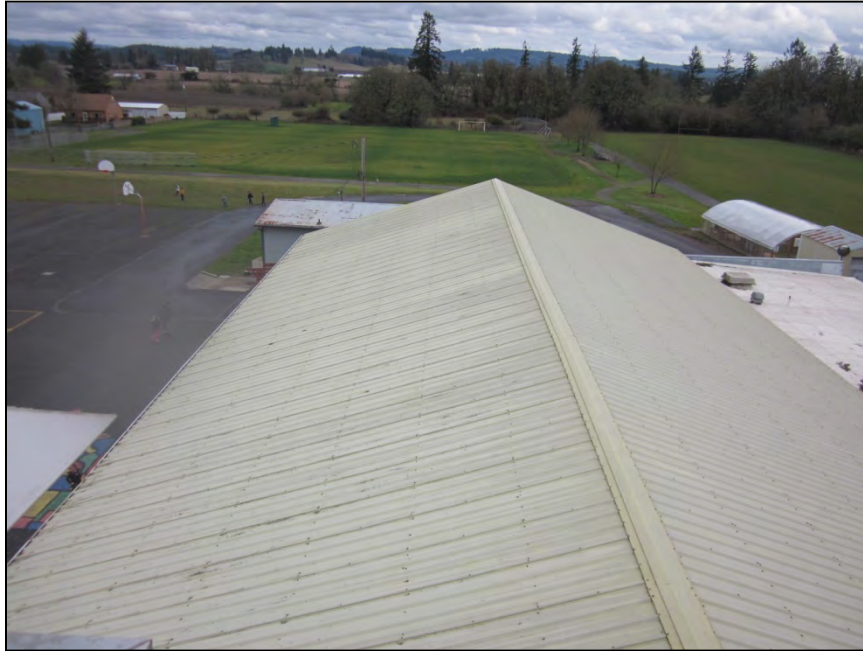
Sec. 1.19 – Roof E: View to east across roof field at north section of the roof. Note some staining at screws.

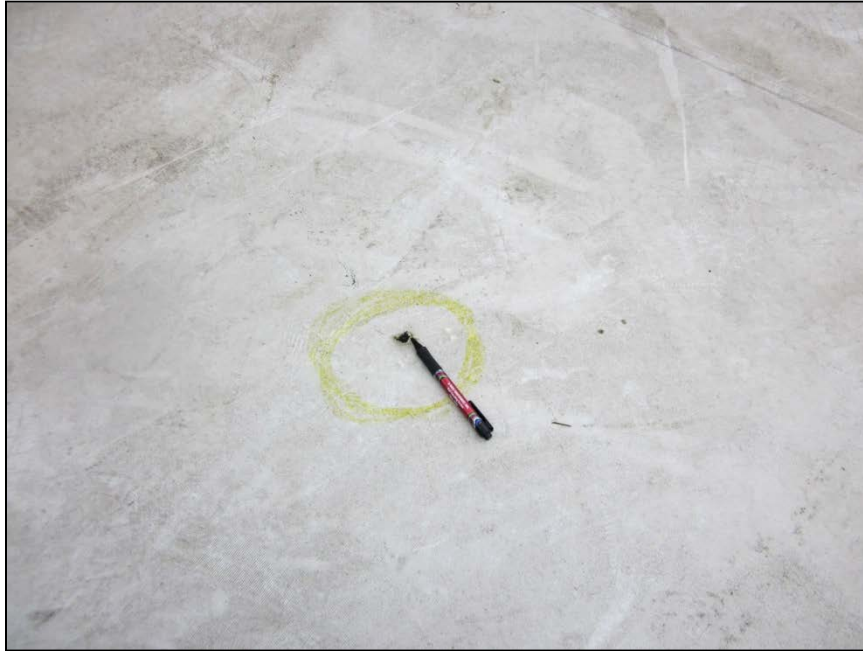
Sec. 1.21 – Roof F: View of hole in membrane at west section of the roof.

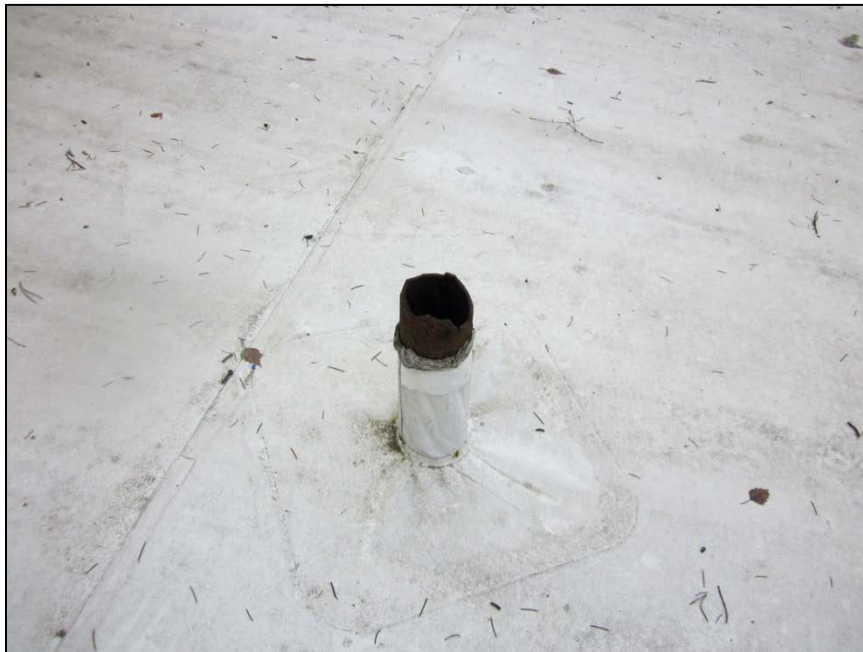
Sec. 1.22 – Roof F: View of void in caulking at plumbing vent at north section of the roof.

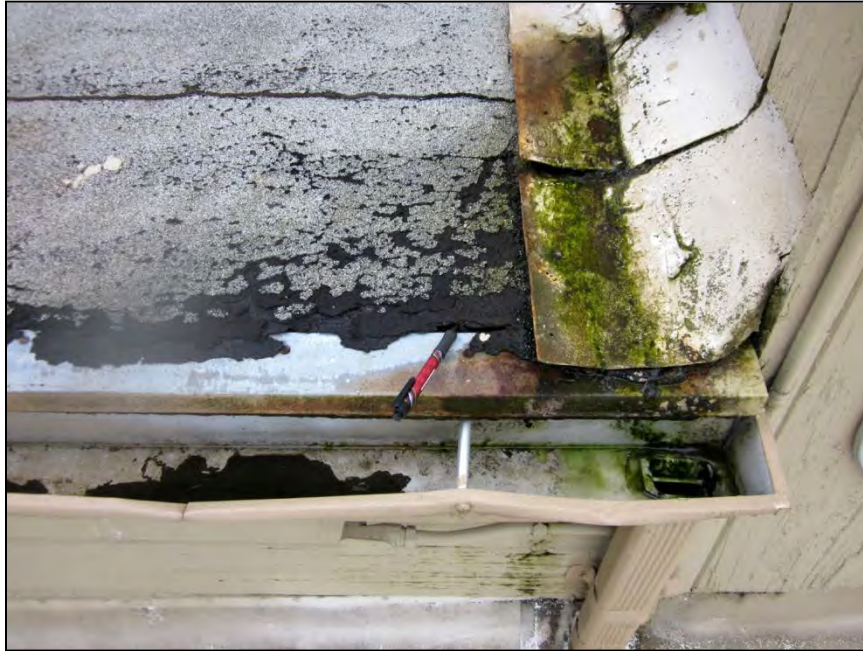
Sec. 1.25 – Roof H: View of hole at the northeast corner.

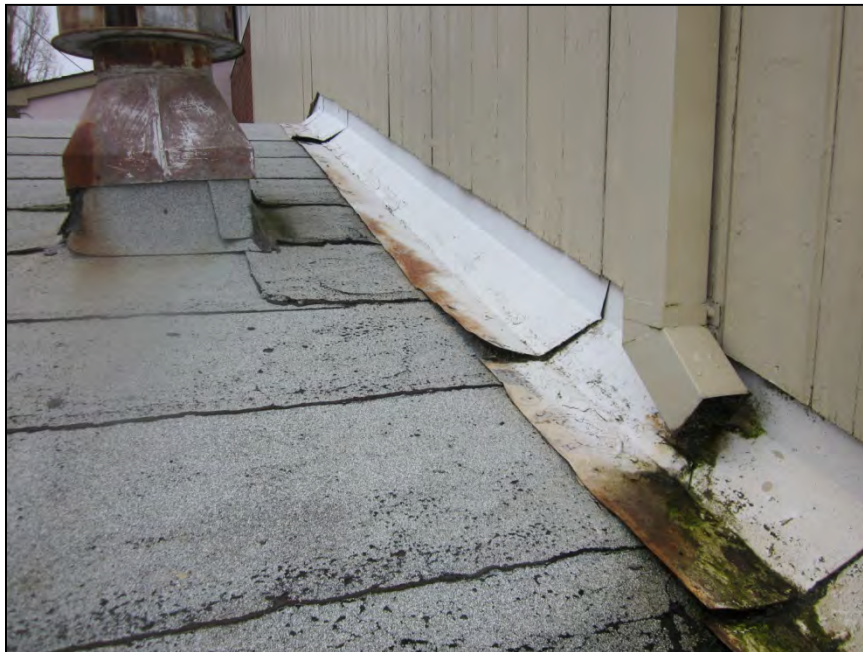
Sec. 1.26 – Roof H: View of loose metal flashing at the north wall.

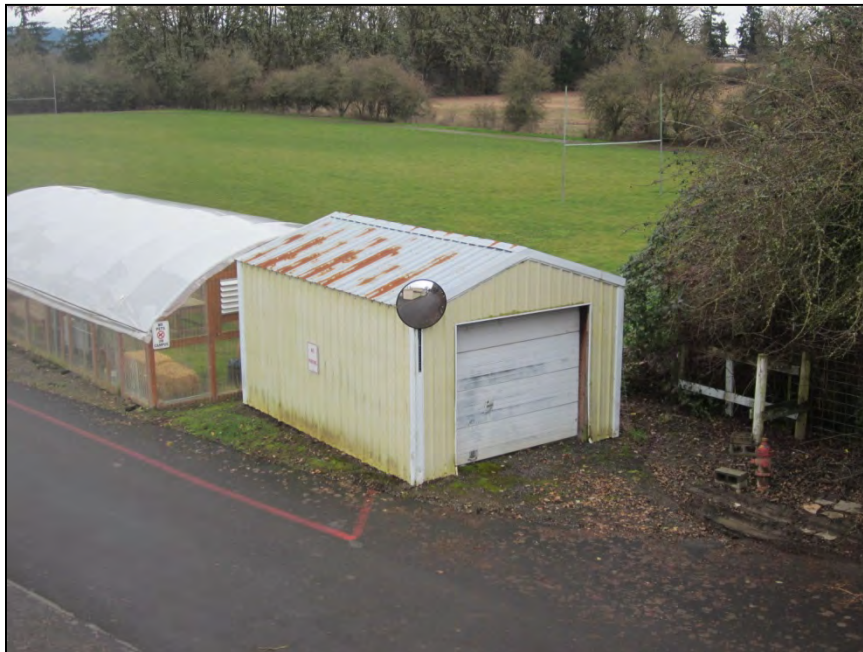
Sec. 1.32 – Roof S: View to southeast across the roof field. Note rusting.

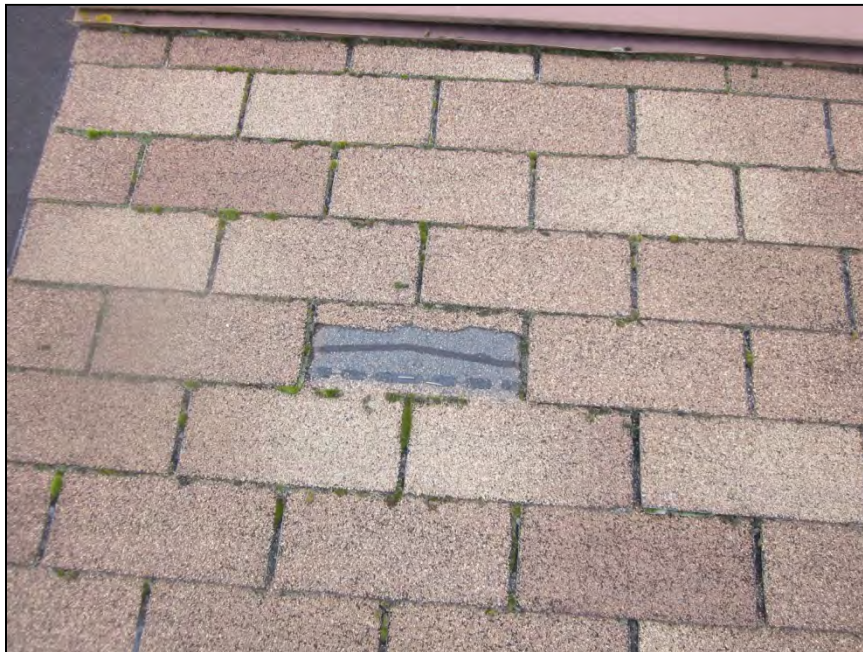
Sec. 1.36 – Roof V: View of missing shingle at southeast section of the roof.

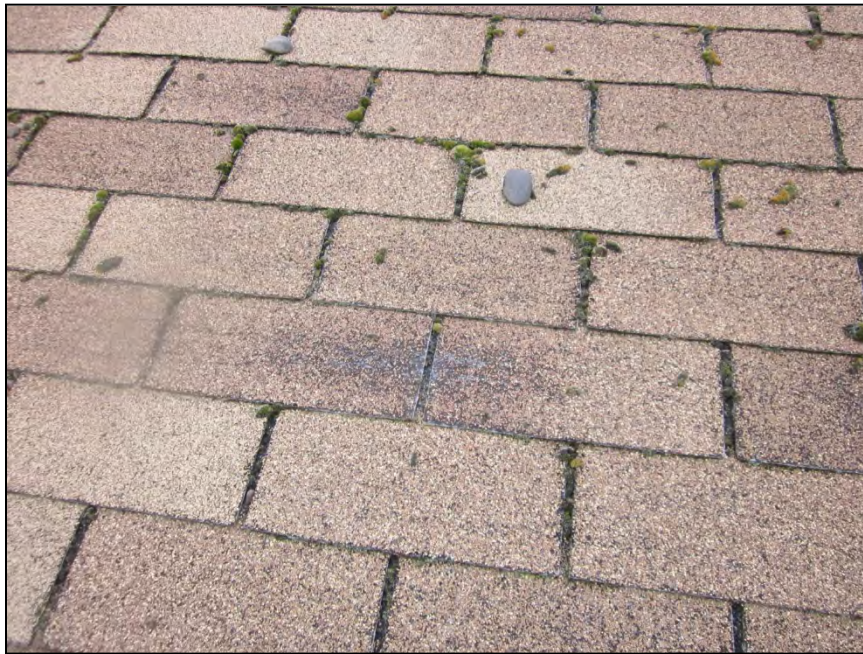
Sec. 1.37 – Roof V: View of fiberglass showing thru shingle at west section of the roof.
