# **Yamhill-Carlton School District**

**Building Assessment**

**Yamhill High School**

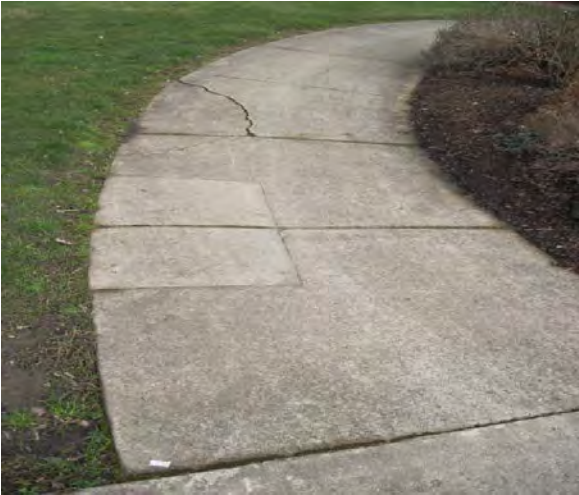
This section of sidewalk is in the front of the building at ground level to the left of the main entry. Concrete is cracking as well as lifting edges may cause trip hazards

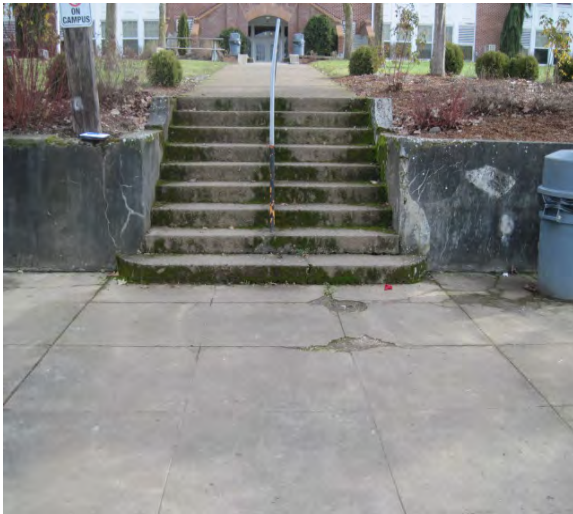
The front stairs at street are showing their age and are in need of updating. Cracking, spalling, moss growth, and inadequate code complaint handrail are all items of concern.

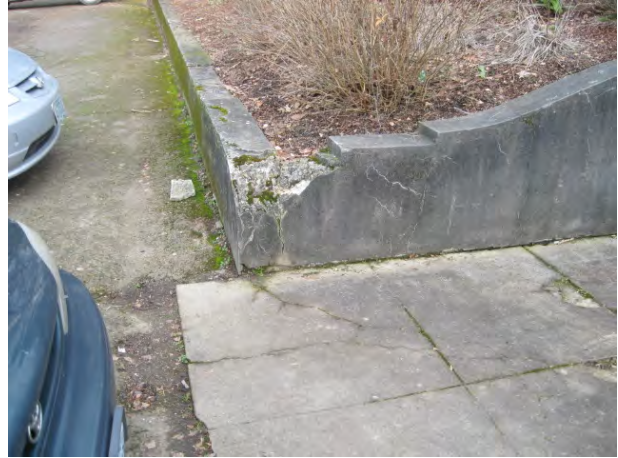
Concrete sidewalks and landscape walls at front parking area are showing signs of deterioration possibly creating a hazard. The District should develop a replacement plan of deterioration site concrete walkways. The plan could schedule replacement over a number of years allowing the work to budgeted with maintenance funds.

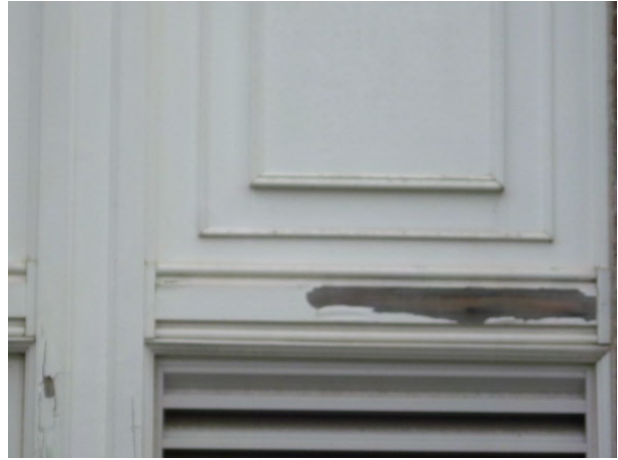
These three pictures are of the front of the building to the right of the main entry. This side of the building faces west and is subject to the prevailing weather. The picture in the upper left corner shows the entire window section while the other two pictures detail close up area of concern.

It appears that the condition primarily is in need of paint. Removal of loose paint, application of a good exterior primer and then 2 coats of high quality exterior paint will provide the necessary protection for the wood. This condition is true for the entire building although not as severe in other areas of the building.

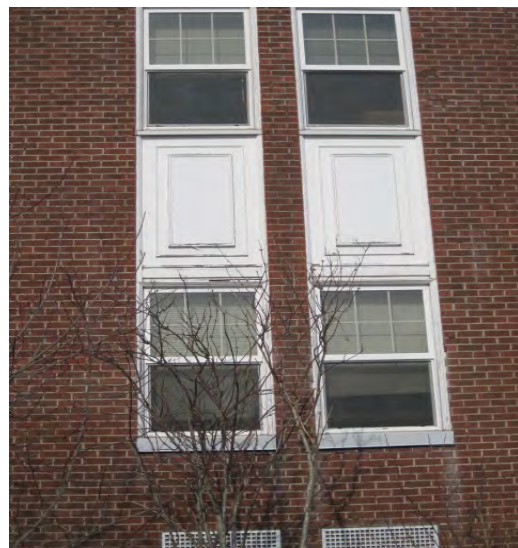
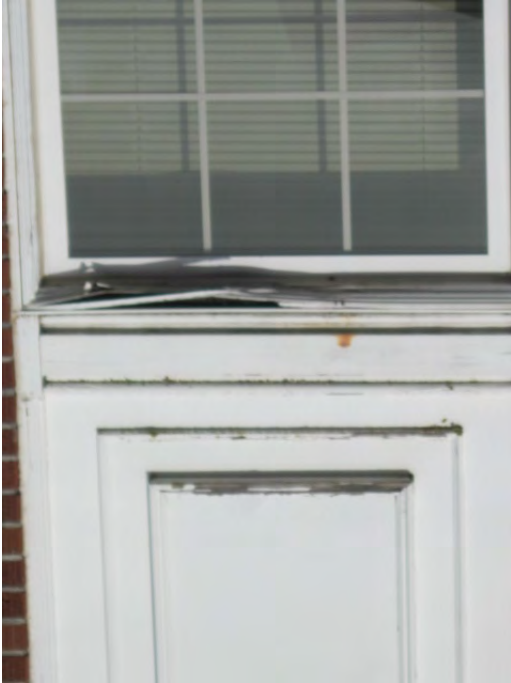
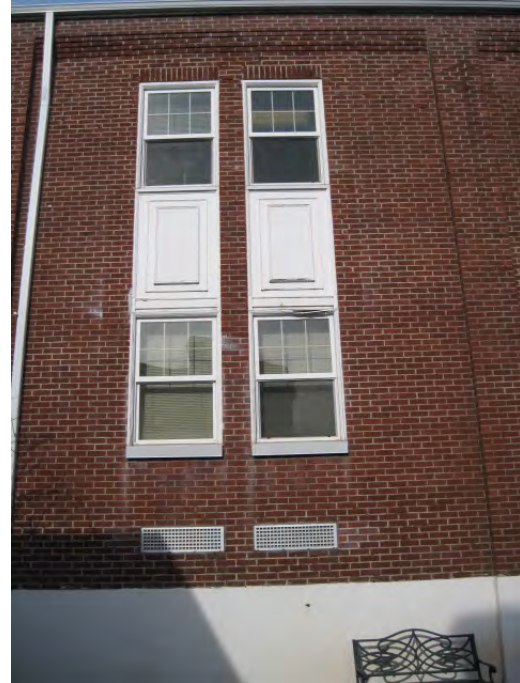
Additional areas showing signs of wood trim deterioration and need of exterior painting. These pictures are of the South facing wall in the rear courtyard.

We recommend that further investigation occur to determine whether the wood has begun experiencing dry rot if found replacement of wood trim prior to painting.

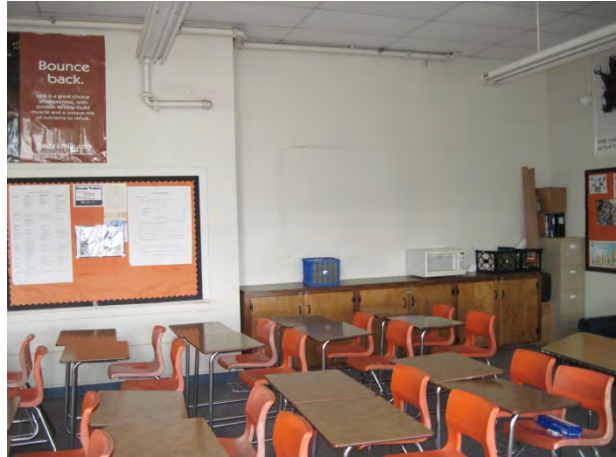
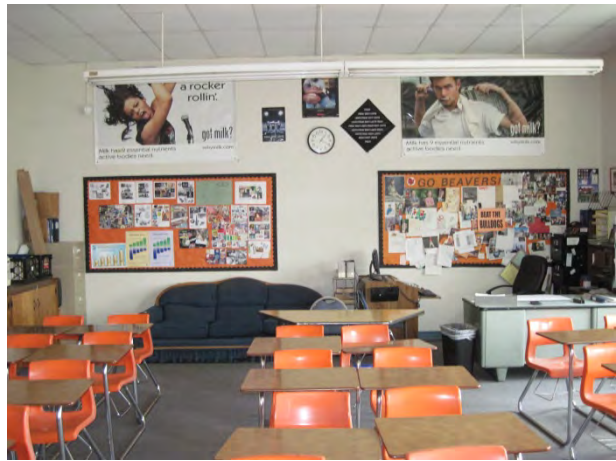
Basement and main floor classrooms do not have adequate storage. Marker boards are inadequate with the porcelain writing surface nearing end of life. Many rooms do not have bulletin boards or have surfaces not made for pinning display materials; teachers use creative ways to display items even when pinnable surfaces are not available. (Pictures below are of room 206)

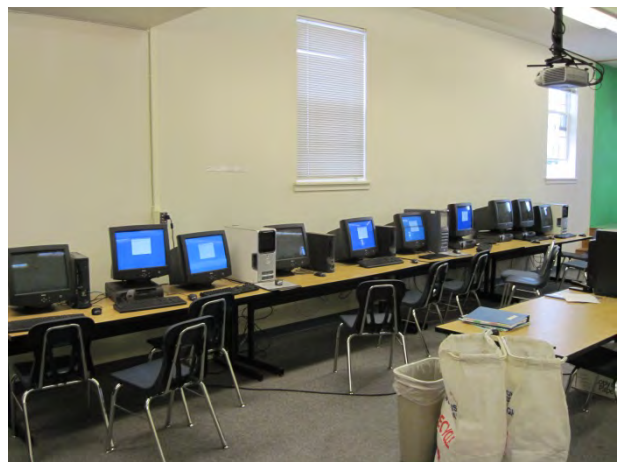
Comfort in the basement computer lab is poor, excessively hot needing additional fans to provide air movement

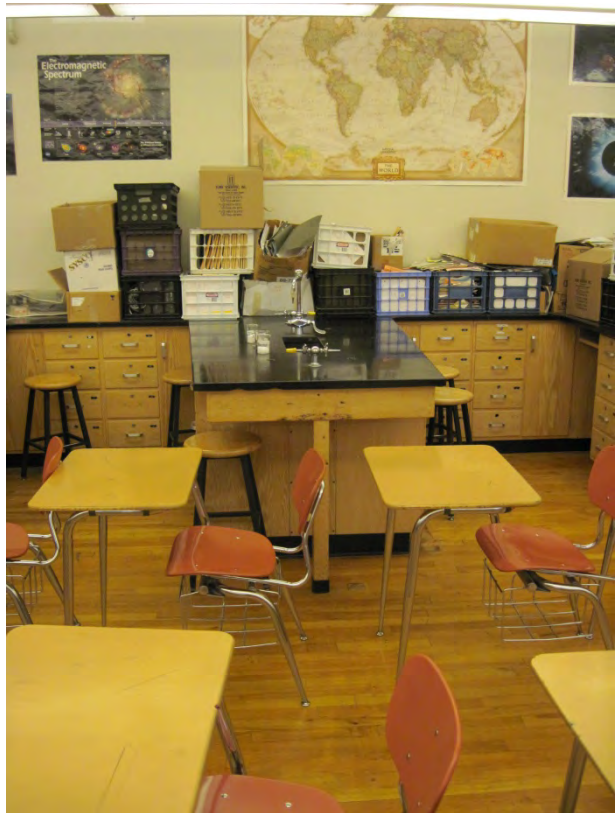
Storage is inadequate and should be considered a hazard both fire and occupant safety.

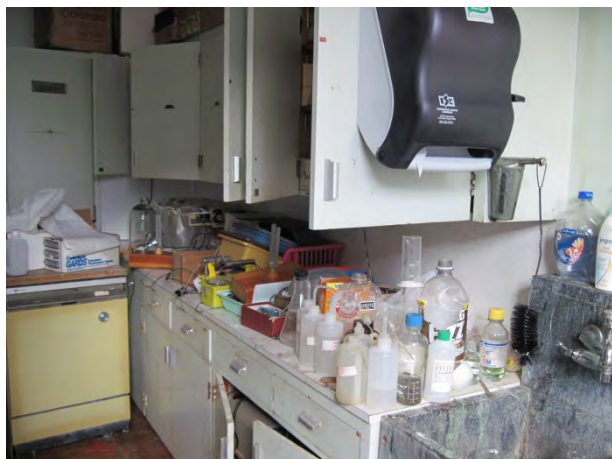
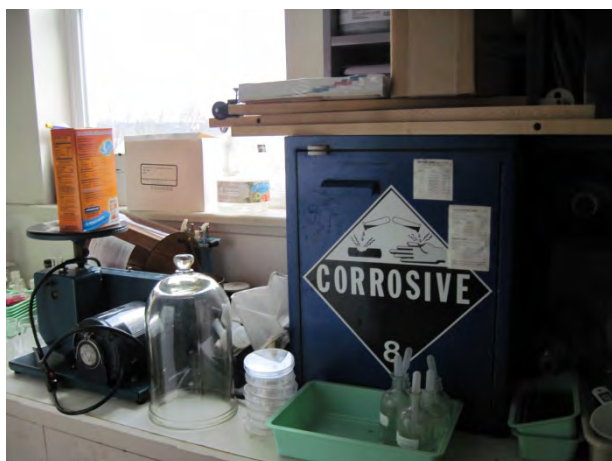
Science prep room storage is inadequate. Chemical storage cabinets are not rated. It is recommended to have a person familiar with the chemical stored to survey age, volatility, and grouping of chemicals in cabinets to determine proper storage and whether chemicals are beyond their allowable shelf life. The teaching wall, room 212, needs upgrading, new storage cabinets, marker board, and teaching lab would make noticeable improvements to the space.

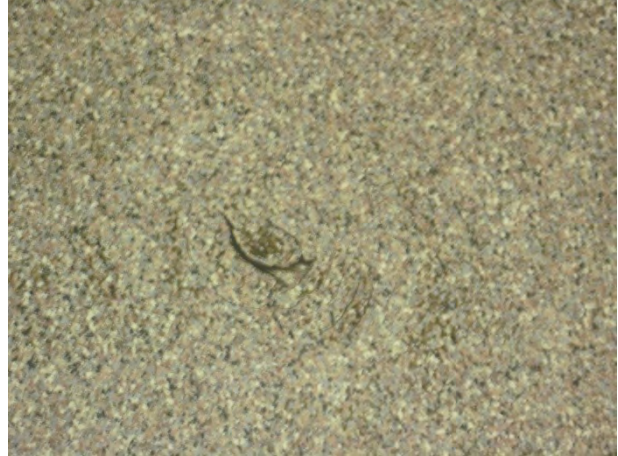
Floors in restrooms on all three floors are in good condition. A number of areas depicted in the following pictures having cracks, tears, or separation of the welded seams. These conditions need repair by a trained floor technician who can use vinyl floor welding techniques to repair these areas. The concern is water over prolonged periods will move migrate beneath the surface promoting mold, mildew, and dry rot.

These pictures are of the basement restrooms. This condition was also noted in 2<sup>nd</sup> floor restrooms.

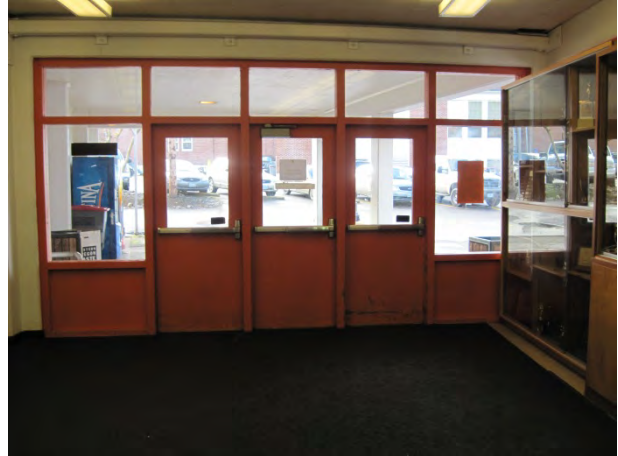
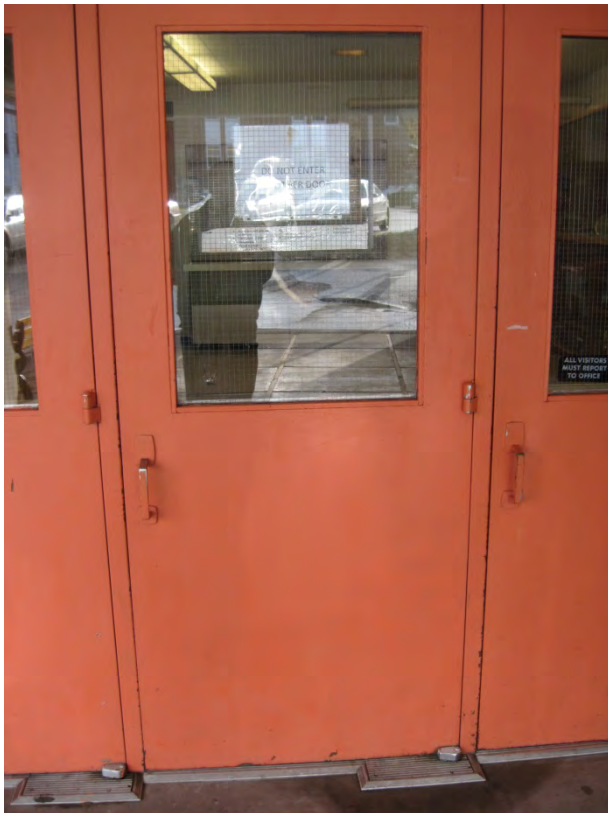
The Main Entry doors are beyond their useful life having experienced failure of the integral hinge door closer system with the middle of the 3 operational doors no longer able to open. The door system is a metal framed metal door with relight. The door is 16'6" X 9'0" with 3 each 3'0" X 7'0" doors. The recommendation is to install new door system fitted within the existing opening.

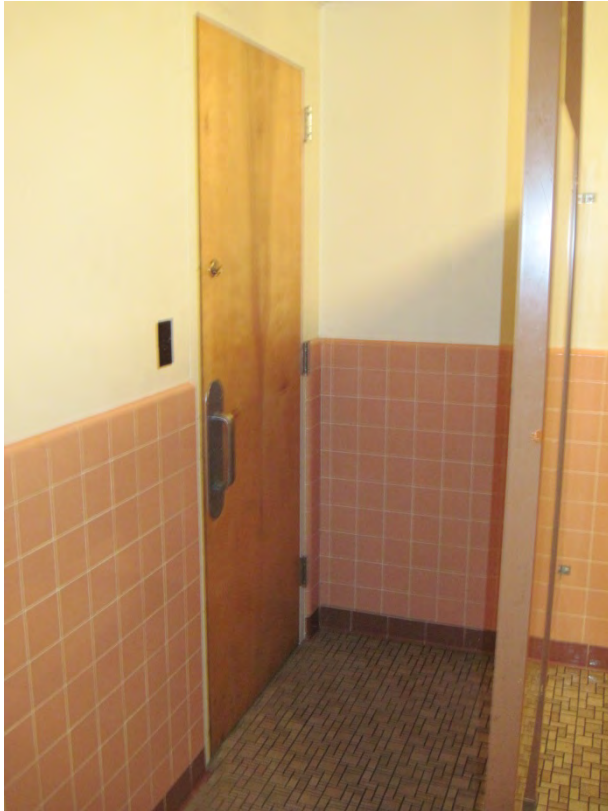
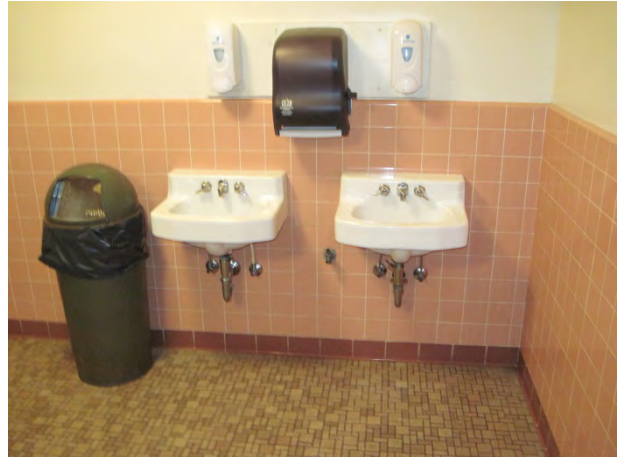
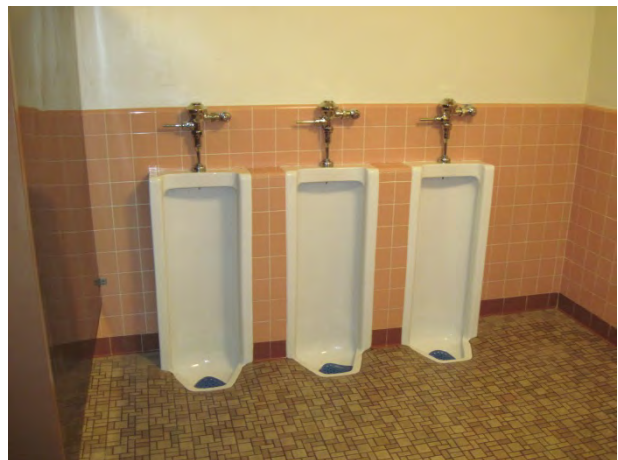
Men's restroom entrance, restroom stalls, urinals and lavatories are all in non-compliance for ADA.

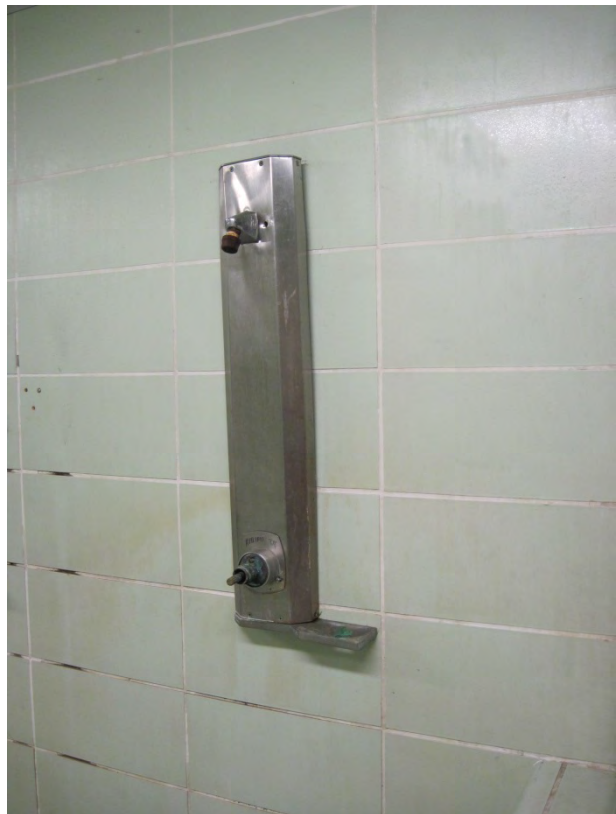
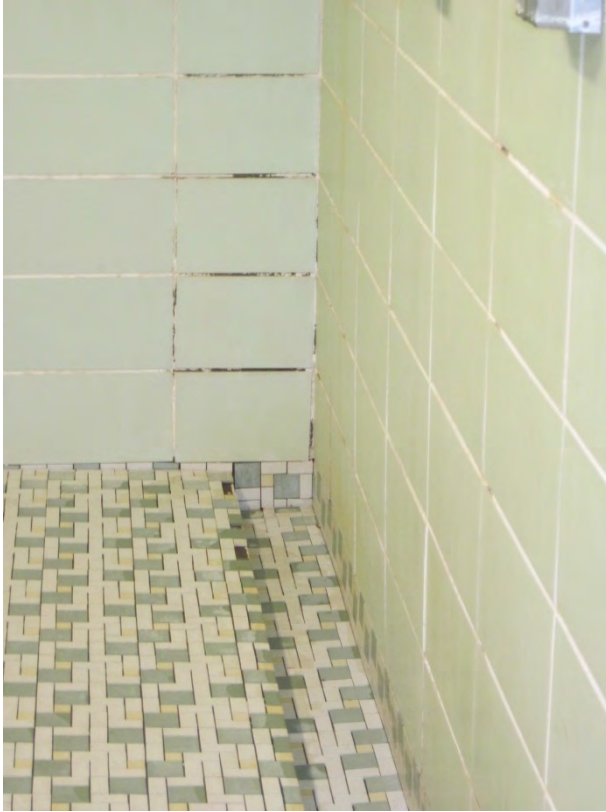
Pictures below show shower area most notable issues are shower faucets having missing handles and no functional. Areas of tile disrepair are seen in the picture below also on the far wall of the picture to the lower left.

Tile disrepair

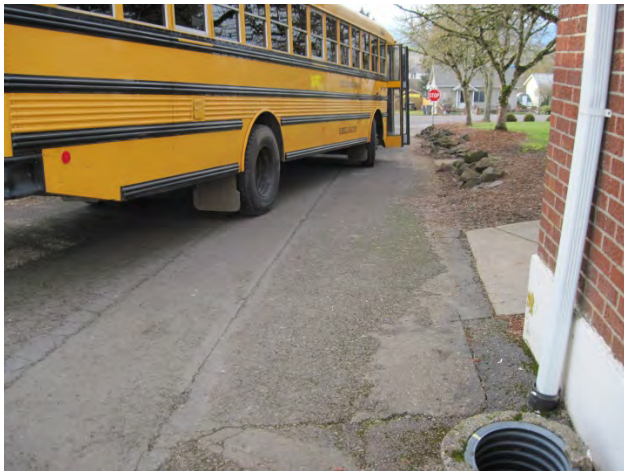
High School – Area-A, Southeast Driveway;  
Note, excessive surface wear, cracking, and  
base failure.

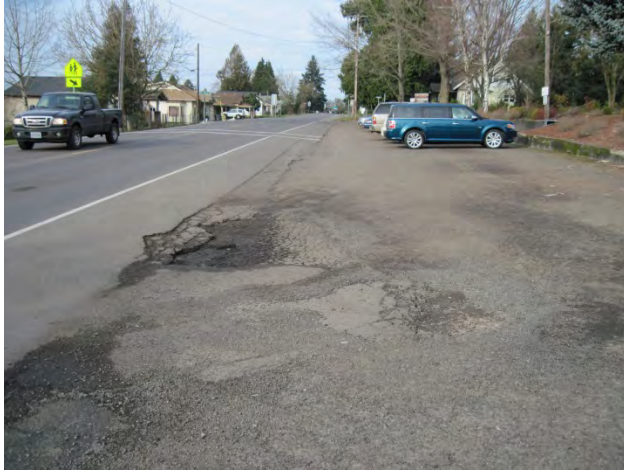
High School – Area-A, East Street Frontage and Parking; Note, excessive surface wear, cracking, and base failure throughout. Concrete retaining wall failure was also noted.

There was inadequate parking demarcation and striping in this area.

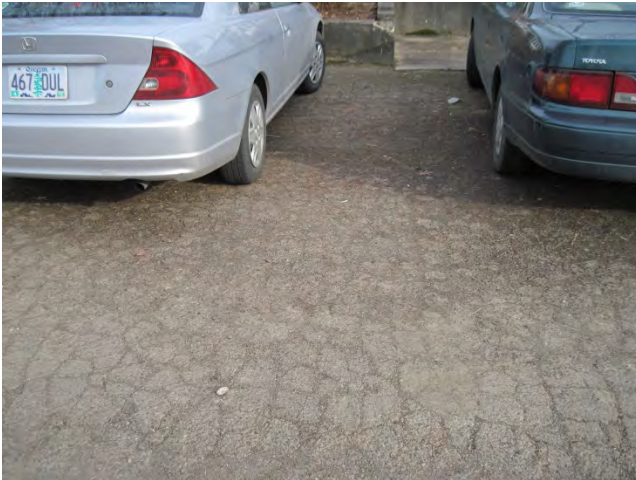
High School – East Street Frontage and Parking; Note, excessive base failure throughout.

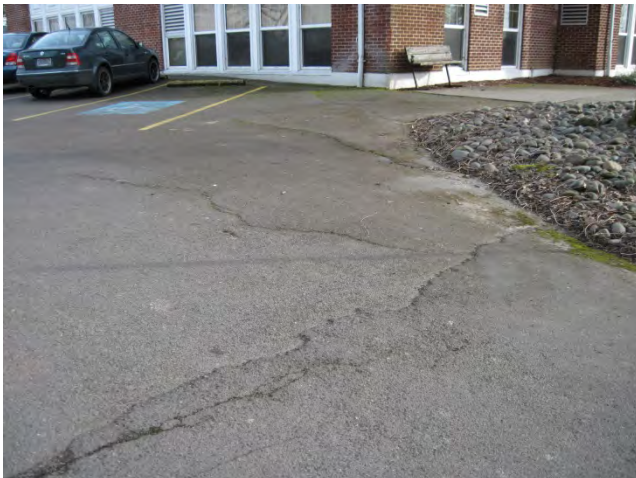
High School – Area-A West Driveway and Parking; Note, excessive surface wear and cracking.

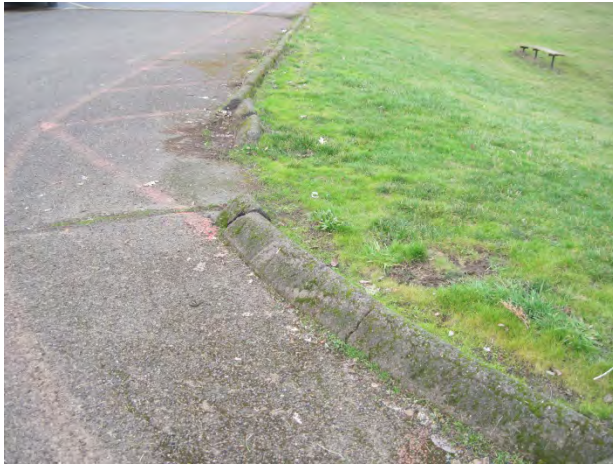
Note; damaged curbing along NW area of Gymnasium (Area-B)

Area-B driveways and parking lots indicating signs of complete base rock and surface asphalt failure. Also indicate above are areas of severe cracking of asphalt drives and deterioration of curbing.

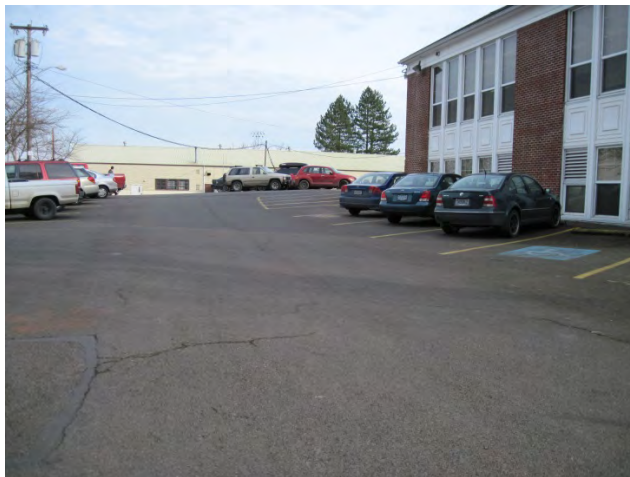
High School – Area-C, North Driveway and Parking Lot; Note, excessive surface wear, cracking, and some base failure.

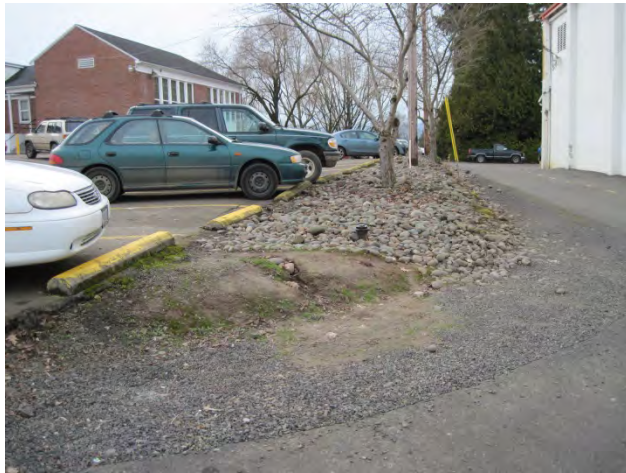
High School – Area-C, North Parking Lot; Note, excessive surface wear, erosion, and inadequate curbing and wheel stops around landscape areas

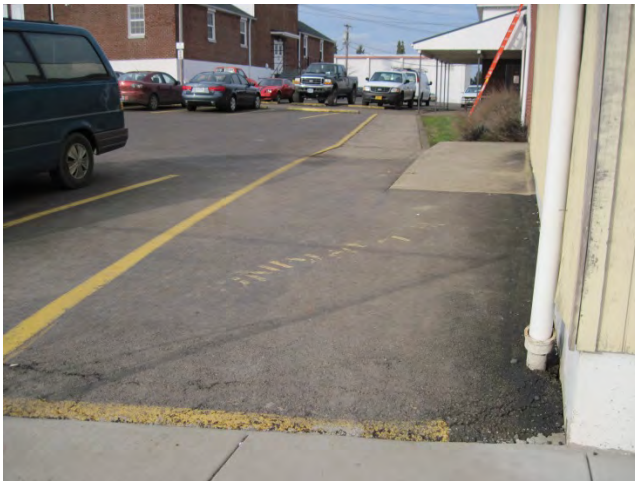
High School – Area-D, South Parking Lot; Note, excessive surface wear, cracking, and some base failure.

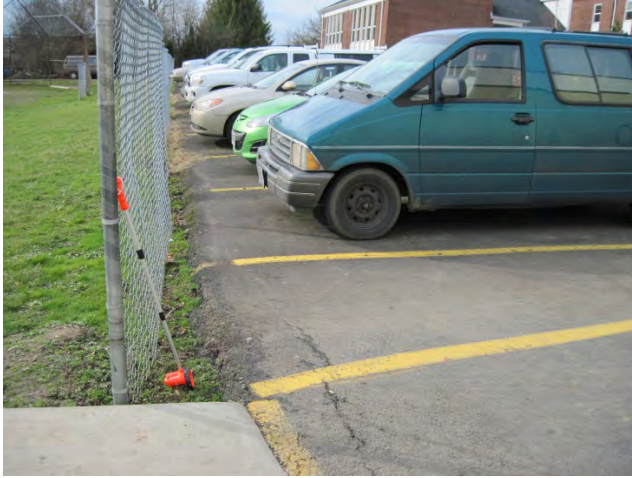
High School – Area-D, South Parking Lot; Note, perimeter erosion, and inadequate curbing or wheel stops causing damage to fencing.

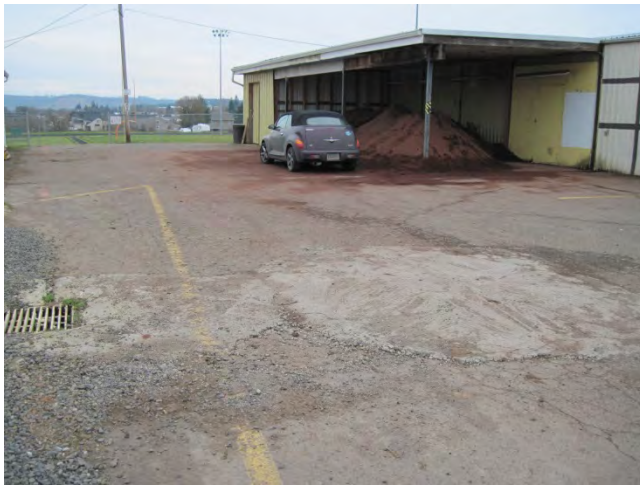
High School – Area-E, Note, excessive surface wear, cracking, and base failure.

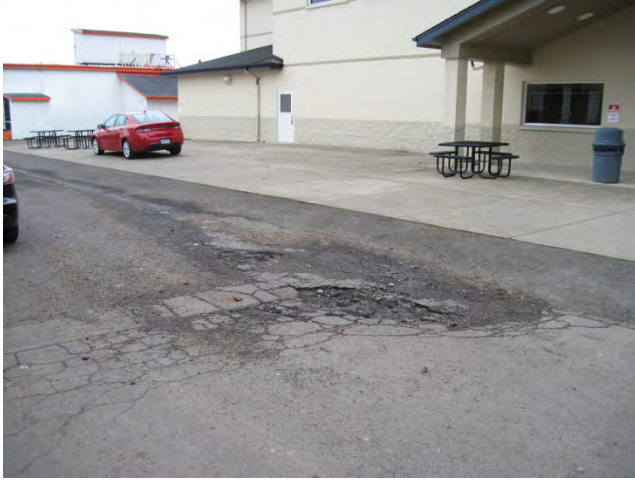
High School – Area-E, Cafeteria Frontage; Note, surface and base rock failure causing pitting.

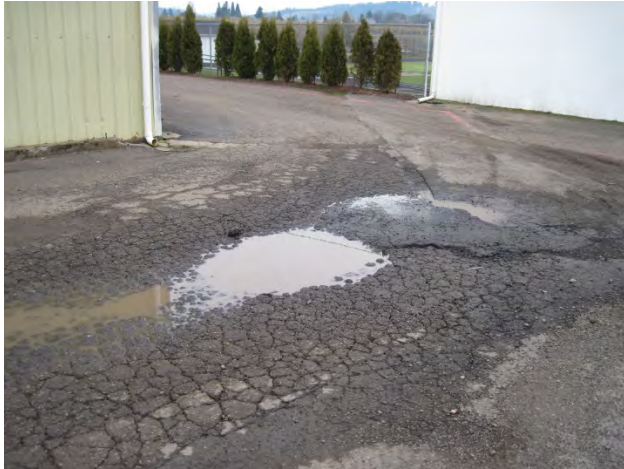
High School – Area-E, Industrial Arts Frontage; Note, surface and base rock failure causing pitting.

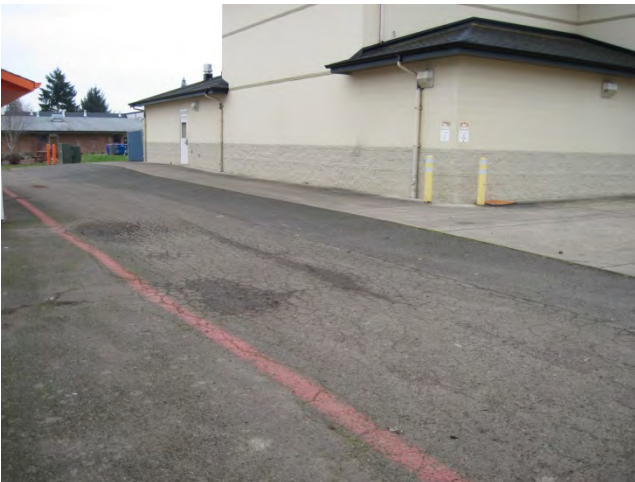
High School – Area-E, Cafeteria South, Note, excessive surface wear, cracking, and base failure.

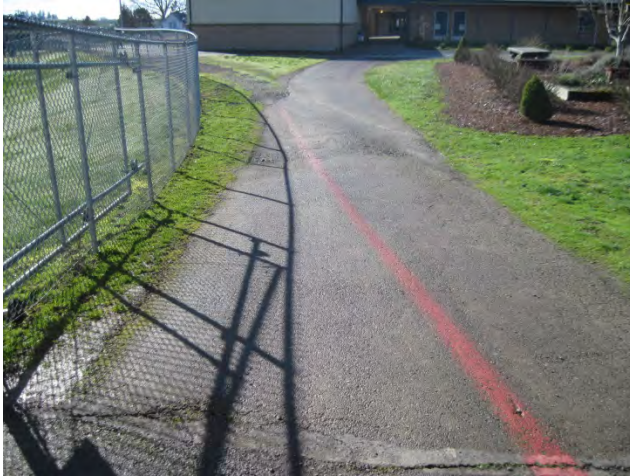
High School – Area-E, Stadium West, Note, excessive surface wear, cracking, and base failure.

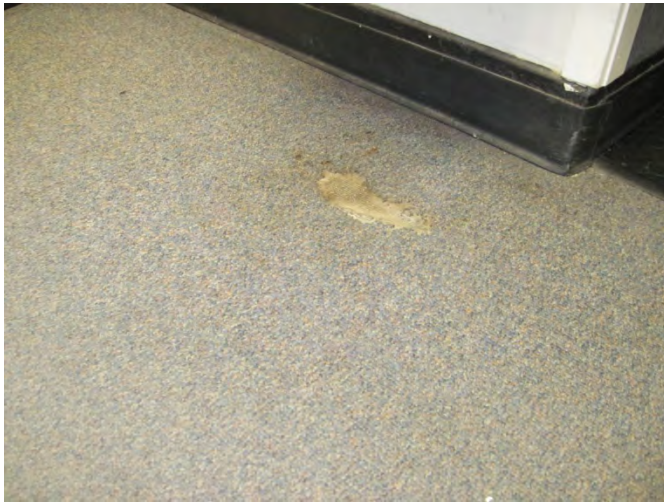
Typical area of worn and outdated carpeting  
First Floor

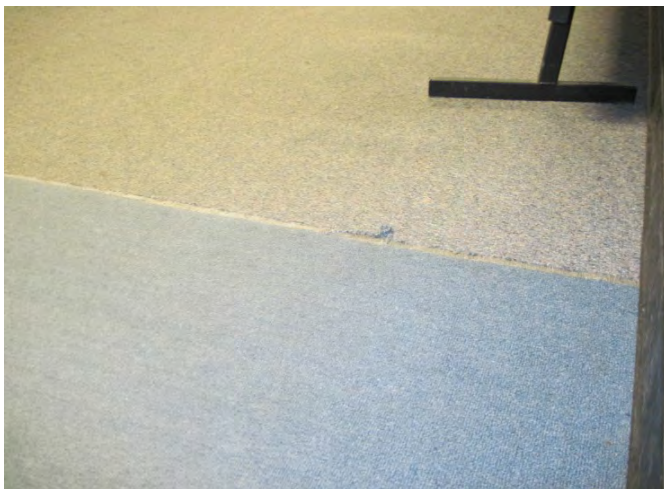
Typical area of worn and outdated carpeting  
First Floor

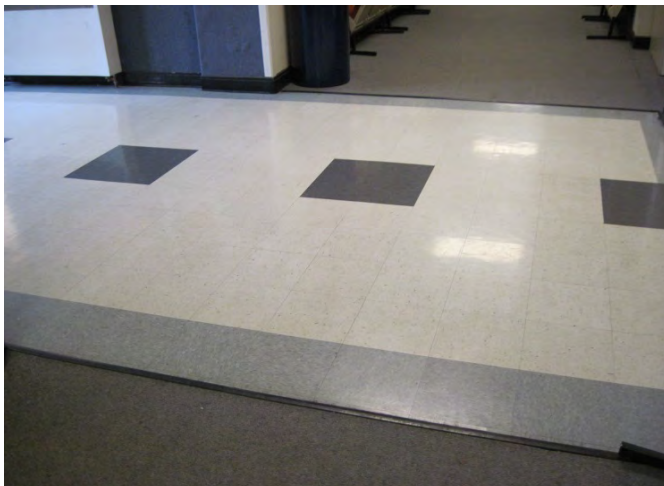
Entry Area 12'x12' Floor Tile and Corridor  
carpeting, First Floor

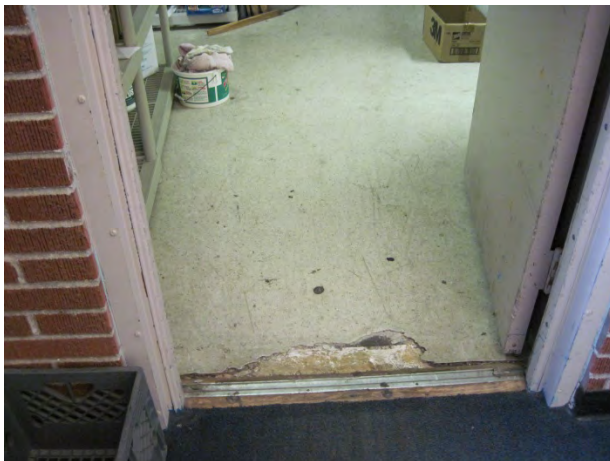
Damaged asbestos containing sheet vinyl

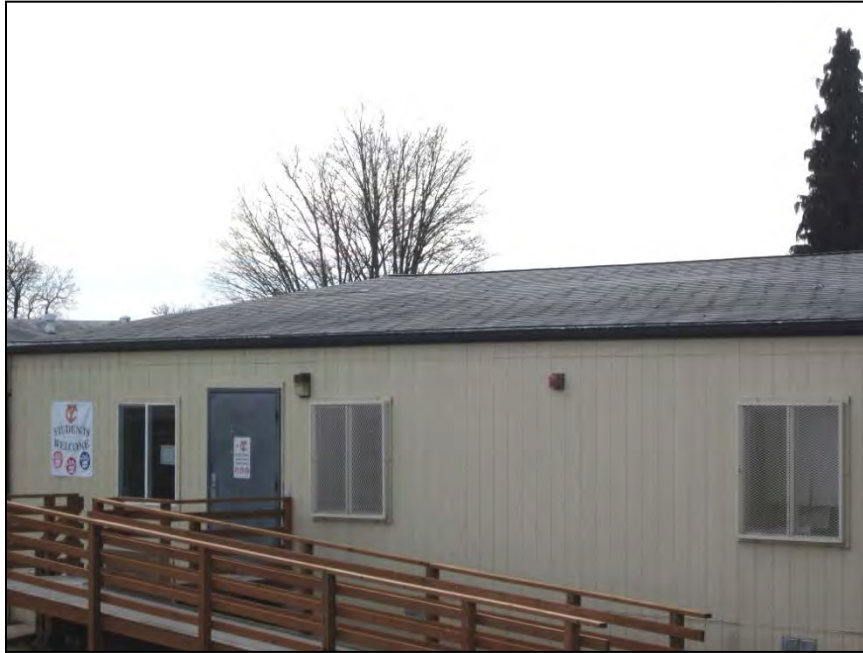
**Sec. 1.03 – Roof A: View of missing shingles at southeast section of the roof.**

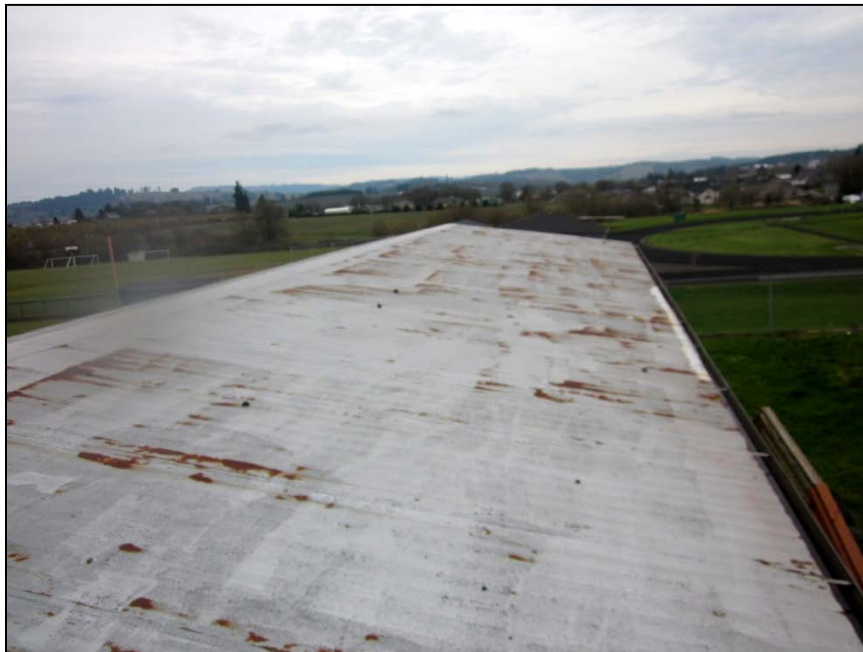
**Sec. 1.02 – Roof A: View to east across roof field at south section of the roof. Note rusting at several locations.**

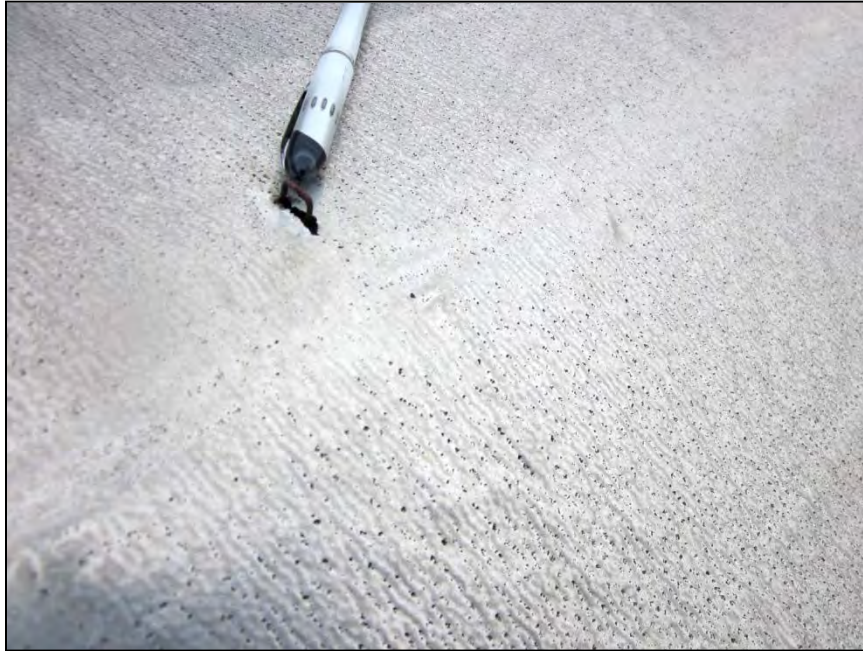
**Sec. 1.03 – Roof A: View of staple that is backing out at center section of the roof.**

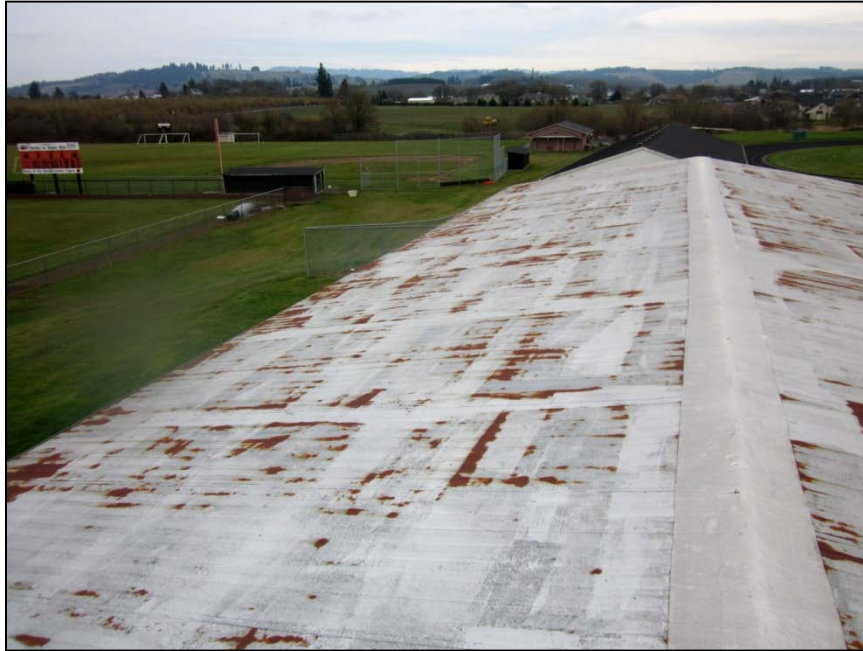
**Sec. 1.05 – Roof A: View to east across roof field at north section of the roof. Note rusting at several locations.**

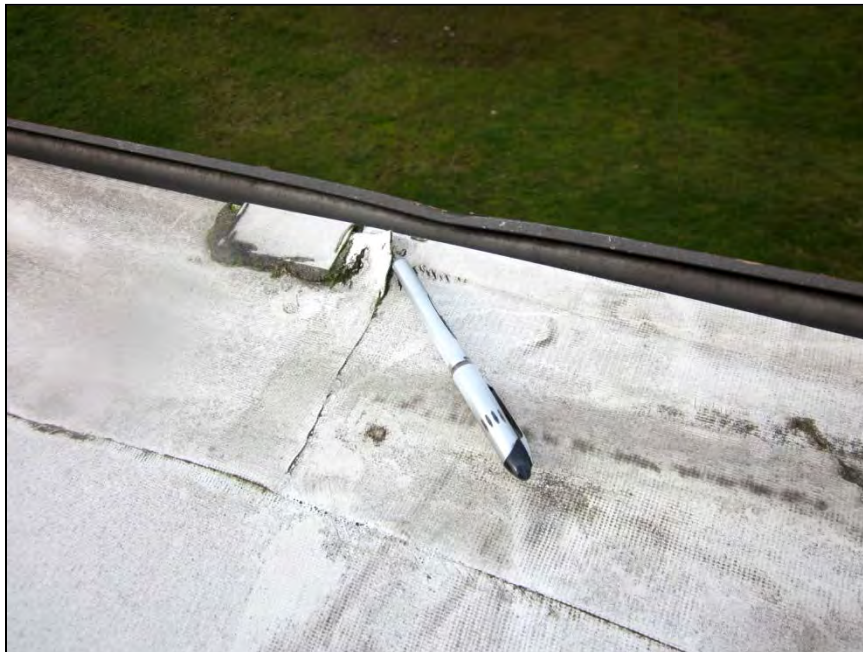
**Sec. 1.04 – Roof A: View of loose seam at north perimeter at center section of the roof.**

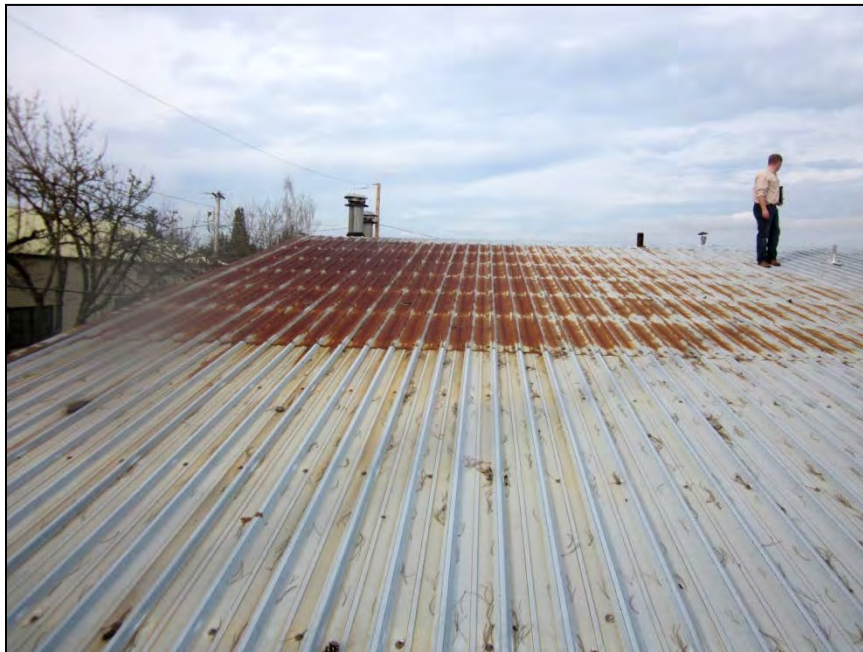
**Sec. 1.02 – Roof A: View to north of rusting at southwest section of the roof.**

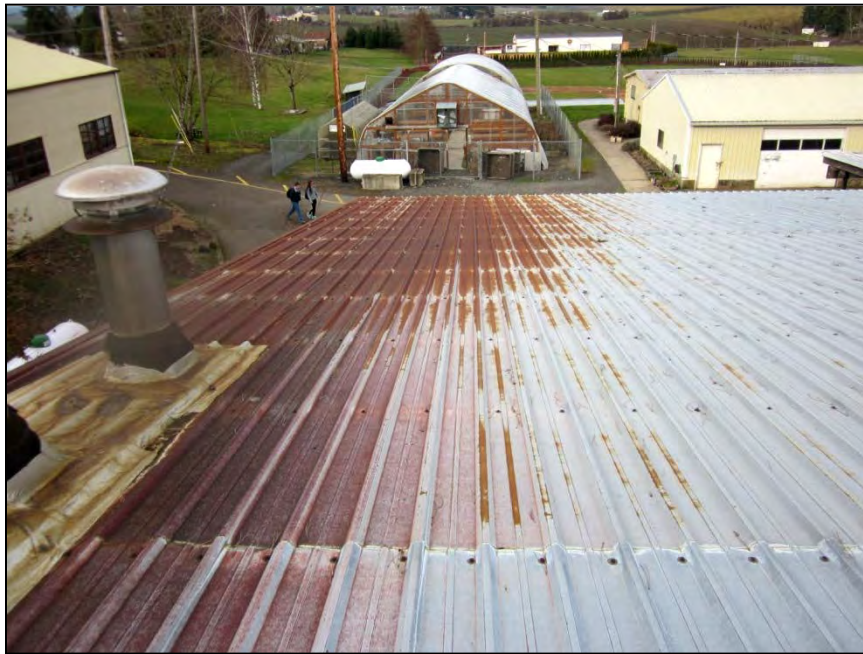
**Sec. 1.03 – Roof A: View to north of rusting at northwest section of the roof.**

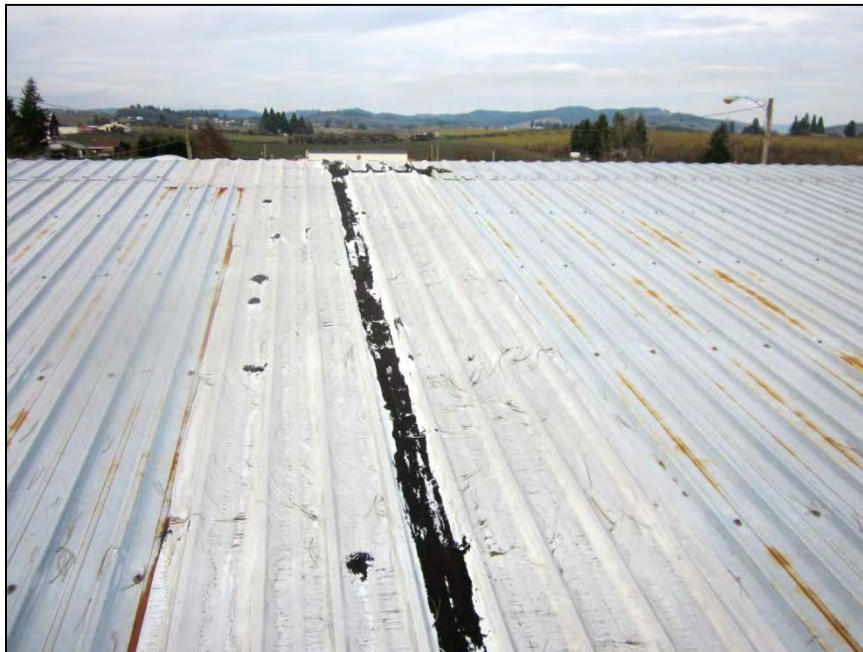
**Sec. 1.06 – Roof A: View of peel and stick repair at center section of the roof.**

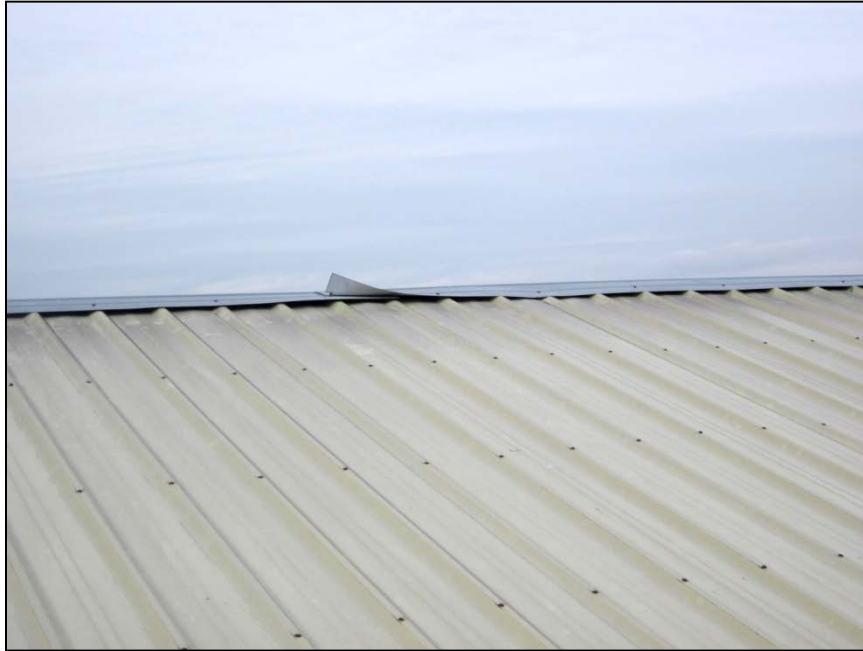
**Sec. 1.03 – Roof A: View of loose ridge metal at west section of the roof.**

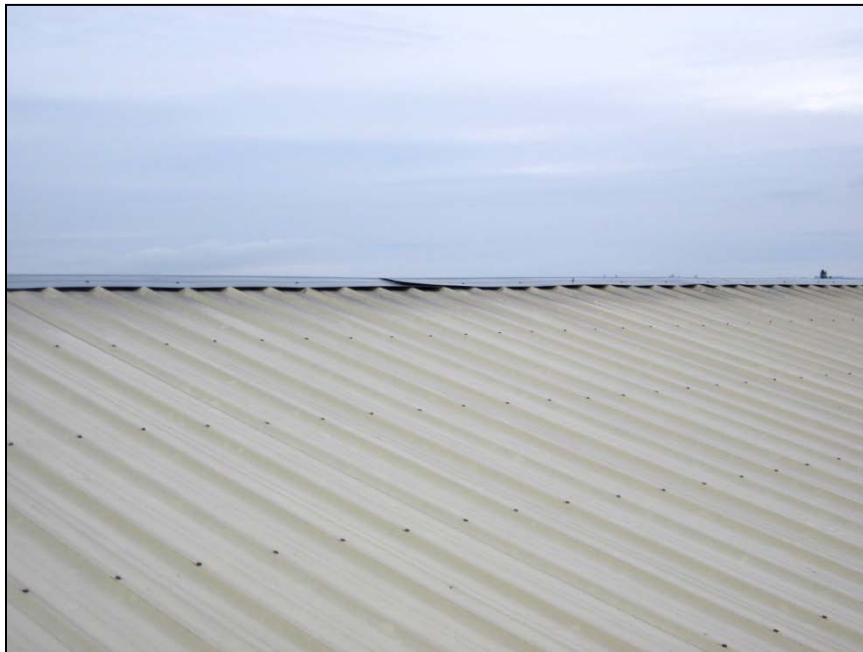
**Sec. 1.04 – Roof A: View of loose ridge metal and fasteners backing out at center section of the roof.**

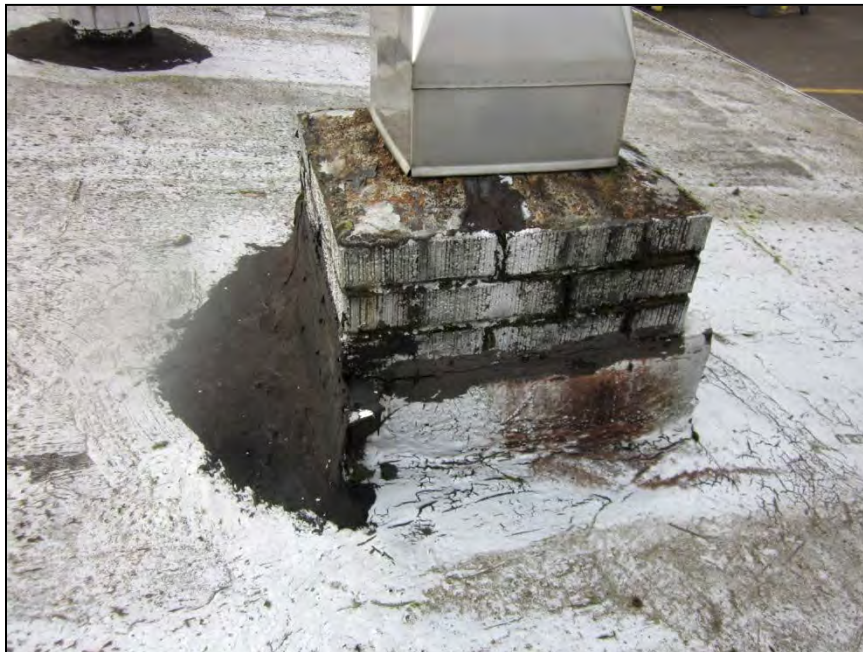
**Sec. 1.04 – Roof A: View of voids in mastic repairs at chimney at northwest section of the roof.**

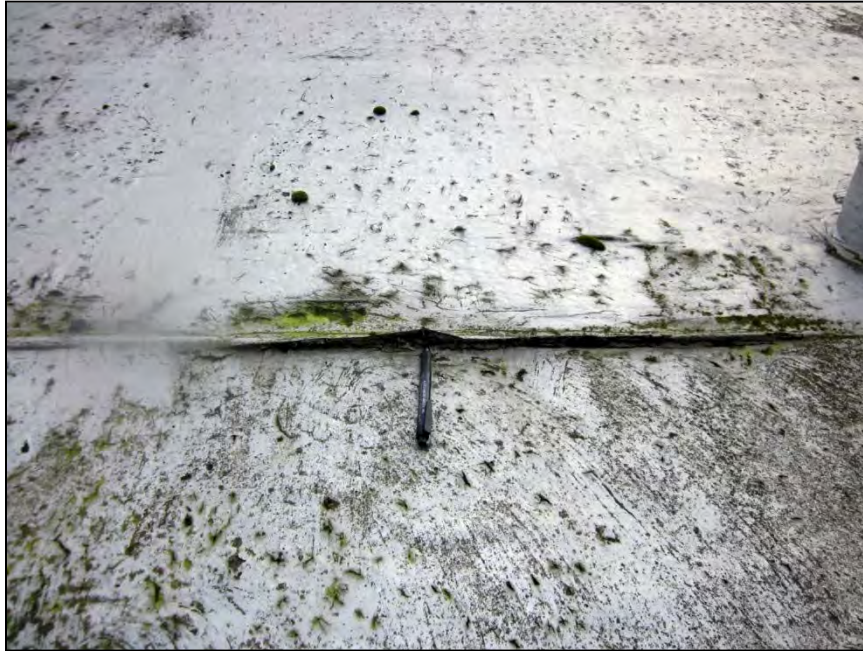
**Sec. 1.05 – Roof A: View of membrane split at southwest section of the roof.**

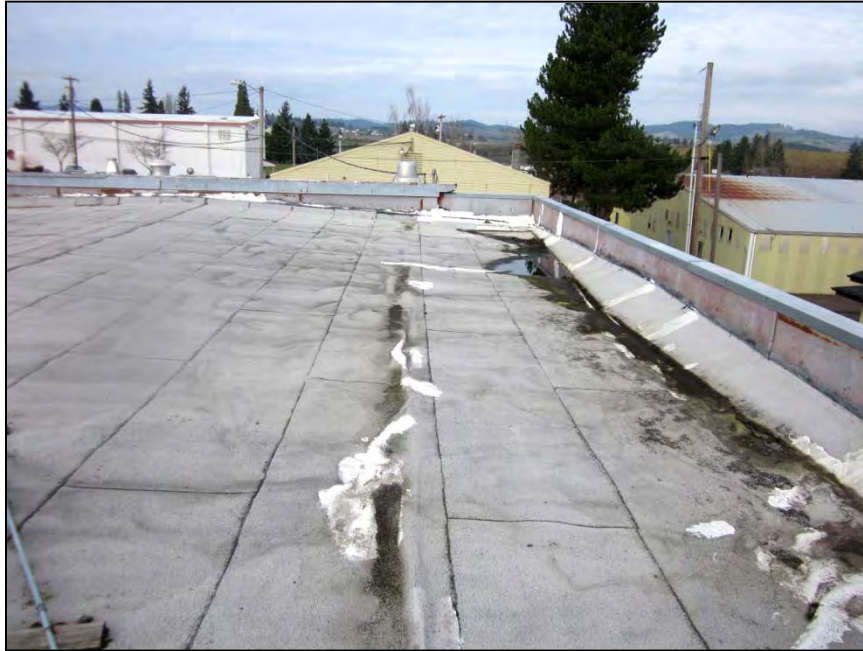
**Sec. 1.07 – Roof B: View to north at east section of the roof. Note previous repairs.**

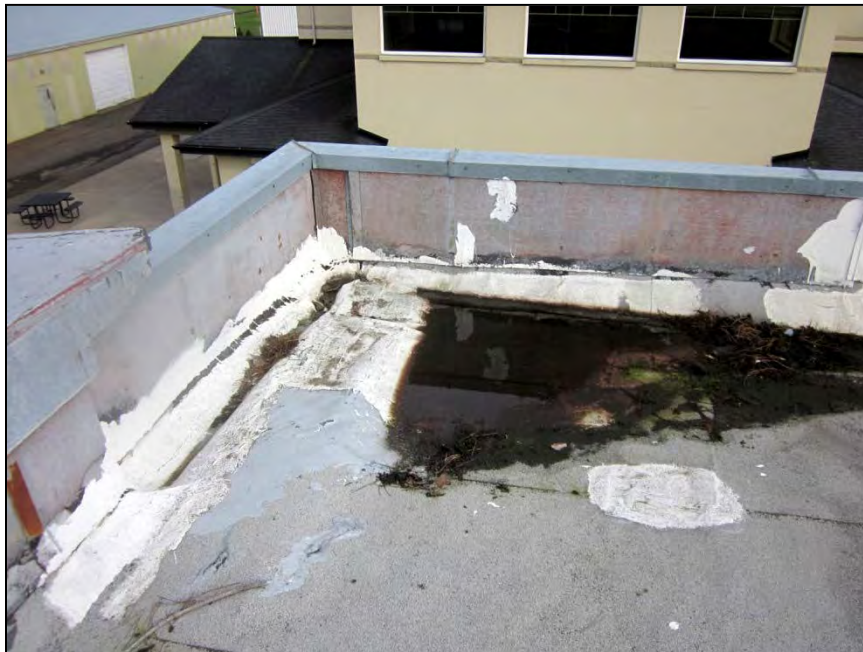
**Sec. 1.08 – Roof B: View of scupper that is roofed over at east parapet at northeast corner of the roof. Note ponding and previous repairs.**

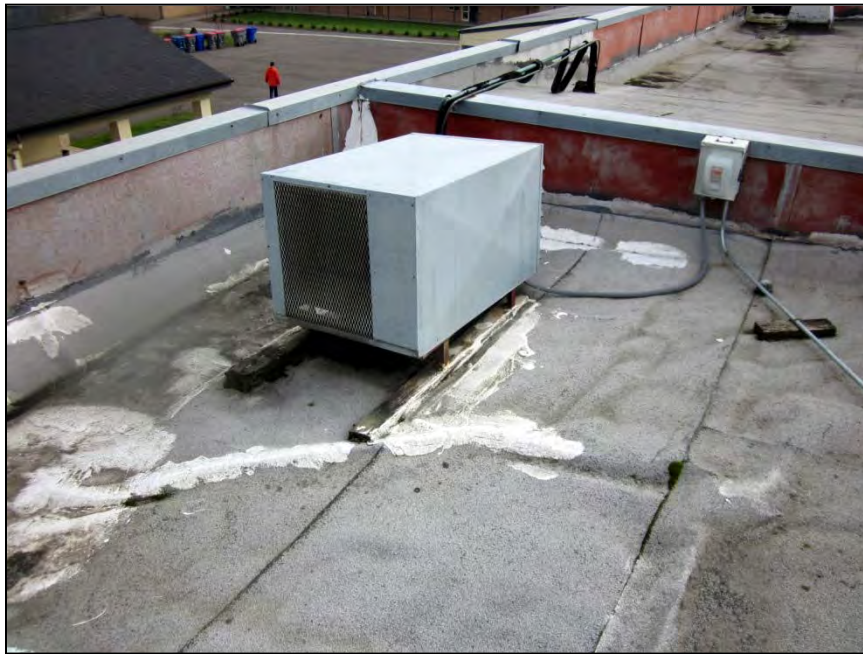
**Sec. 1.09 – Roof B: View of wood sleepers that are nailed thru roofs at southeast corner of the roof.**
