# **Yamhill-Carlton School District**

**Building Assessment**

**Yamhill High School**

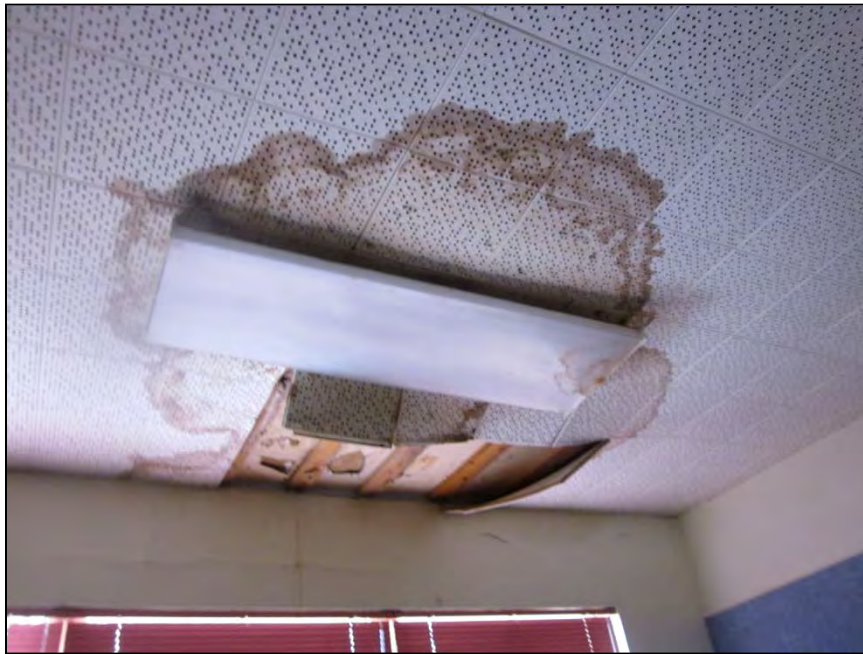
**Sec. 1.15 – View of water stained ceiling tile below northwest corner at Roof A.**

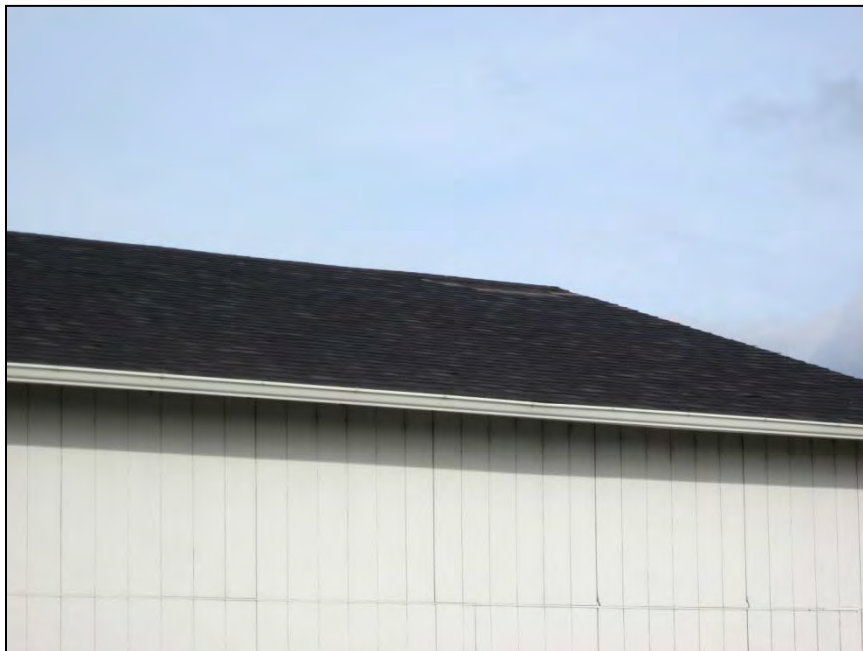
**Sec. 1.02 – Roof A: View of missing shingle near ridge line at southeast section of the roof.**

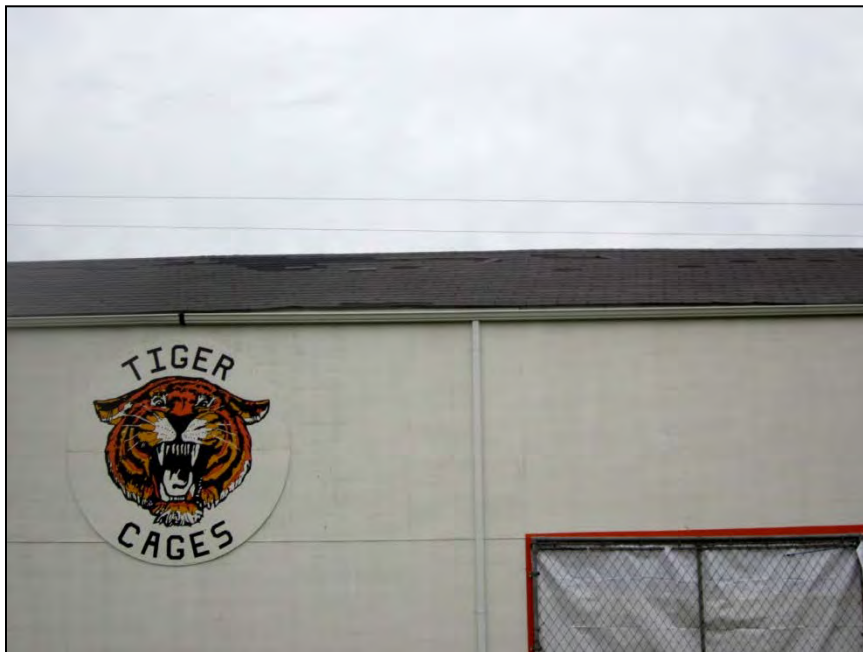
**Sec. 1.02 – Roof A: View of missing shingle near ridge line at south section of the roof.**

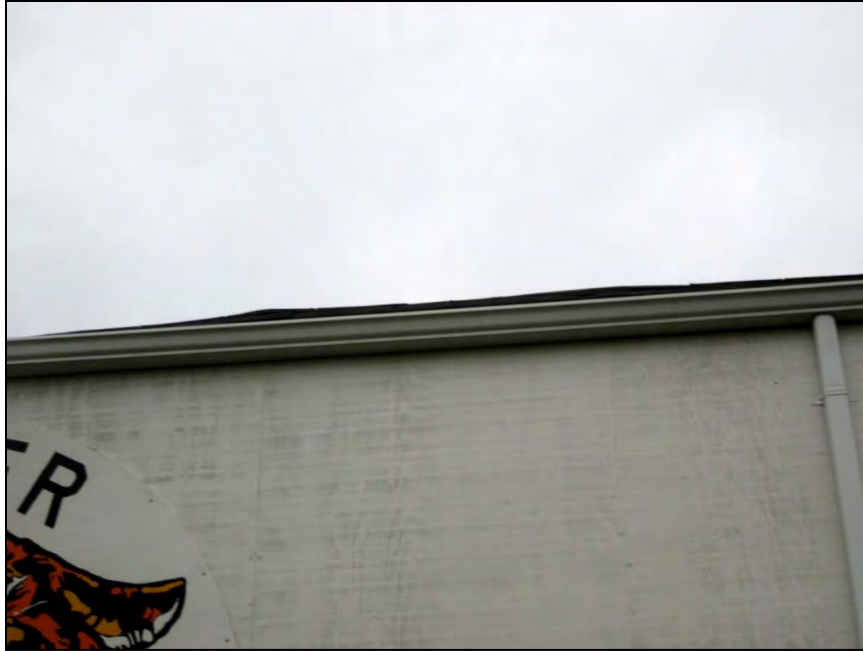
**Sec. 1.03 – Roof A: View of curling shingles above gutter at south section of the roof.**

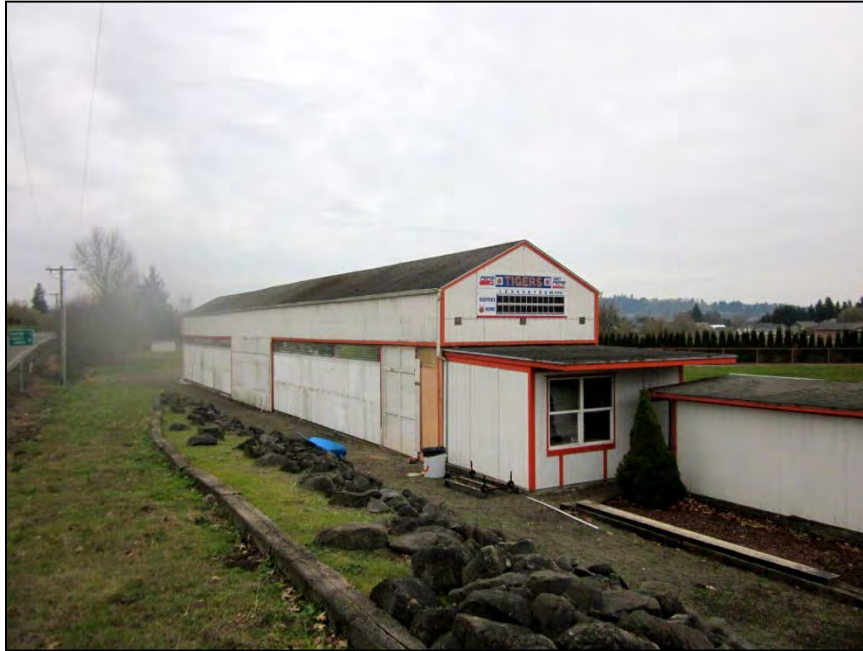
**Sec. 1.05 – Roof A: View to east of moss growing at north section of the roof.**
