# **Yamhill-Carlton School District**

**Building Assessment**

**Yamhill High School**

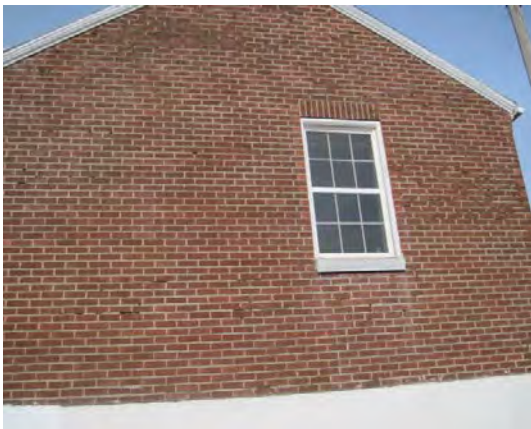
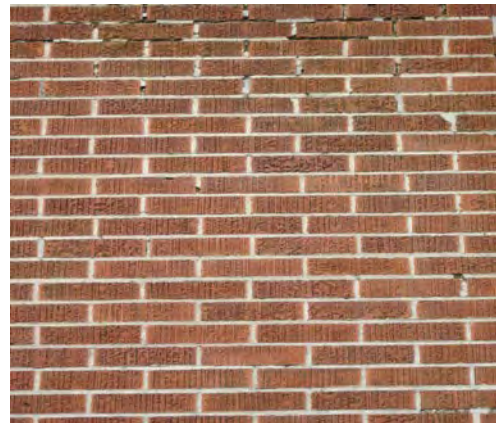
The building exterior as previously stated is in good condition even though a number of issues are being identified in this report as recommendations for repair. The brick façade is in need of being tuckpointed. This repair removes loose mortar between the brick installing new mortar. In addition, a good brick sealant and anti-graffiti guard; one that would provide a factory certified warranty of at least 10 years for water sealant and 5 years for anti-graffiti guard is recommended. These two items will help prolong the life of the building.

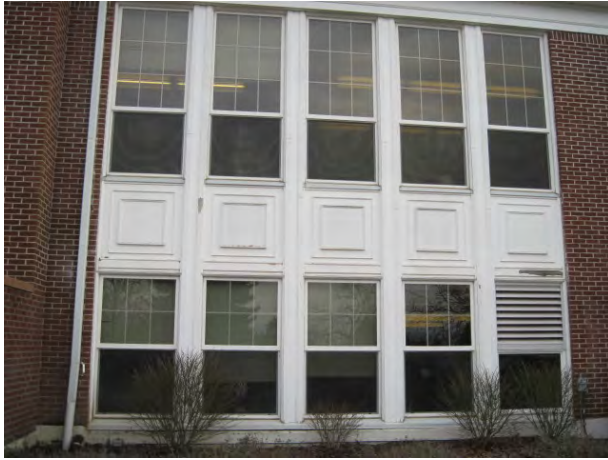
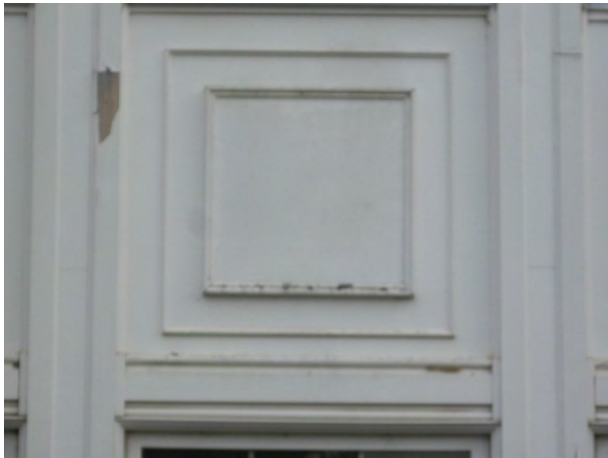
There are a number of areas around the building where the wood trim placard between the 1<sup>st</sup> and 2<sup>nd</sup> floor windows are showing signs of deterioration. The following pictures depict some of those areas.

These three pictures are of the front of the building to the right of the main entry. This side of the building faces west and is subject to the prevailing weather. The picture in the upper left corner shows the entire window section while the other two pictures detail close up area of concern.

This same condition was observed on the windows to the left of the main entry as well.

We recommend that further investigation occur to determine whether the wood has begun experiencing dry rot if found replacement of wood trim prior to painting.

It appears that the condition primarily is in need of paint. Removal of loose paint, application of a good exterior primer and then 2 coats of high quality exterior paint will provide the necessary protection for the wood. This condition is true for the entire building although not as severe in other areas of the building.

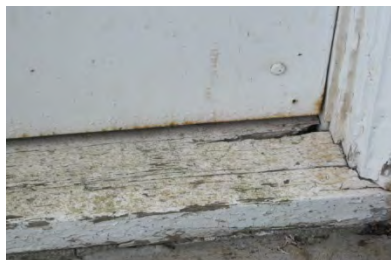
This is the exterior door on the rear side of the building North Facing wall exiting from room 211. The door is a 3'4" X 7'0" wood door and is in poor condition. The wood sill is split and rotting, hinges are original with the building.

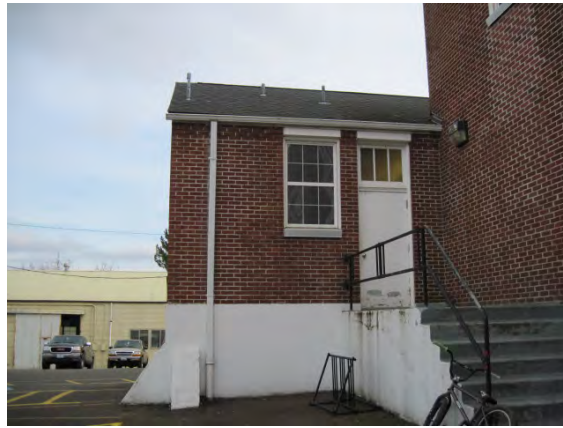
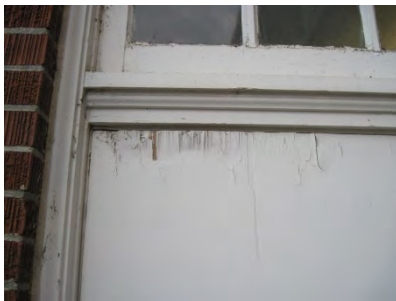
One additional door is in poor condition needing replacement is the exterior library door that egresses to the rear north paved parking area. The door is a 3'0" X 7'0" with a 3' transom light above. The doors shows signs of sticking, delamination of the exterior door veneer, dry rot wood sill.

Top of the door is experiencing delamination of wood veneer.

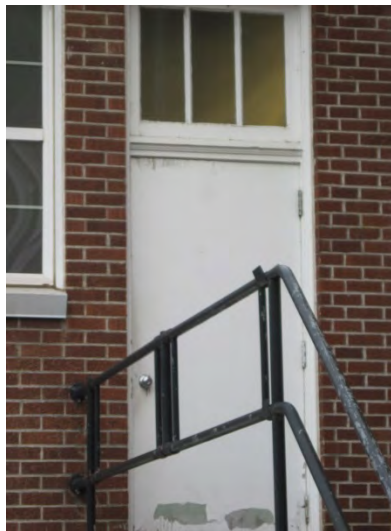
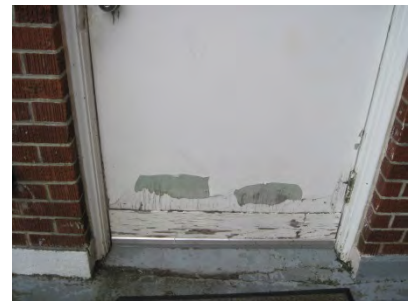
Door observation includes delamination of wood veneer at door bottom as well as dry rot and deteriorating wood sill.

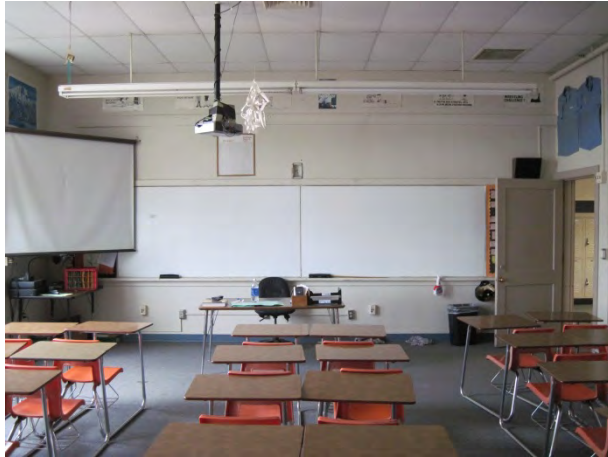
Basement and main floor classrooms do not have adequate storage. Marker boards are inadequate with the porcelain writing surface nearing end of life. Many rooms do not have bulletin boards or have surfaces not made for pinning display materials; teachers use creative ways to display items even when pinnable surfaces are not available. (Pictures below are of room 206)

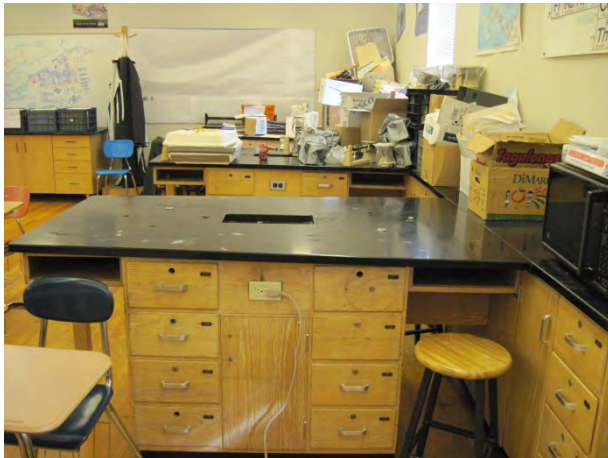
Science rooms need upgrading with new labs, vented fume hood, chemical storage, and improved science prep area. Many of the science labs do not have working fixtures, water faucet, air & gas connections. Lab casework is old drawer locks are missing, door and drawer handles are broken or missing, electrical outlets do not meet current code for GFI protection, and acid resistant tops need upgrading. The student lab configuration of peninsula style casework does not provide the flexibility desired in modern science rooms. (Pictures are of room 212)

The lab above no longer has water faucet or gas and air connections. Of the 6 student labs in the classroom only 2 had working fixtures.

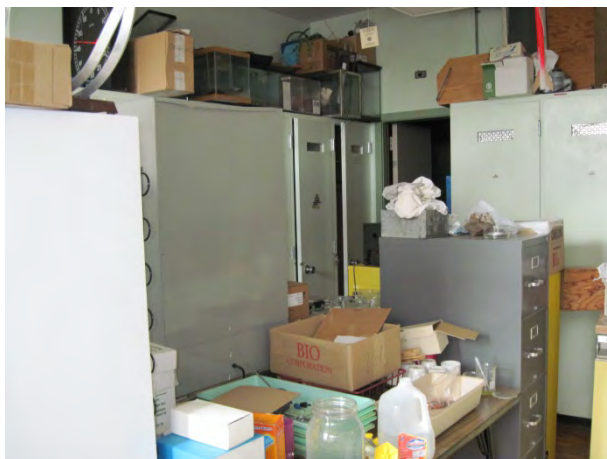
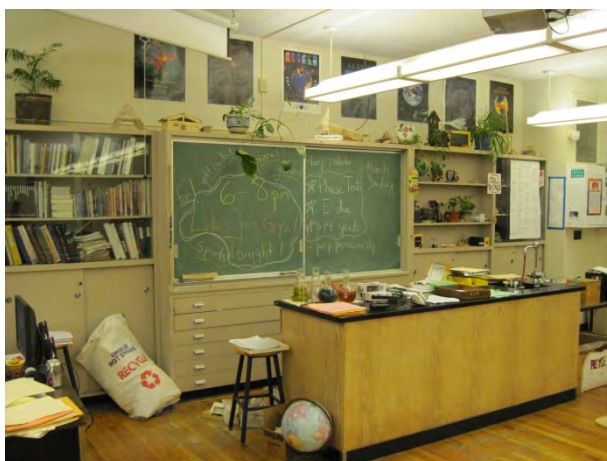
Storage is inadequate and should be considered a hazard both fire and occupant safety.

Science prep room storage is inadequate. Chemical storage cabinets are not rated. It is recommended to have a person familiar with the chemical stored to survey age, volatility, and grouping of chemicals in cabinets to determine proper storage and whether chemicals are beyond their allowable shelf life. The teaching wall, room 212, needs upgrading, new storage cabinets, marker board, and teaching lab would make noticeable improvements to the space.

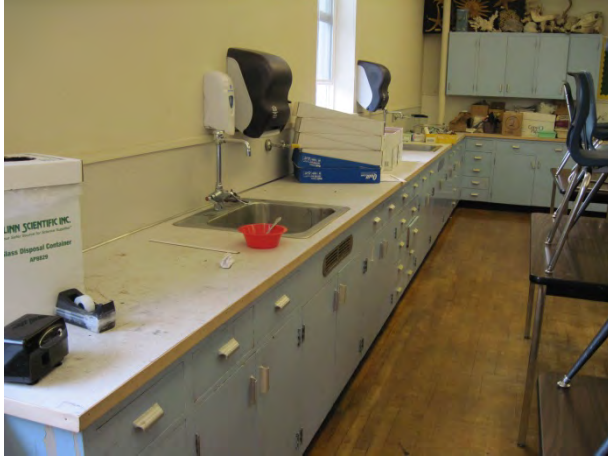
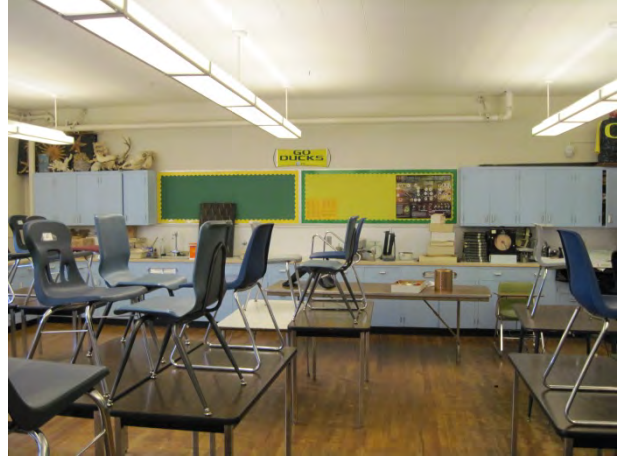
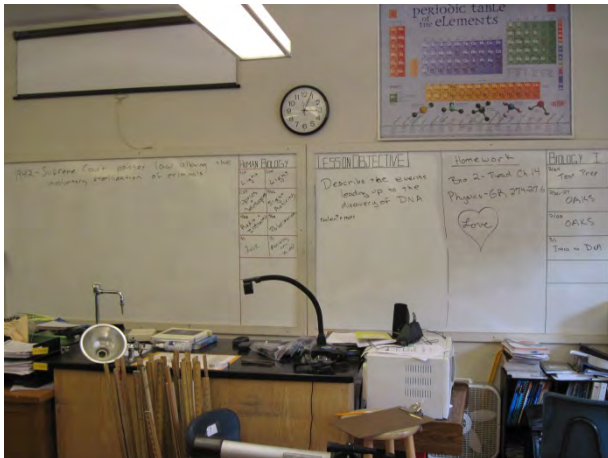
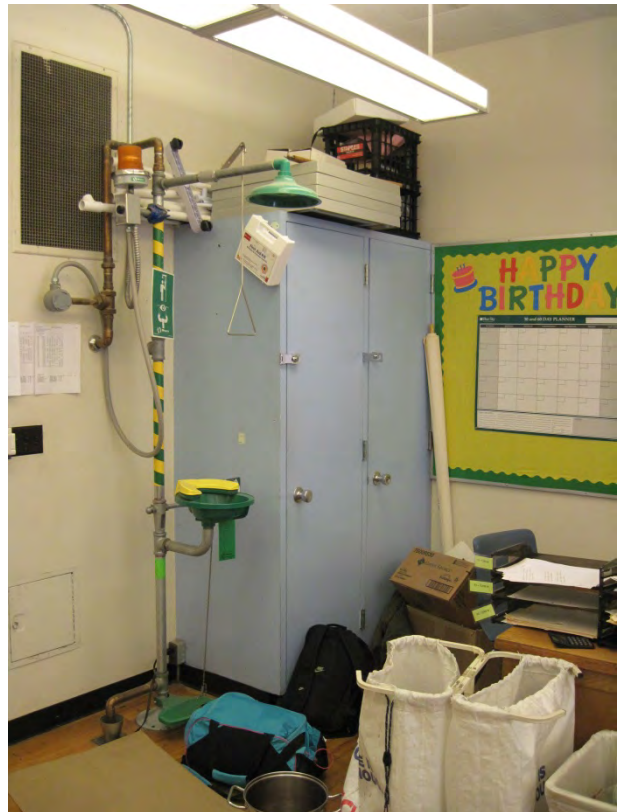
Earth Science room 210, countertops and casework are in poor condition and not constructed out of materials typically used in science classrooms. The teaching wall, teacher's lab needs upgrading. Classroom does have whiteboards although the porcelain finish is at end of life. Storage is inadequate needs significant upgrading allowing for science materials to be stored away.

Both science classrooms share one chemical shower housed in room 210. Installation of another emergency shower in room 212, providing immediate adjacency to the space is recommended.

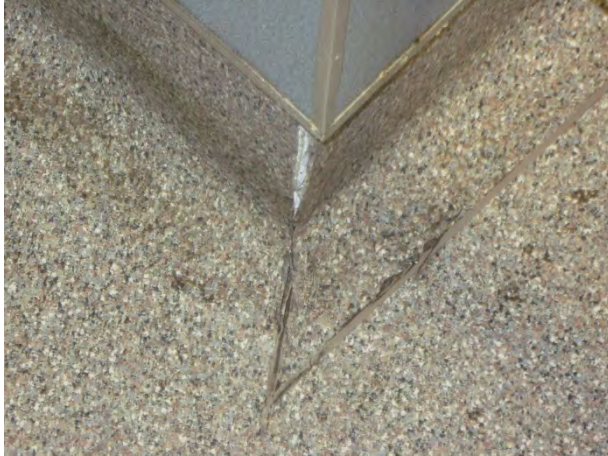
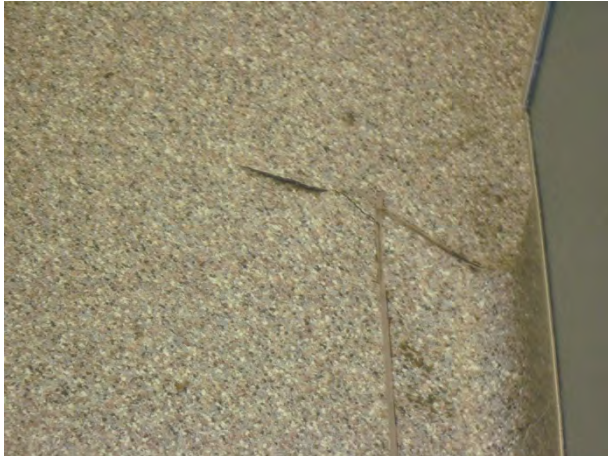
Floors in restrooms on all three floors are in good condition. A number of areas depicted in the following pictures having cracks, tears, or separation of the welded seams. These conditions need repair by a trained floor technician who can use vinyl floor welding techniques to repair these areas. The concern is water over prolonged periods will move migrate beneath the surface promoting mold, mildew, and dry rot.

These pictures are of the basement restrooms. This condition was also noted in 2<sup>nd</sup> floor restrooms.

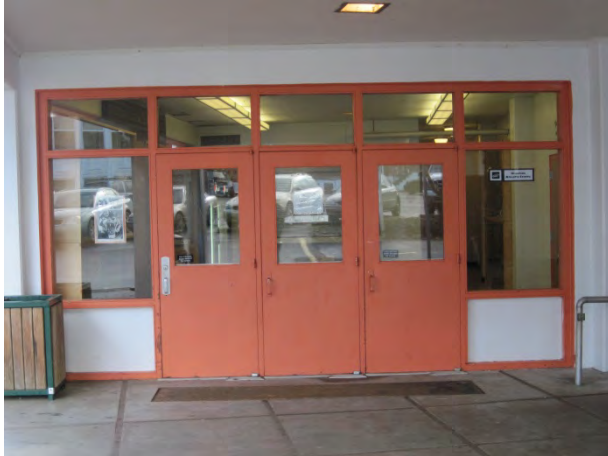
The Main Entry doors are beyond their useful life having experienced failure of the integral hinge door closer system with the middle of the 3 operational doors no longer able to open. The door system is a metal framed metal door with relight. The door is 16'6" X 9'0" with 3 each 3'0" X 7'0" doors. The recommendation is to install new door system fitted within the existing opening.

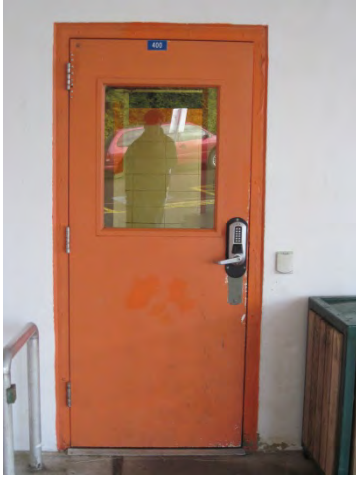
This door is off of the main entry and enters a small hallway to the woman's locker room and stairs leading to upper floor.

The door operation is fair, hardware showing years of continued service. They may require continuous maintenance until the Athletic Building receives a thorough update.

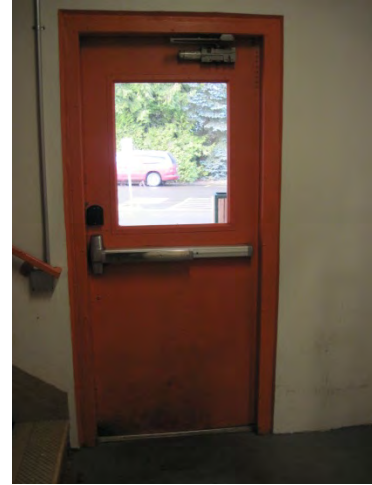
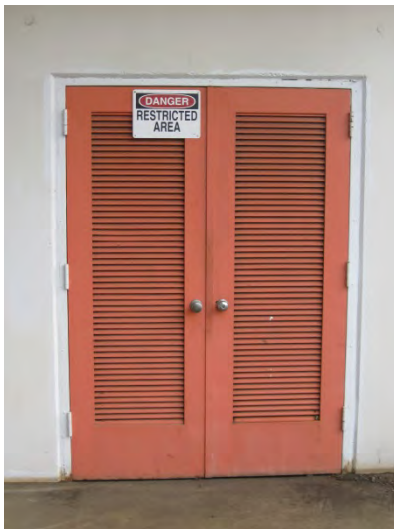
Louvered door to the left are for the mechanical room. The doors are beginning to rust out on the bottom as well as the door jamb at concrete sidewalk. It is recommended that when this door is replaced to install a larger single door allowing for a better maintenance access.

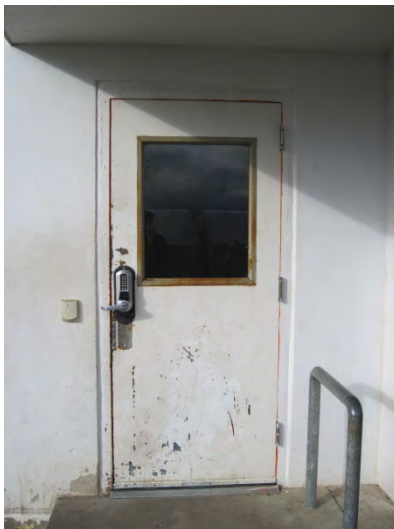
This doors is on the back side of the building (east side) and enters a small hallway to the men's locker room and stairs leading to the upper floor. Doors appear to have experienced greater use/abuse through the years.

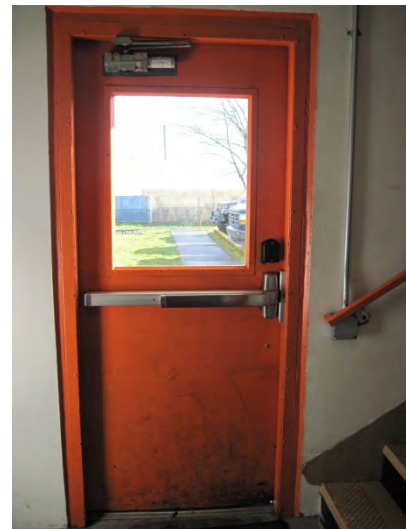
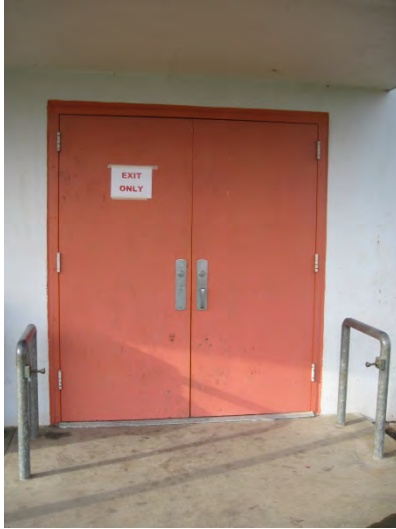
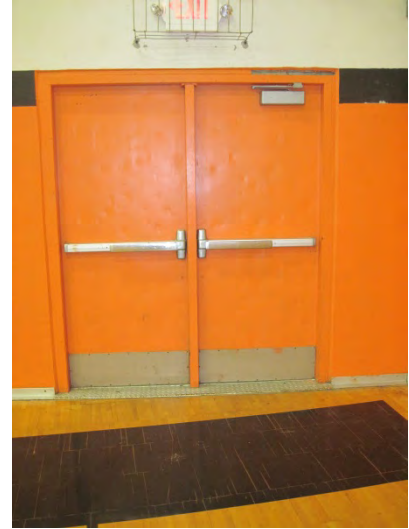
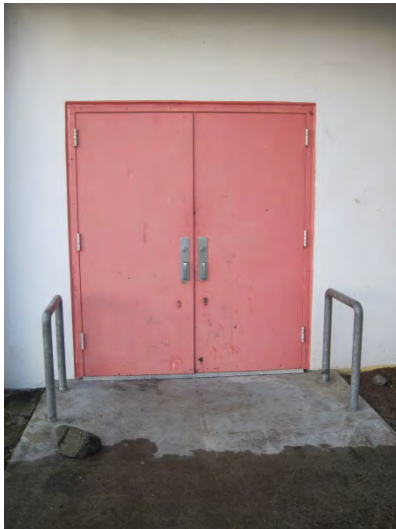
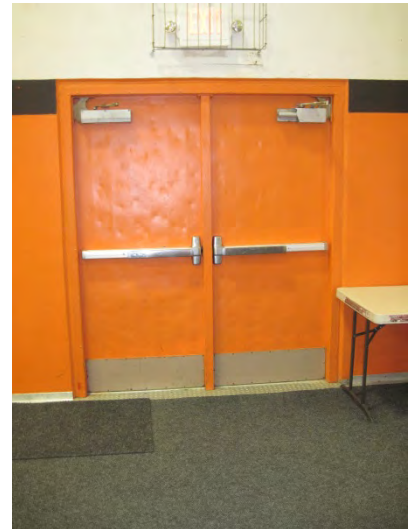
The remaining exterior doors all show years of continuous use. Condition of the doors are fair with the recommendation that if modernization occurs in this building that the doors systems be replaced.

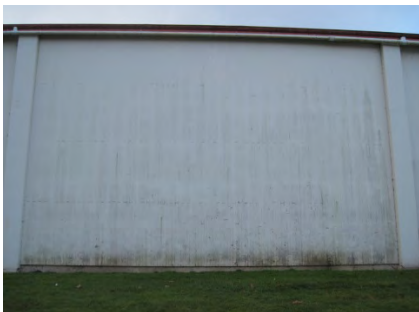
Three primary areas need attention with recoating of the exterior finish. The North side of the building has a cedar siding feature wall that needs have exterior paint applied.

It is recommended to power wash , apply new caulking, and prime & paint with good exterior paint.

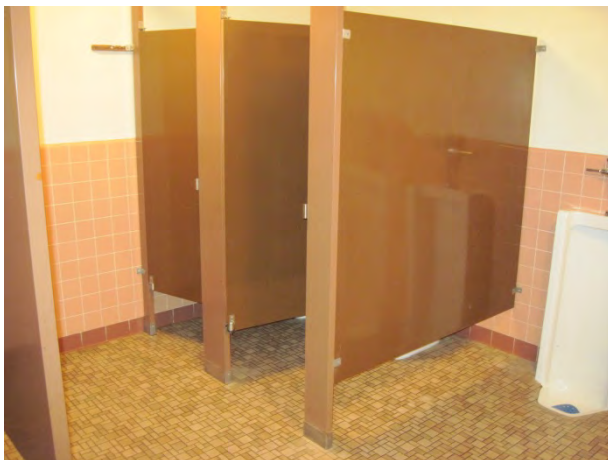
Men's restroom entrance, restroom stalls, urinals and lavatories are all in non-compliance for ADA.

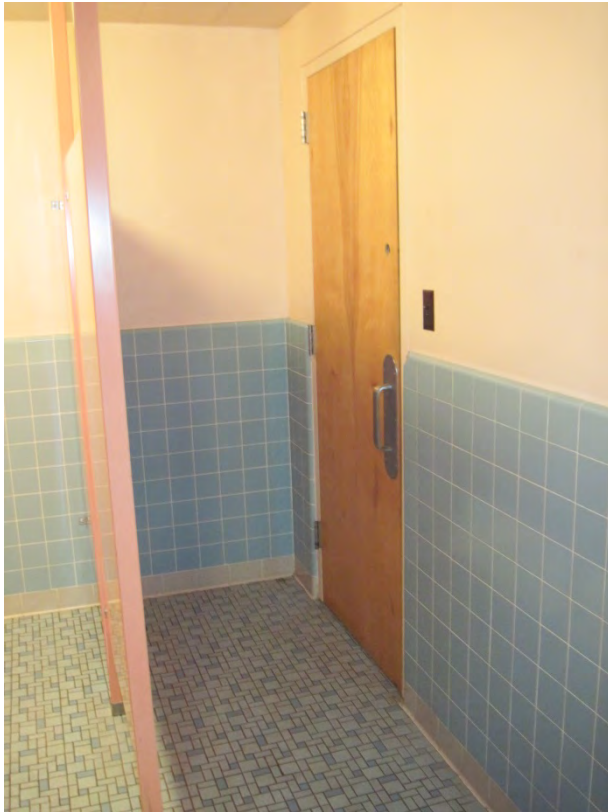
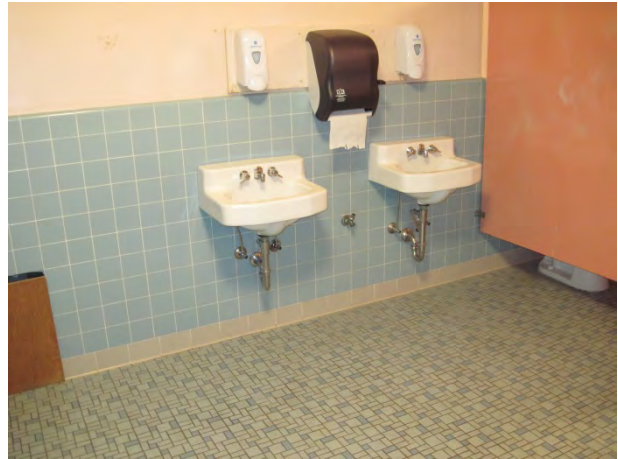
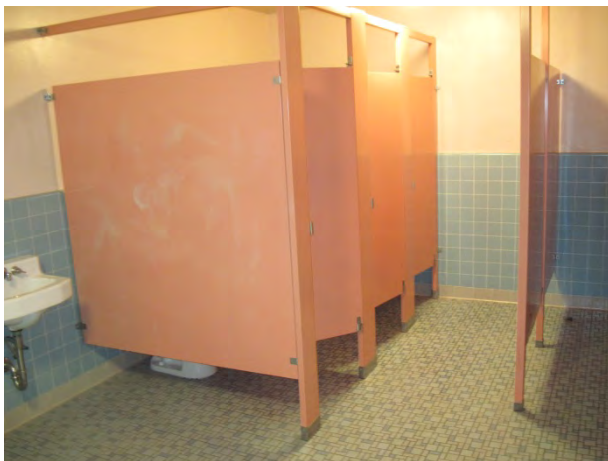
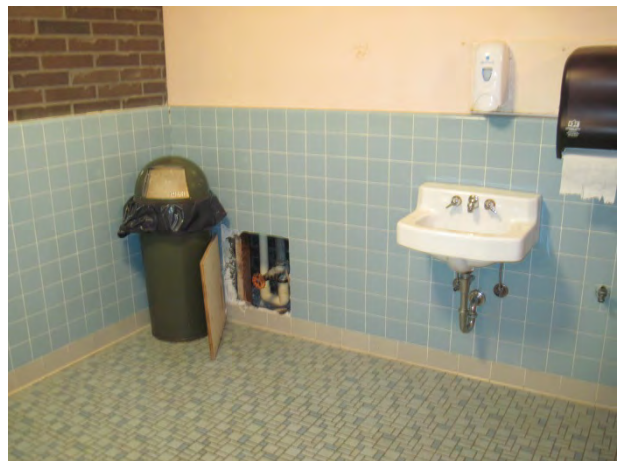
Women's restroom has the same compliance issues that the men's does. There is evidence of plumbing issues as shown in lower right hand picture where an area of the wall was opened to access plumbing.

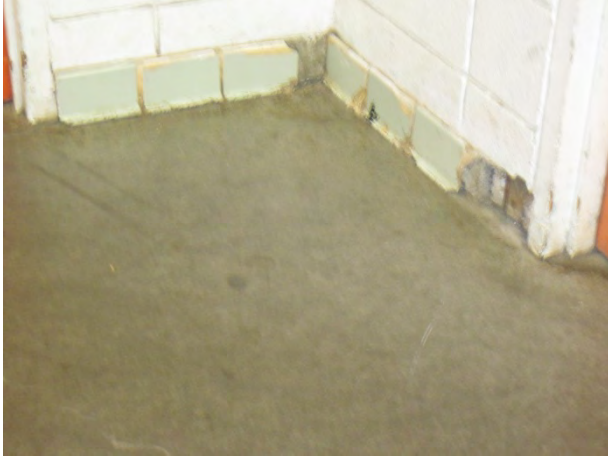
The Locker Rooms both men's and women's are in similar conditions with the men's being slightly worse. They are not ADA accessible, restroom facilities are aged and at end of life. Showers have nonfunctioning shower facets and heads. Ventilation needs to be improved providing code compliant air exchanges.

Tile base in the men's locker room is broken and deteriorating.

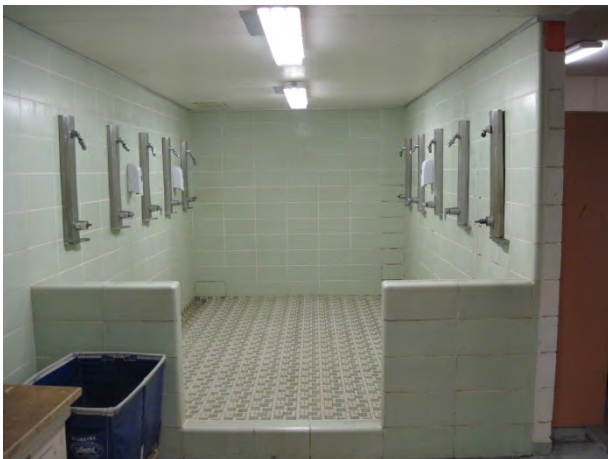
Pictures below show shower area most notable issues are shower faucets having missing handles and no functional. Areas of tile disrepair are seen in the picture below also on the far wall of the picture to the lower left.

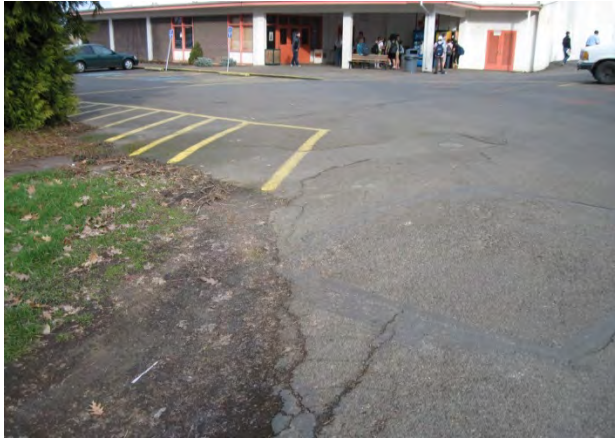
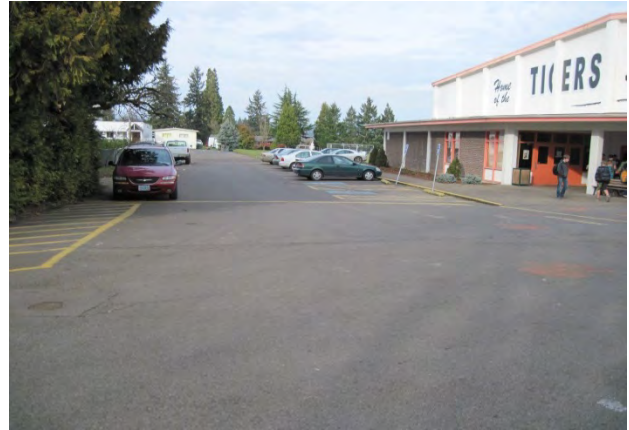
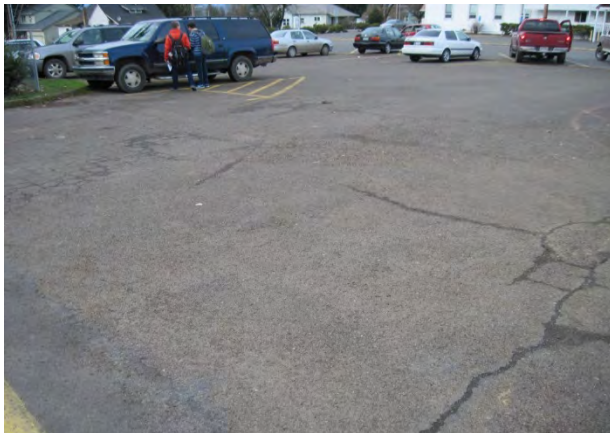
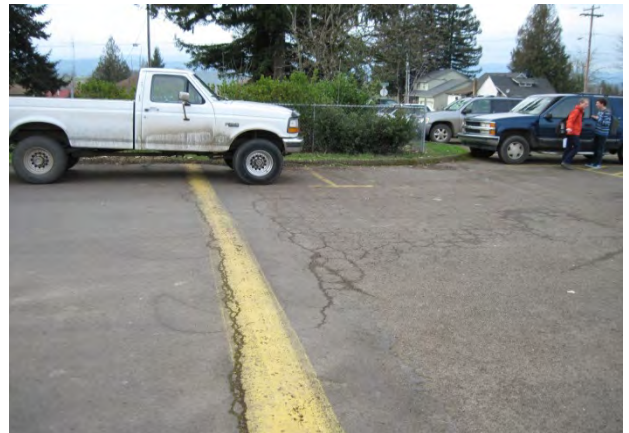
The overall condition of the Gymnasium Area-B asphalt driveways and parking lots are in poor to critical condition and a plan to making necessary improvements is recommended. Many of these main driveway and parking areas indicate signs of base rock and surface failure which is in need of complete replacement and new paving. Several areas of curbing are damaged or missing all together and Inadequate parking demarcation and striping is also noted in this area.

Note; damaged curbing along NW area of Gymnasium (Area-B)

Area-B driveways and parking lots indicating signs of complete base rock and surface asphalt failure. Also indicate above are areas of severe cracking of asphalt drives and deterioration of curbing.

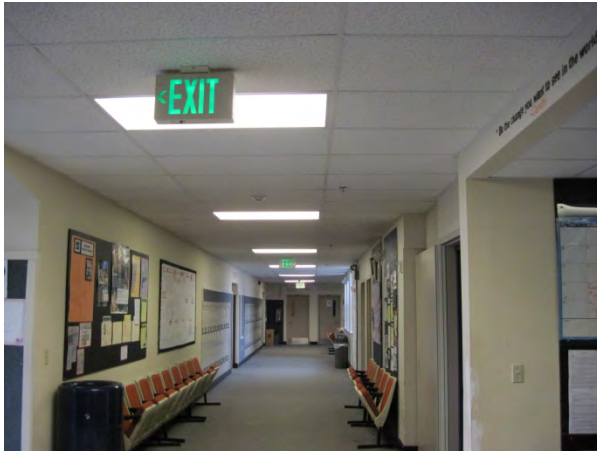
Corridor Carpeting, Basement

The majority of the floor coverings on the Basement Floor are in fair to poor condition and a plan for making necessary replacement is recommended. The carpeting in all corridors and classrooms is worn, showing signs of age and deterioration, and beyond its useful life. In addition, this carpeting has been

installed over the original asbestos floor tile, which will need to be addressed when the carpeting is replaced. The flooring in the restrooms consists of older sheet vinyl that is also showing signs of wear.

The carpeted area in need of replacement is approximately 8,000 square feet. The majority of this carpeting has been installed over the original 9'x9' asbestos floor tile and mastic which may require asbestos abatement during the carpet replacement. The restroom area sheet vinyl flooring in need of replacement is approximately 400 square feet

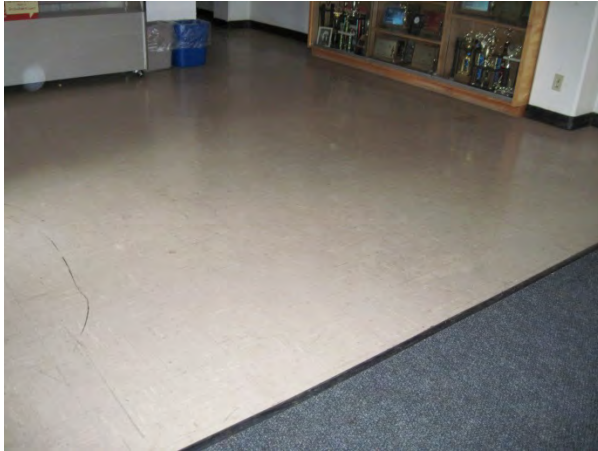
The majority of the floor coverings in the Gymnasium Building are wood, with the exception of the Main entry, restroom, and stairways which consist of 9'x9' asbestos containing floor tile. The asbestos floor tile is in fair to poor condition and a plan for making necessary replacement is recommended.

9'x9' Asbestos Floor Tile, Main Entry of Gymnasium Building

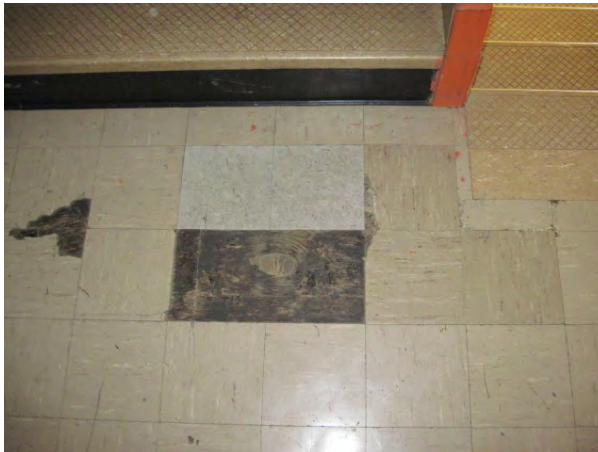
Damaged 9'x9' in Gymnasium Stairway

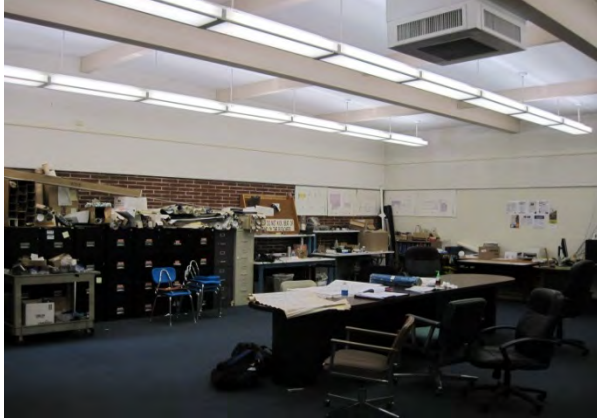
The majority of the floor coverings in the Maintenance Building are a mixture of old carpeting, asbestos containing floor tile and asbestos containing sheet vinyl. All of the flooring throughout this building is in fair to poor condition showing signs of wear, delamination, and some irreversible damage. A plan for making necessary replacement is recommended for this entire building's floor coverings.

Carpeting in Main area

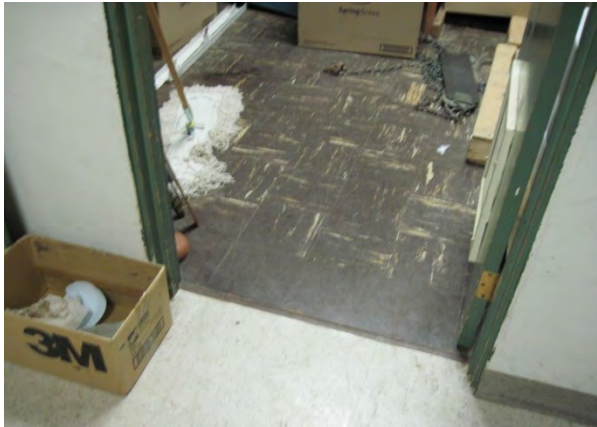
Asbestos Sheet Vinyl and 9'x9' Floor Tile

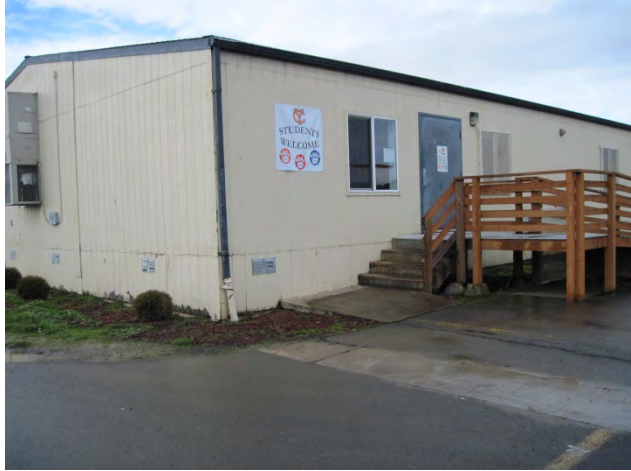
The majority of the floor coverings in the Arts Modular Building consist of 12'x12' vinyl floor tile. This flooring was in good to fair condition during our inspection and replacement is not recommended for this building's floor coverings.

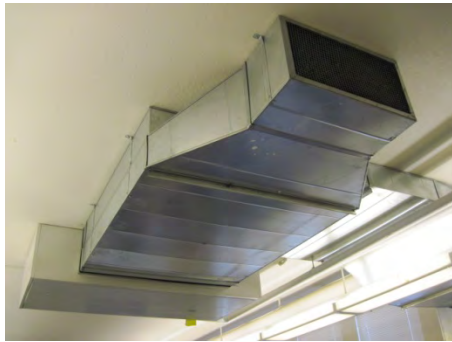
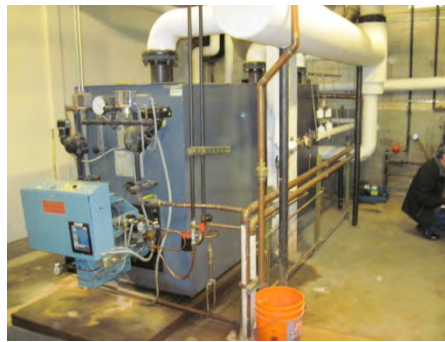
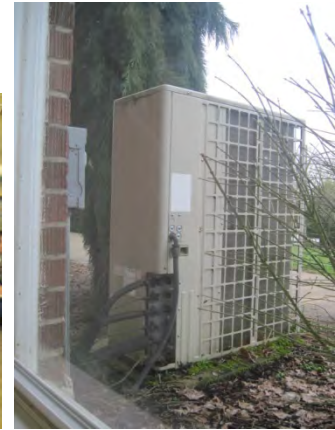
1. The steam system infrastructure and piping are old and leaks should be anticipated. Many of the leaks recorded by the Facilities department have been "pinhole" leaks in the steam piping.
2. The boiler efficiency is only 78%.
3. The exhaust fans in the restrooms are not operating.
4. The building control system cannot control within specifications.
5. The outside air requirement for the classrooms may not be adequate and the classrooms get too much outside air during unoccupied and warm-up periods.
6. Combustion air to the boiler room does not meet current code requirements.

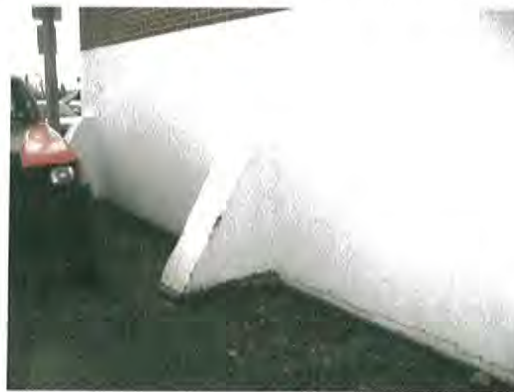
Overall, the high school structure appears to be in good structural condition with no significant structural defects observed. Minor cracks were observed in the terra cotta tile wall of the boiler room, but these are not deemed structural. Also, the lower level concrete walls, including buttresses, have numerous minor nonstructural cracks which should be sealed to prevent water intrusion.

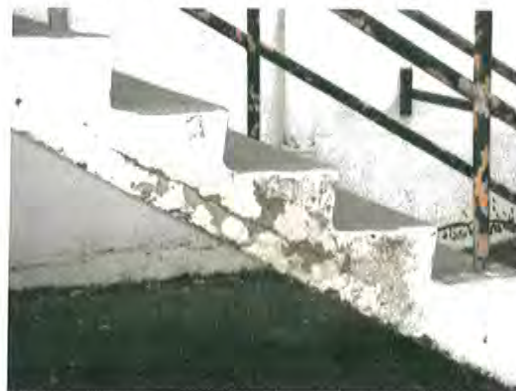
The only structural cracks observed were the south stairs on the east side where the concrete stairs show a significant crack and the landing shows cracking and damage due to apparent impact. These issues are not a structural hazard at this time but repair should be undertaken in the near future.

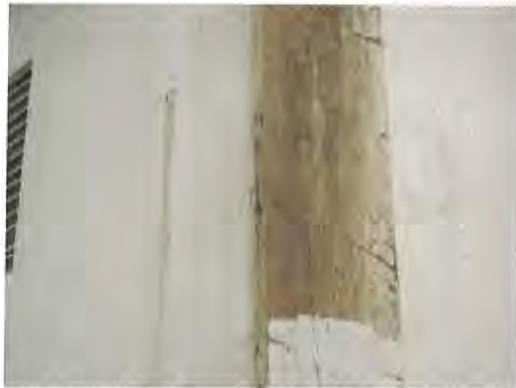
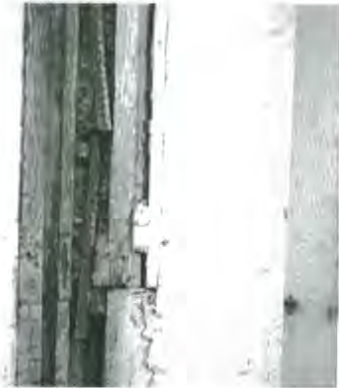
Exterior pilasters are typically exhibiting significant "map cracking" and associated deterioration of surface finish. We do not consider the cracks to be a serious structural issue at this time, but unless patched and sealed, deterioration of reinforced steel will occur which is a structural concern.

The northeast corner pilaster is an exception. This pilaster shows severe deterioration with exposed rebar. This pilaster is in need of immediate attention. At a minimum, the loose material should be removed, rebar cleaned and the void area filled with high quality patching mortar.

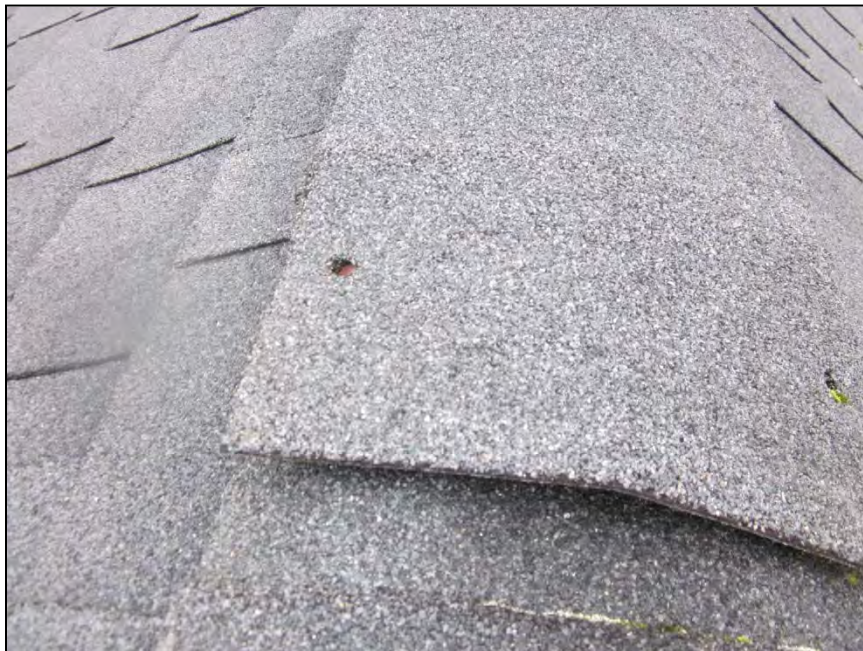
**Sec. 1.02 – Roof A: View of fastener that is starting to back out at ridge cap at northeast corner of the roof.**

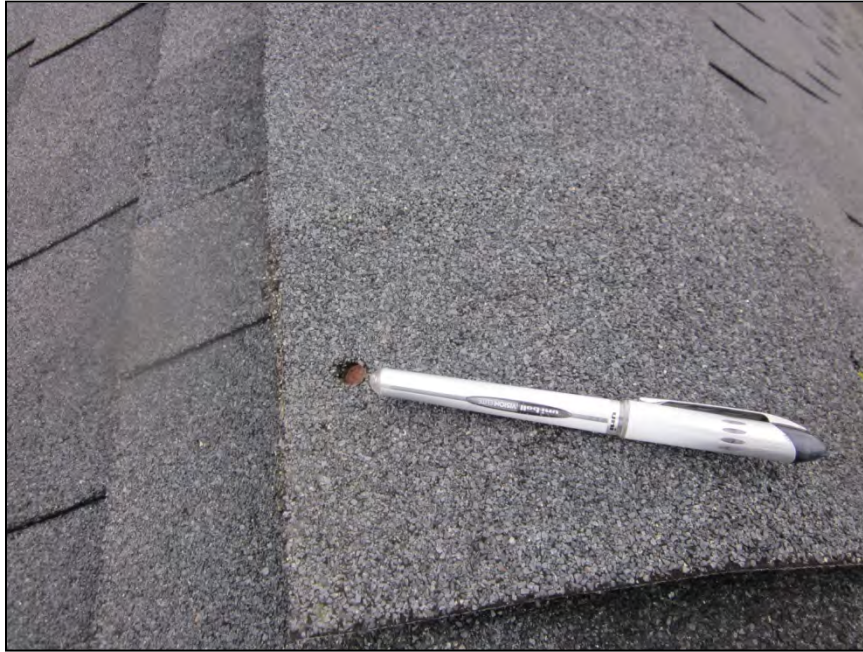
**Sec. 1.03 – Roof A: View of fastener that is starting to back out at ridge cap at southeast corner of the roof.**

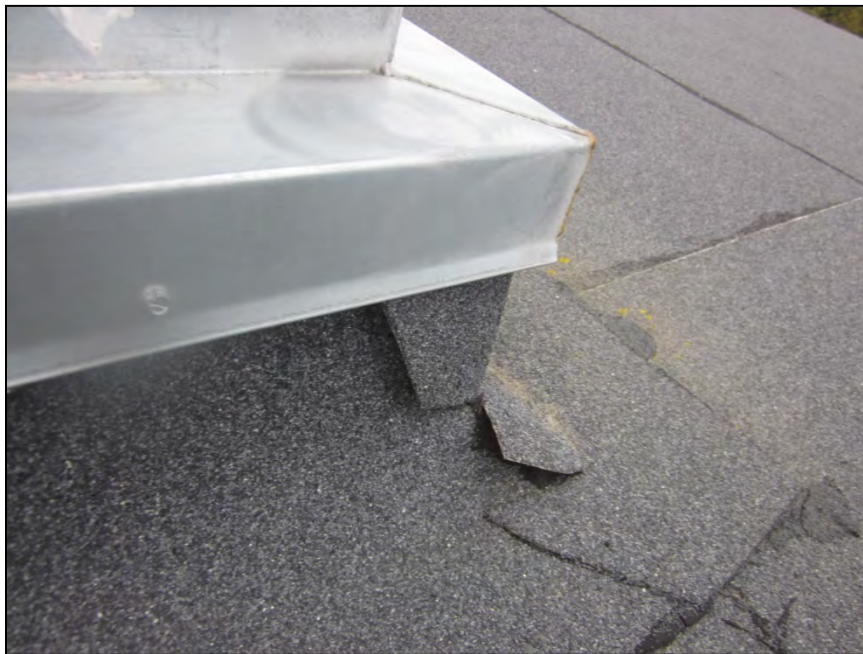
**Sec. 1.06 – Roof F: View of base flashing that is not tight at equipment curb at northwest section of the roof.**

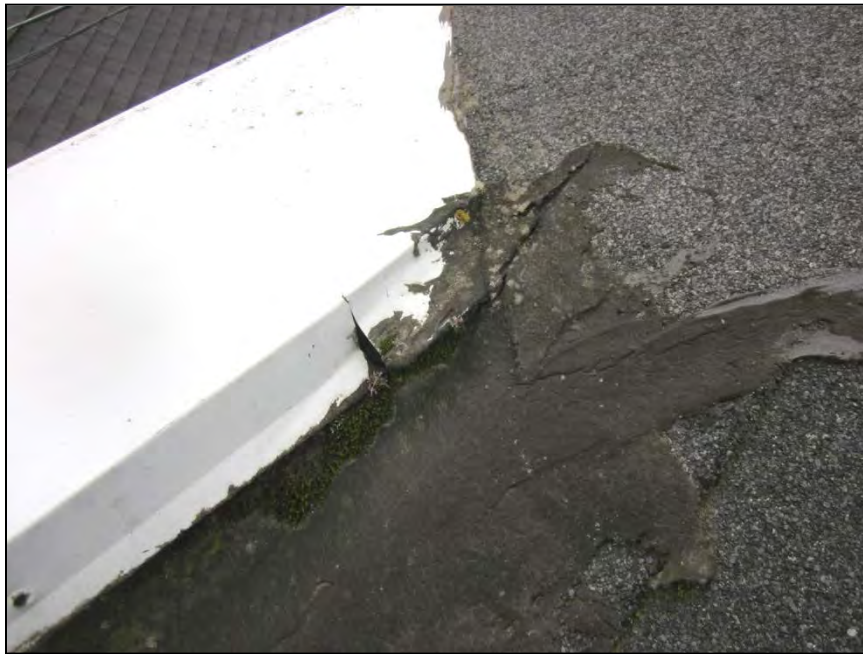
**Sec. 1.07 – Roof M: View of cut in metal coping at southwest section of the roof.**

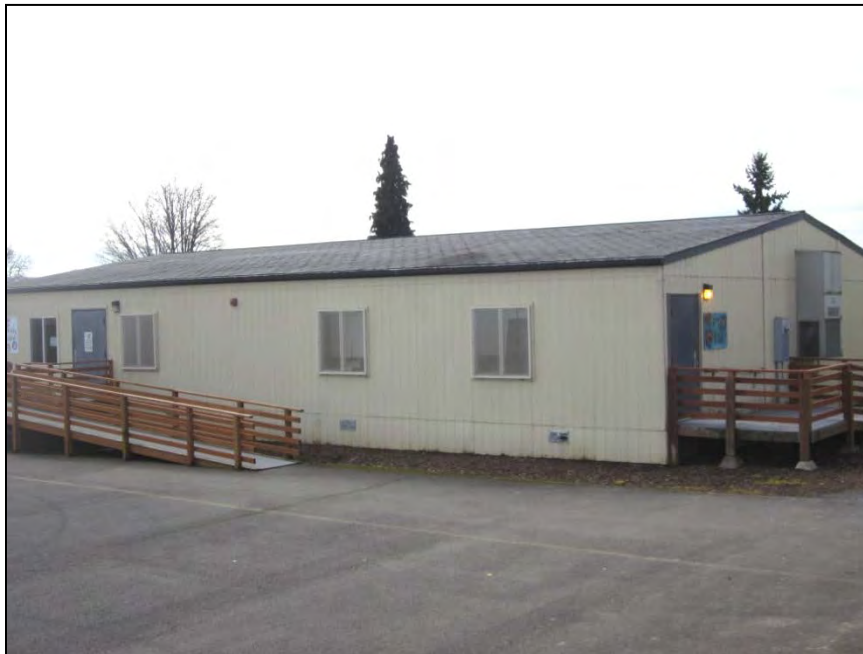
**Sec. 1.02 – Roof A: View of curling shingles at east section of the roof.**

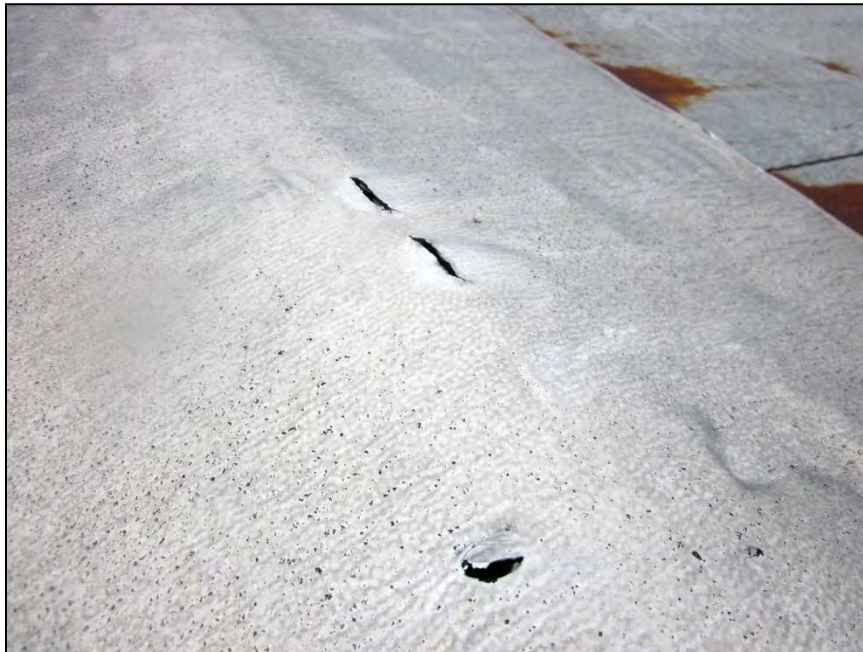
**Sec. 1.04 – Roof A: View of holes in peel and stick material at center section of the roof.**

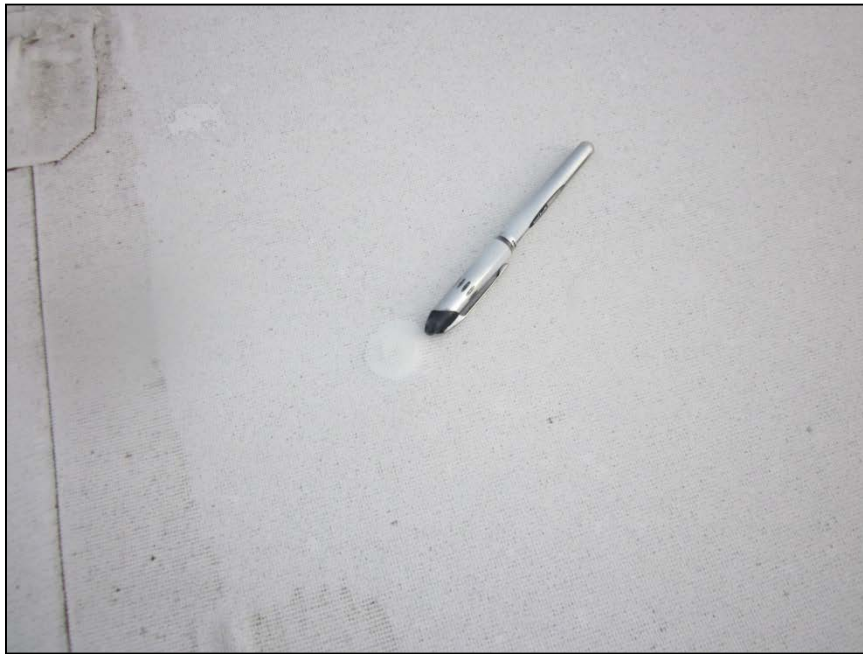
- a. Loose seam at north perimeter at the center section of the roof. This is considered a potential future interior leakage problem.
  - (1) **ACTION:** Repair loose seam. (*contractor item*)
- b. Fasteners are starting to back out in the roof field. This is considered a potential future interior leakage problem.
  - (1) **ACTION:** Inspect fasteners and repair as required. (*contractor item*)

**Sec. 1.07 – Roof A: View of typical fastener that is backing out at northeast section of the roof.**

- a. Repair loose seam.
- b. Inspect fasteners and repair as required.

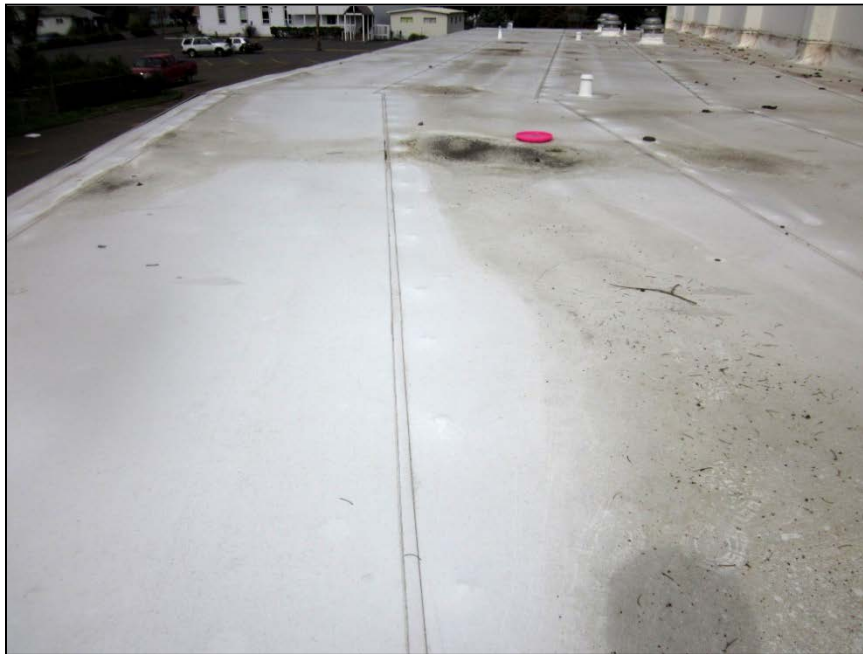
- a. Fasteners are starting to back out in the roof field. This is considered a potential future interior leakage problem.
  - (1) **ACTION:** Inspect fasteners and repair as required. (*contractor item*)

**Sec. 1.09 – Roof B: View of fasteners starting to back out in the roof field.**

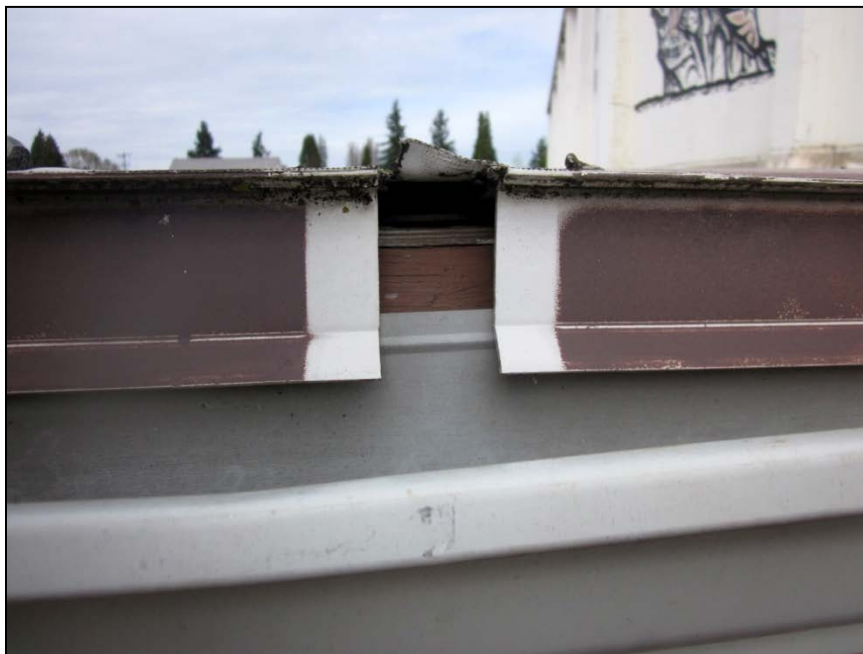
- a. Gaps in drip edge metal at perimeter of the roof. This is considered a potential future interior leakage problem.
  - (1) **ACTION:** Repair gaps. (*contractor item*)

**Sec. 1.10 – Roof B: View of gap in drip edge metal at the south perimeter.**

- c. Repair gaps in drip edge metal.

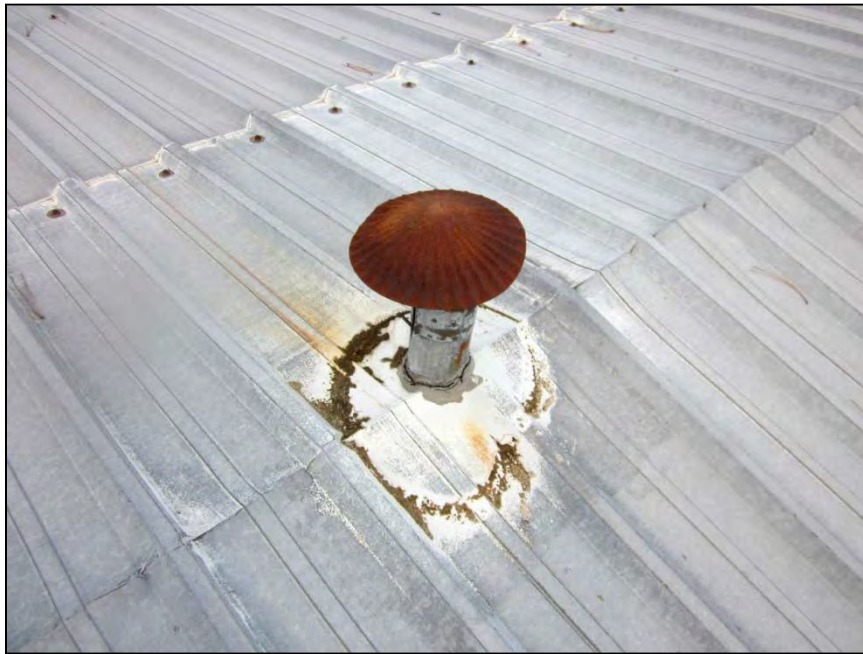
- a. A few fasteners are backing out in the roof field. This is considered a potential future interior leakage problem.  
(1) **ACTION:** Inspect fasteners and repair as required. (*contractor item*)
- b. Voids in sealant at base of vent at the center section of the roof. This is considered a potential future interior leakage problem.  
(1) **ACTION:** Replace sealant. (*contractor item*)
- c. Metal is rusting at the west section of the roof. This is considered a minor problem at this time.  
(1) **ACTION:** Monitor rusting metal for any changes. (*in-house*)

**Sec. 1.05 – Roof A: View of voids in sealant at vent at center section of the roof.**

- a. Repair fasteners that are backing out.
- b. Replace sealant at vent.
