# **Yamhill-Carlton School District**

**Building Assessment**

**Yamhill High School**

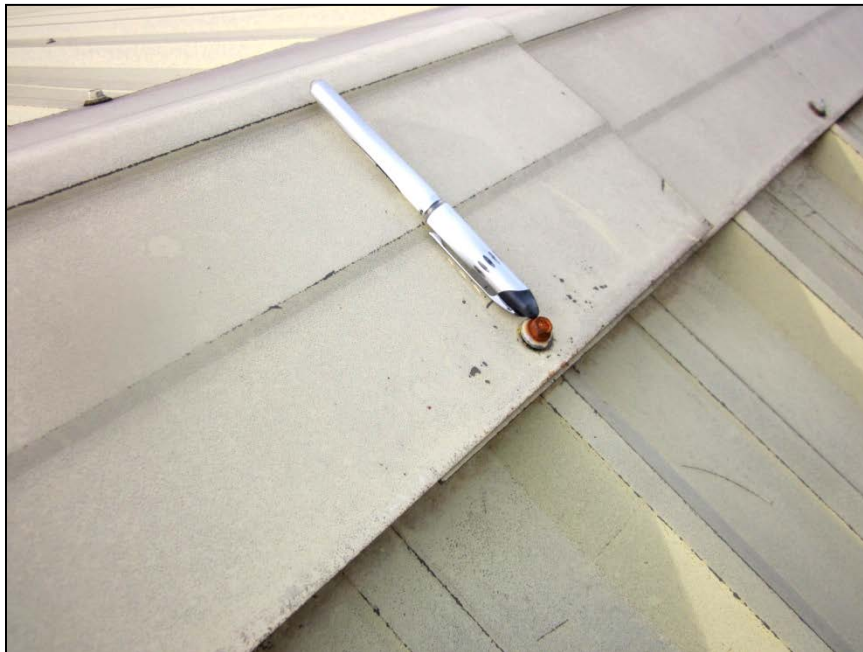
**Sec. 1.04 – Roof A: View of fastener backing out at ridge cap at center of the roof.**

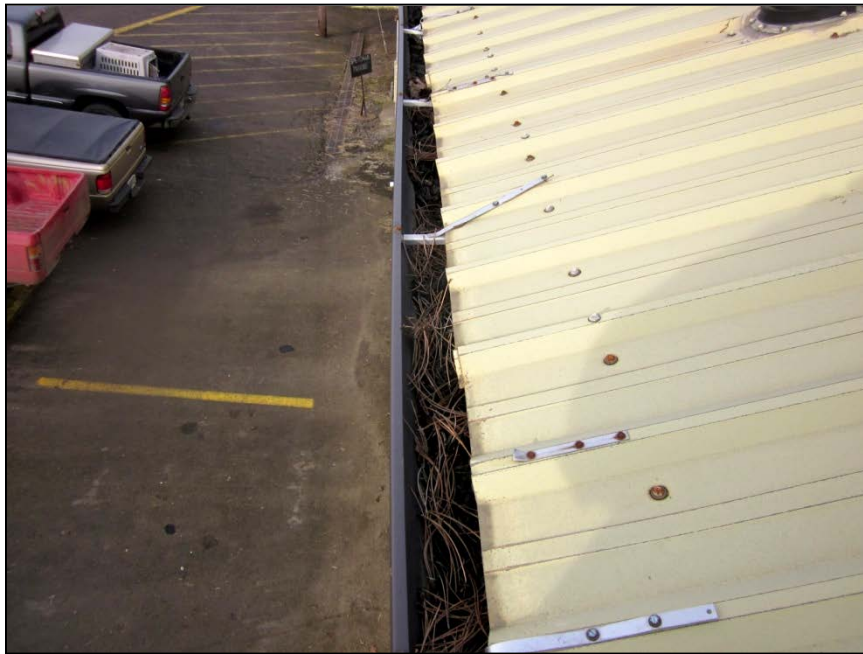
**Sec. 1.05 – Roof A: View to north of organic debris in west gutter.**

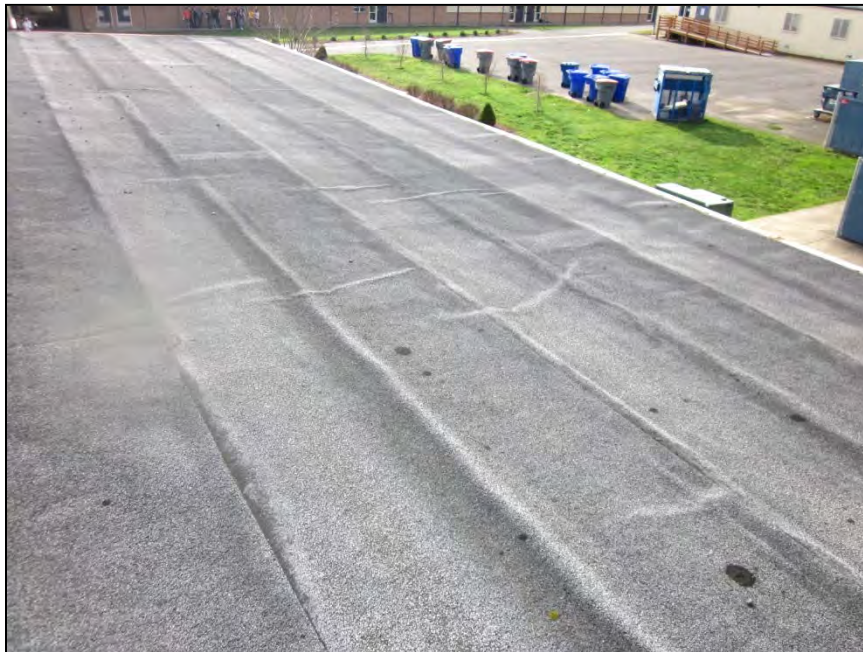
**Sec. 1.04 – Roof A: View of typical cap sheet ridging in roof field.**

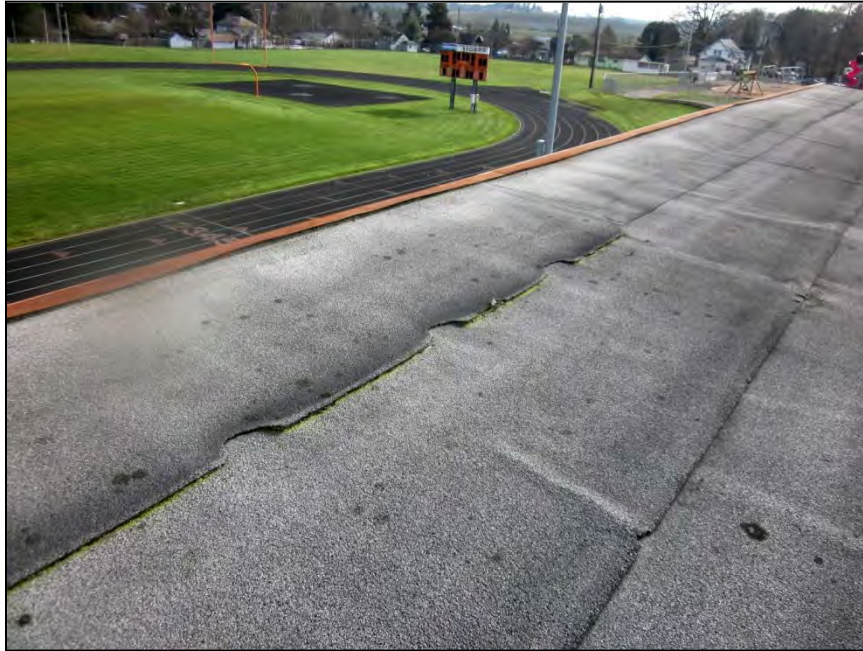
**Sec. 1.05 –Roof A: View of cap sheet breaking along lap at southeast section of the roof.**

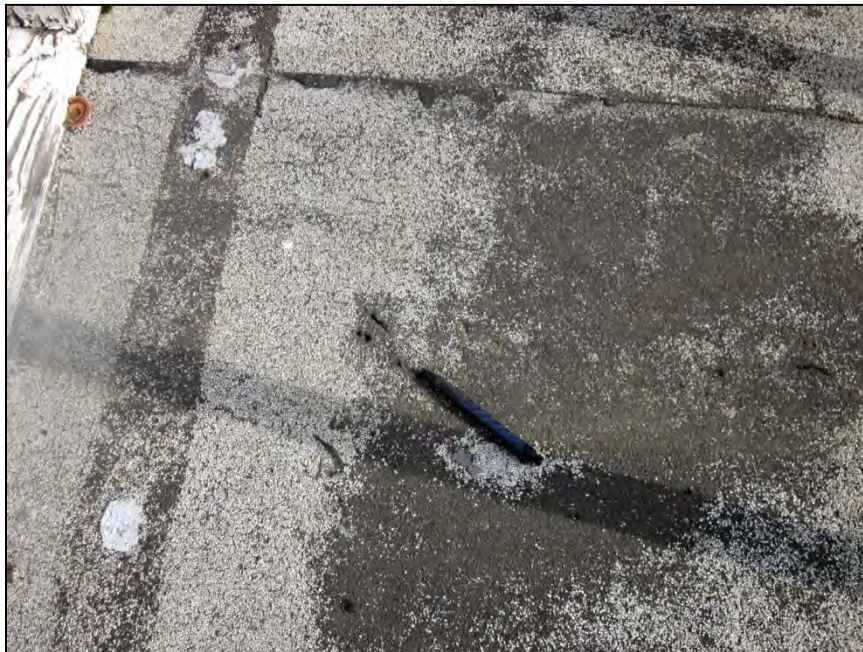
**Sec. 1.06 – Roof A: View of holes in cap sheet at walkway at center section of the roof.**

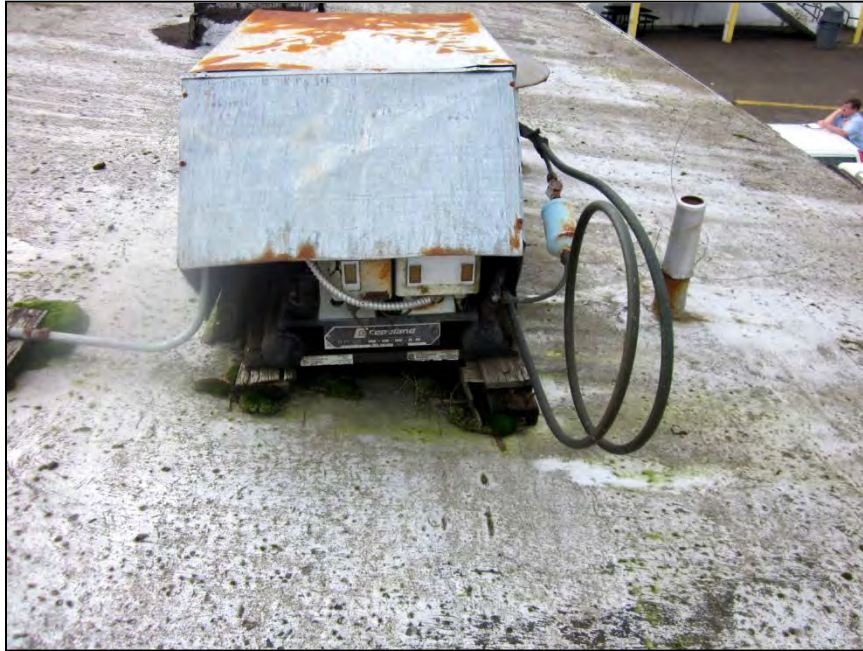
**Sec. 1.03 – Roof A: View of wood sleepers nailed thru roof at north section of the roof.**

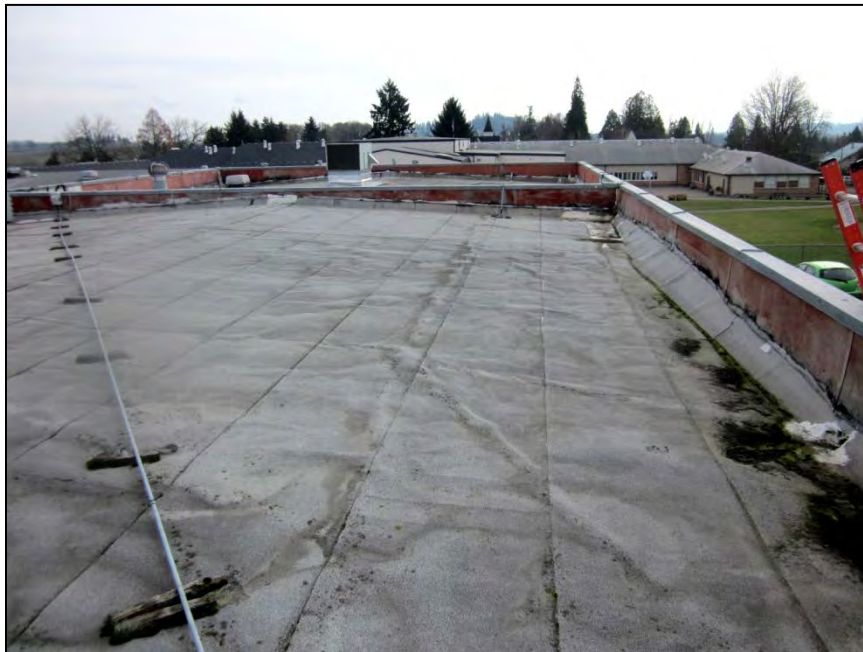
**Sec. 1.06 – Roof B: View to south at west section of the roof. Note cap sheet blisters and ridging.**

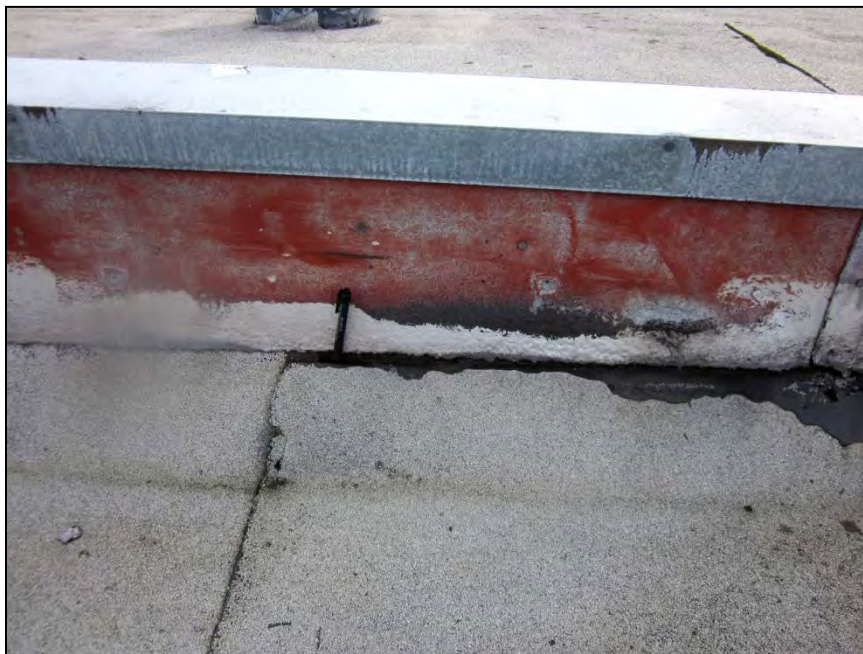
**Sec. 1.10 – Roof B: View of base flashing that is not tight at south parapet at southeast section of the roof.**

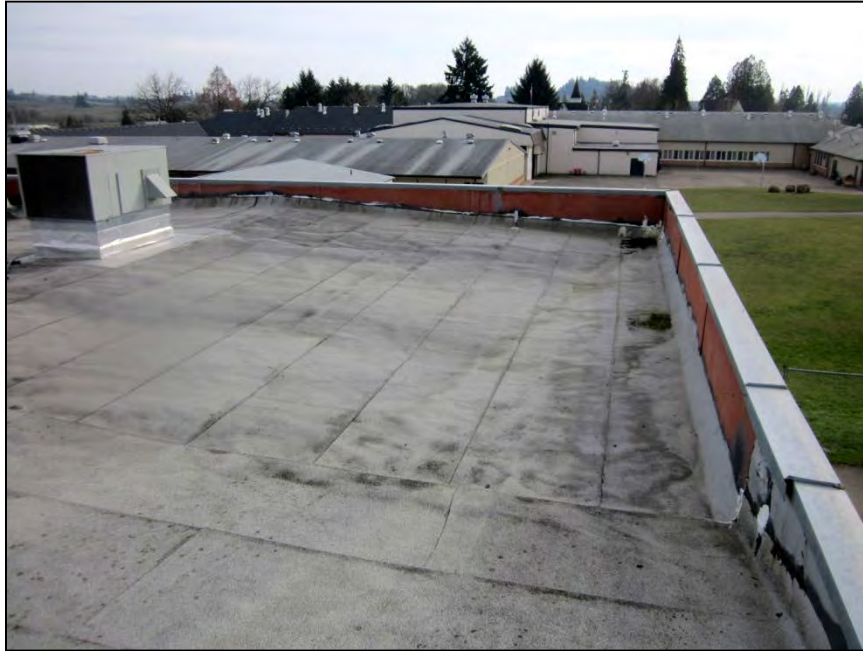
**Sec. 1.11 – Roof C: View to south at west section of the roof. Note cap sheet blisters and ridging.**

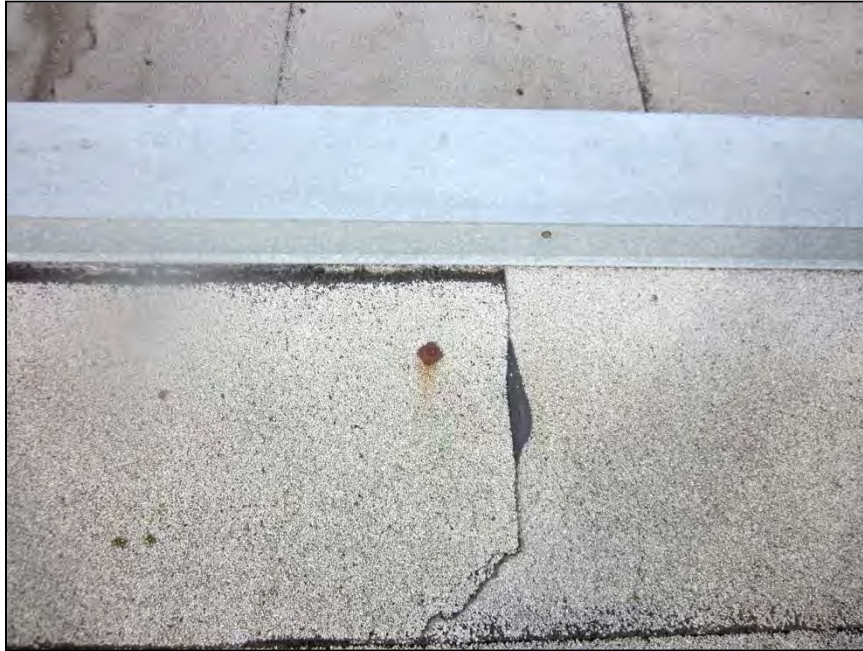
**Sec. 1.13 – Roof C: View of typical nail thru base flashing along north parapet.**

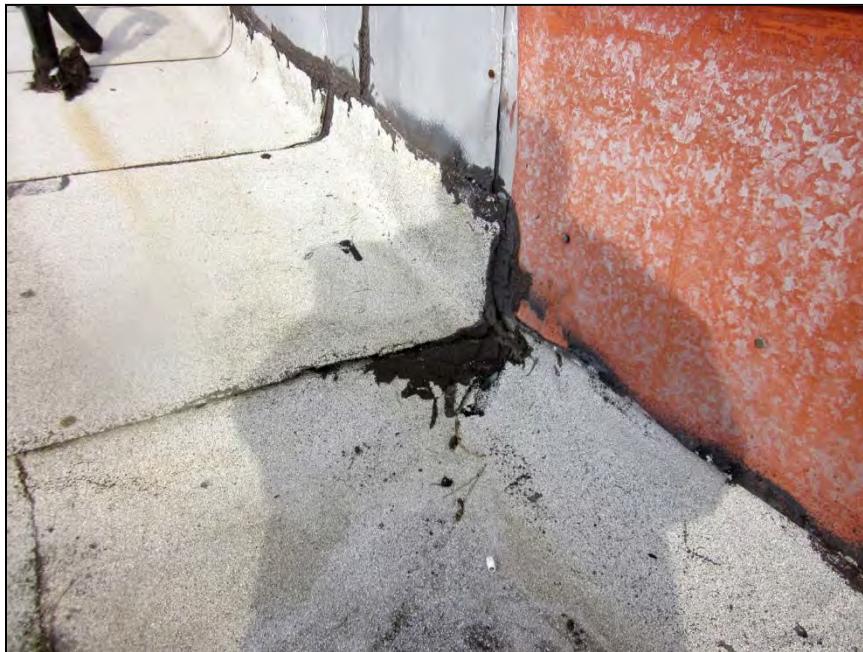
**Sec. 1.14 – Roof C: View of cap sheet that is not watertight at east parapet at northeast section of the roof.**

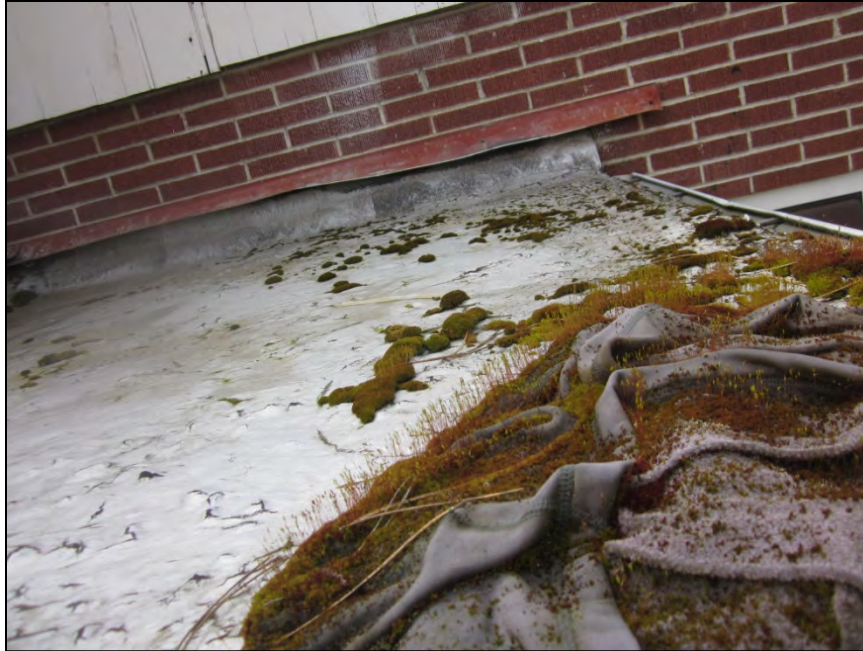
**Sec. 1.17 – Roof E: View to debris on roof surface.**

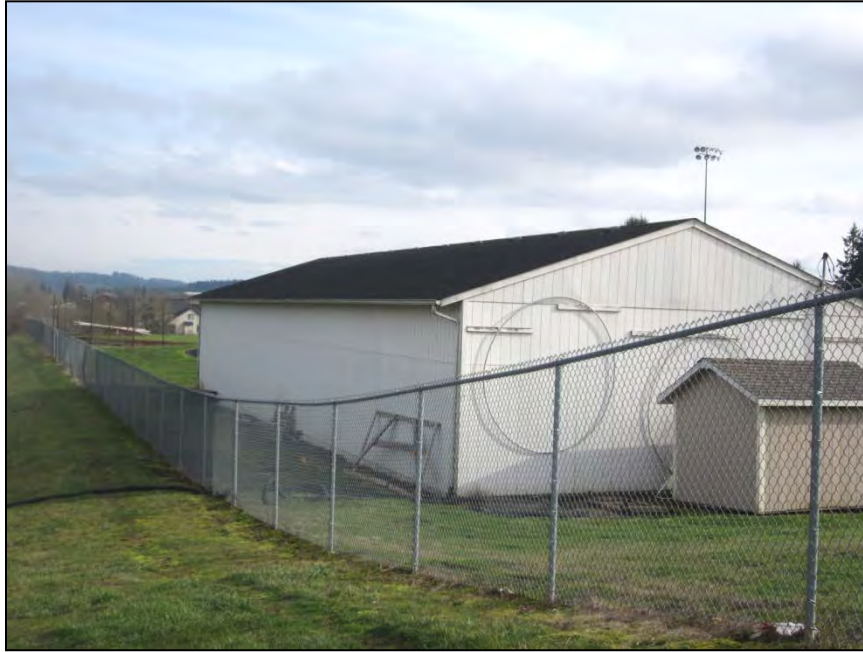
**Sec. 1.02 – Roof A: View of missing shingle near ridge line at southeast section of the roof.**

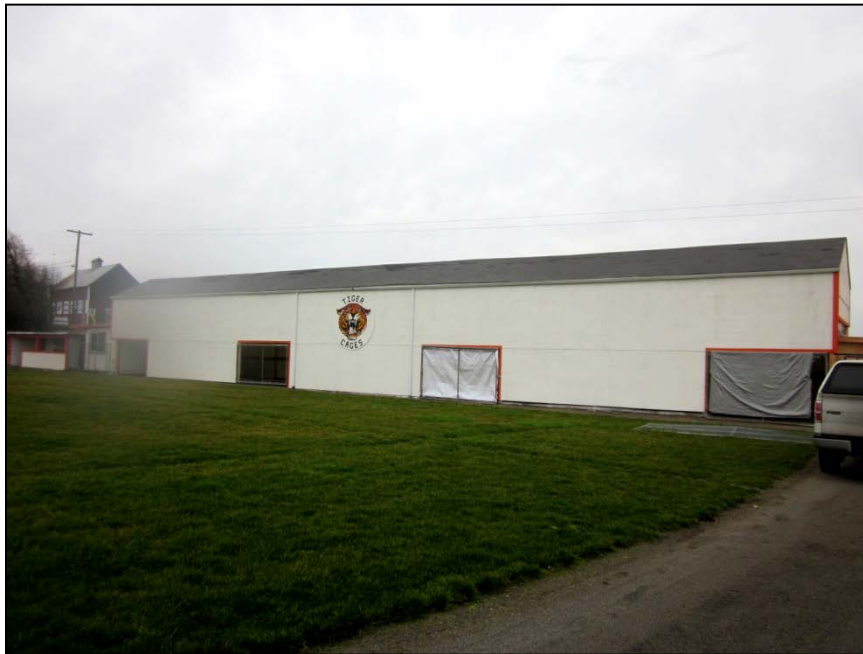
**Sec. 1.01 – View to northwest of south elevation.**

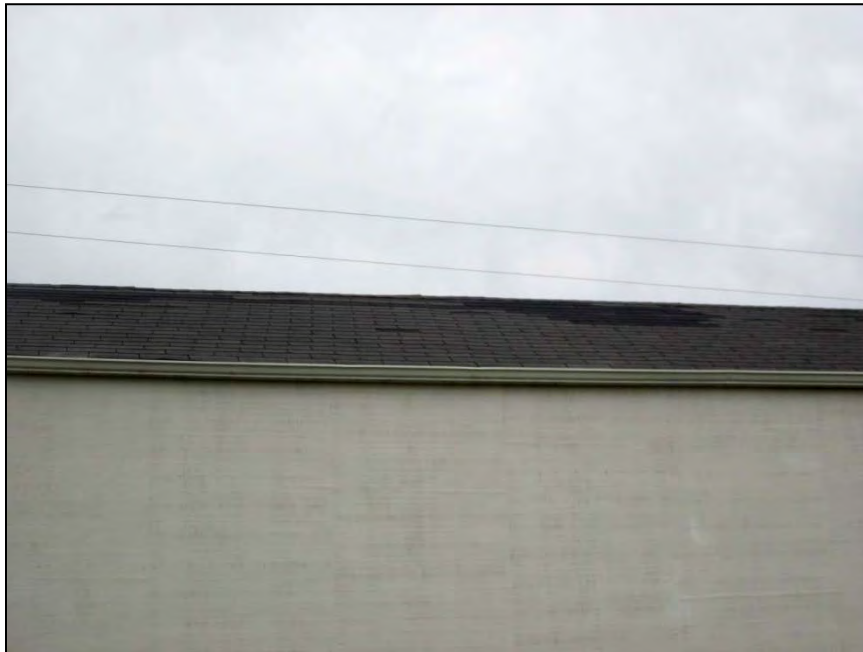
**Sec. 1.04 – Roof A: View of replacement shingles at southwest section of the roof.**

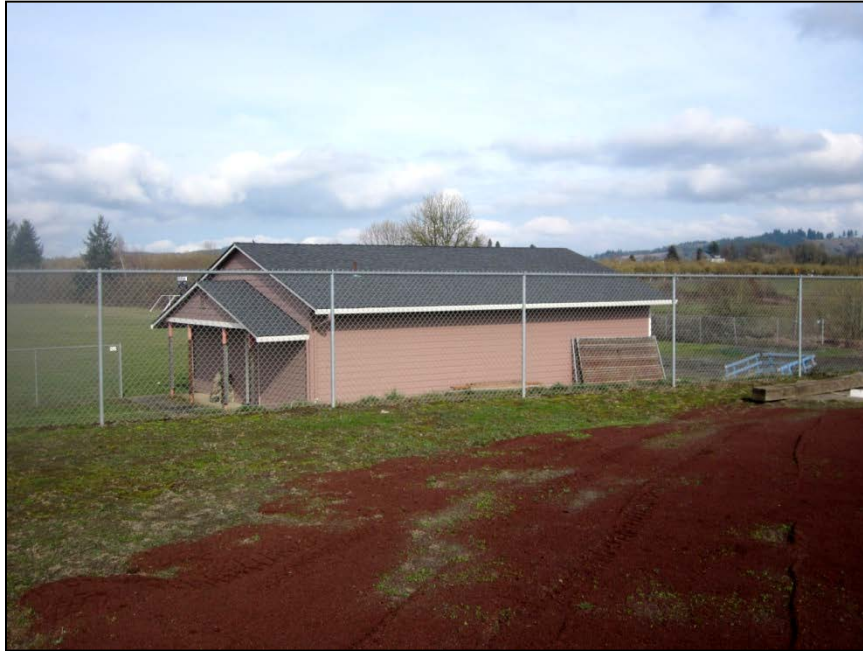
**Sec. 1.01 – View to northeast of south elevation at right and west elevation at left.**
