Yamhill-Carlton School District

Building Assessment

Carlton Elementary School

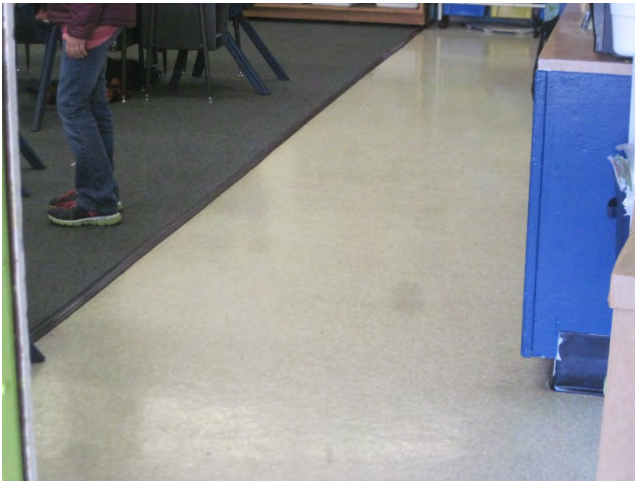
Typical classroom older carpeting and sheet
vinyl, Lower Floor

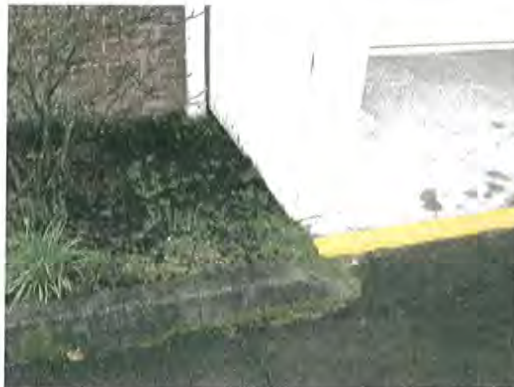
Numerous areas of the exterior wall wood siding are showing deterioration, particularly at the east end of the north wing, the east wall of the main building and at the southeast exit cover. If not addressed, these can become structural issues. Also near the front entry, an area of wood framed wall is in contact with soil.

- Replace all siding that is showing signs of deterioration.

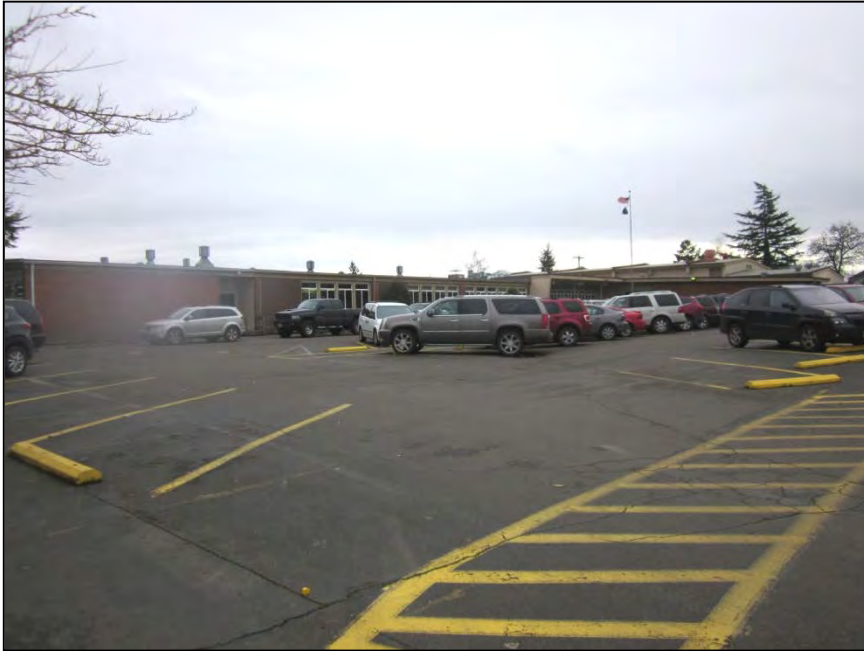
Sec. 1.01 – View to southeast of west elevation at front of school.

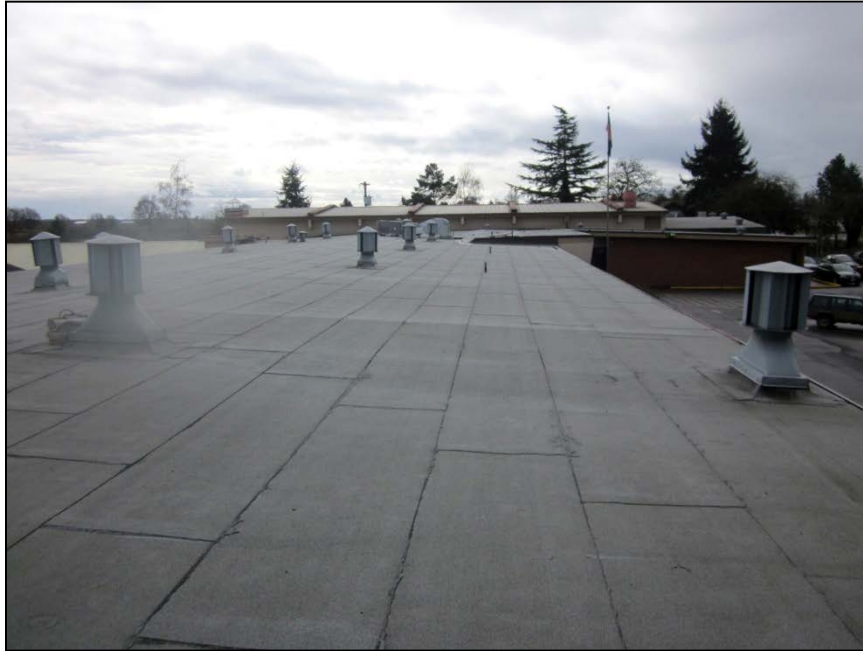
Sec. 1.03 – Roof A: View to south across roof field at west section of the roof.

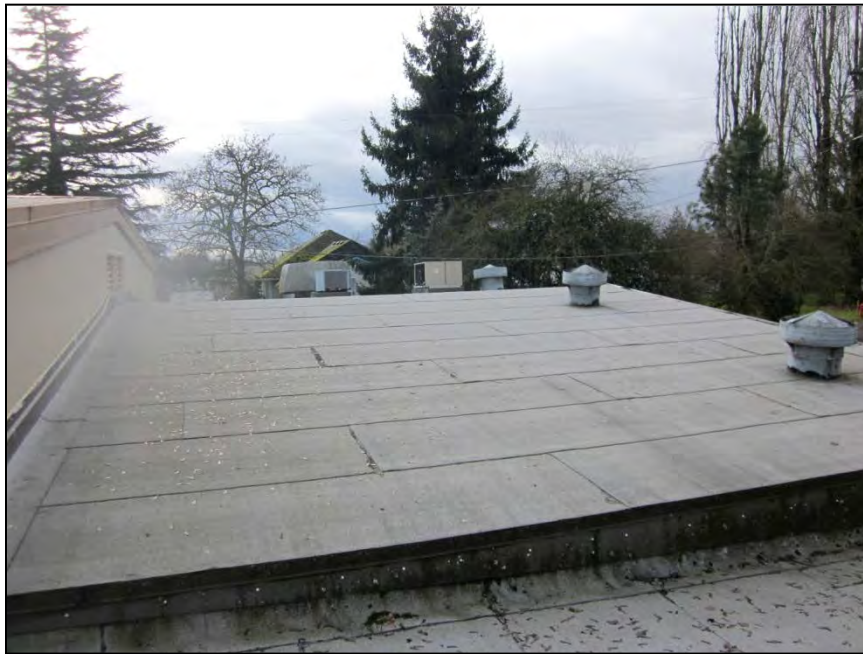
Sec. 1.11 – Roof B: View to south across roof field from Roof A.

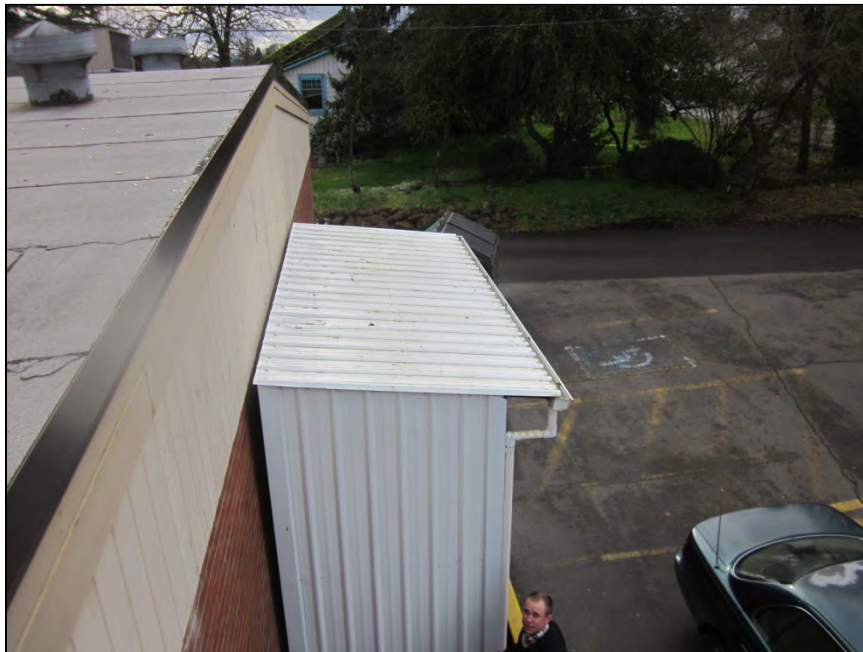
Sec. 1.14 – Roof C: View to south across roof field from Roof B.

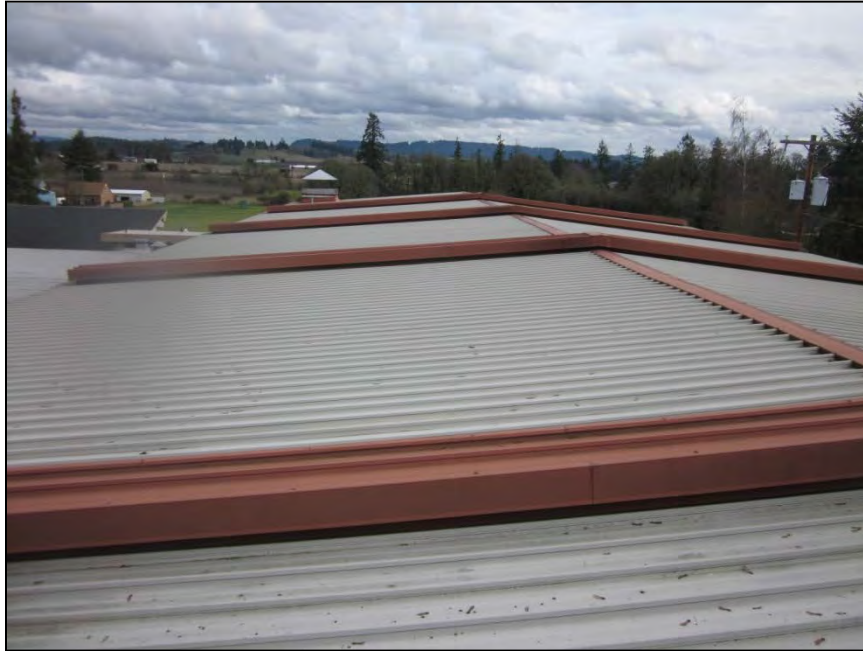
Sec. 1.15 – Roof D: View to east across roof field at north section of the roof.

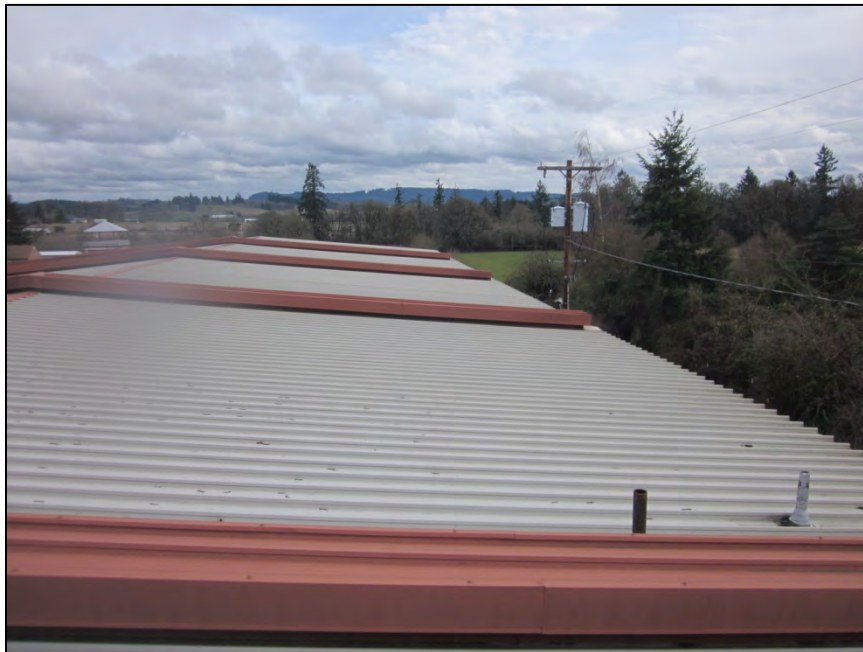
Sec. 1.16 – Roof D: View to east across roof field at south section of the roof.

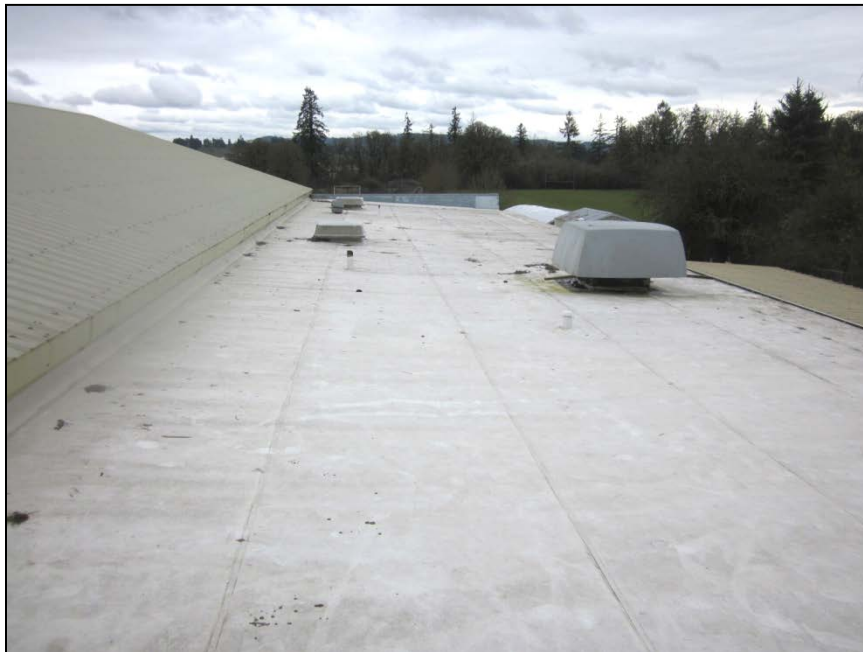
Sec. 1.20 – Roof F: View to east across roof field. Roof E is at left.

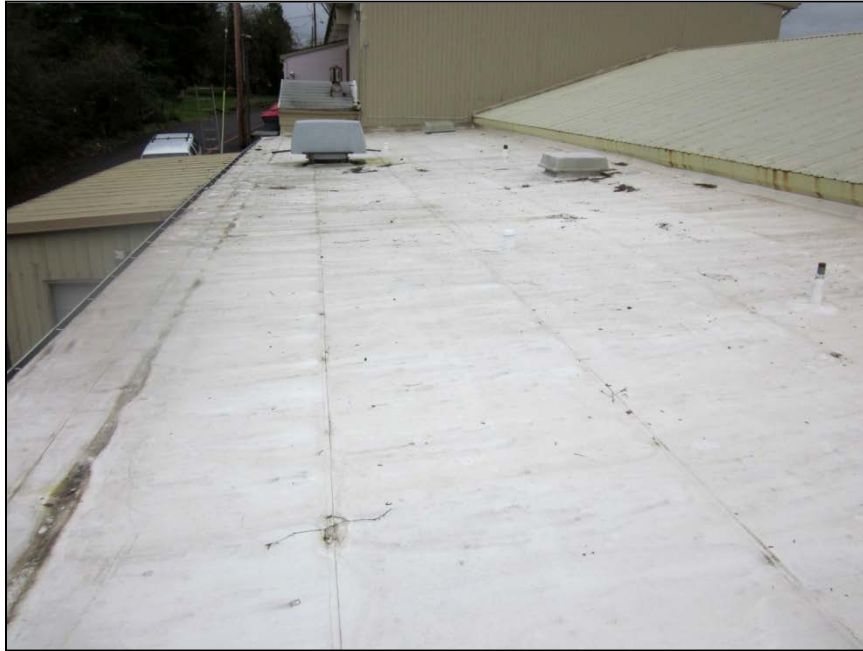
Sec. 1.23 – Roof F: View to west across roof field. Roof E is at right and Roof G is at left.

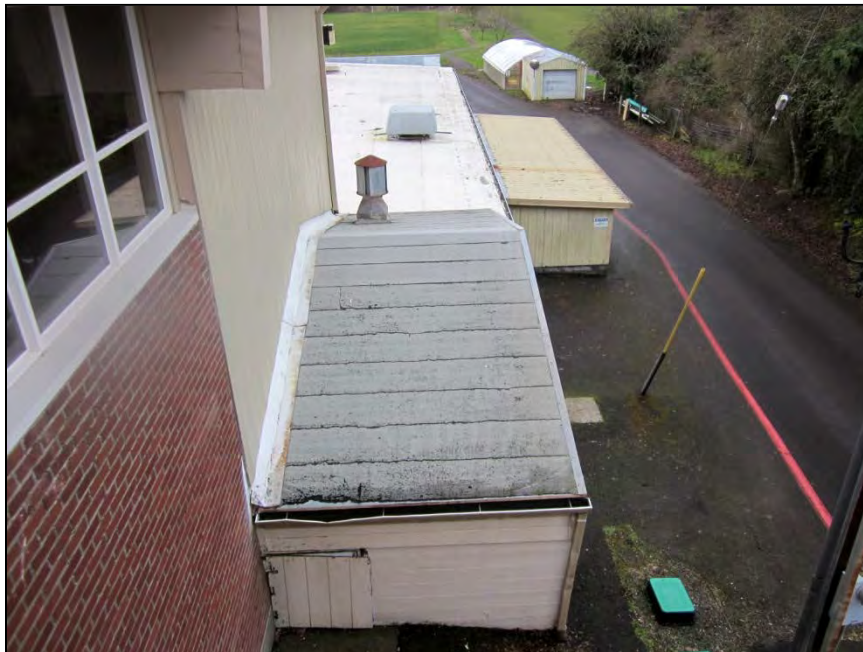
Sec. 1.24 – Roof H: View to east across the roof field.

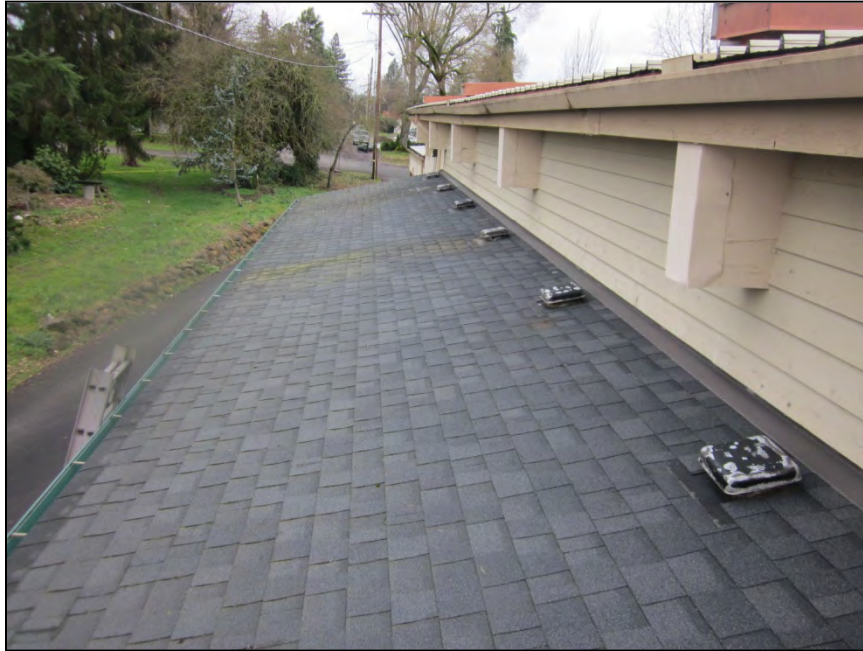
Sec. 1.27 – Roof I: View to west across the roof field.

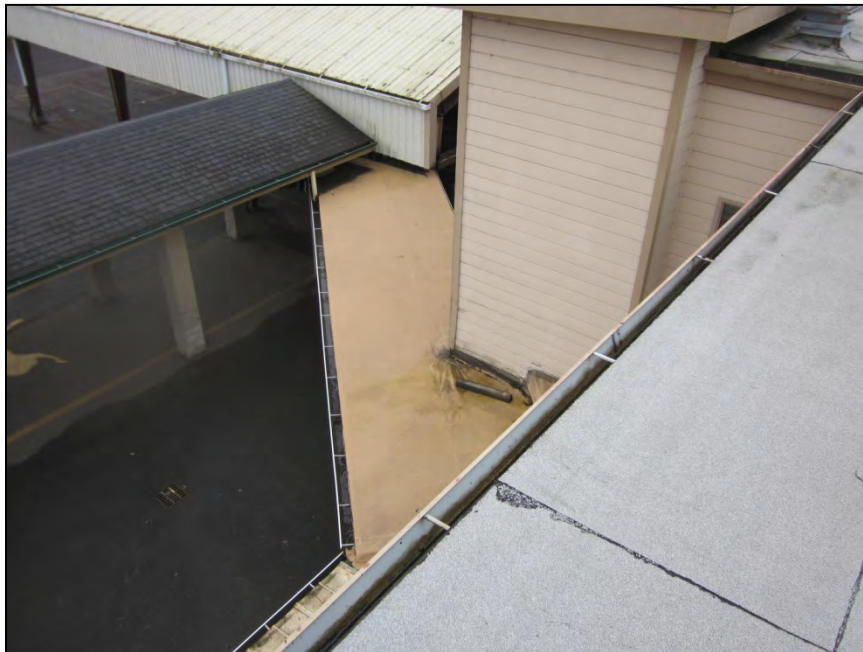
Sec. 1.28 – Roof K: View to east across the roof field.

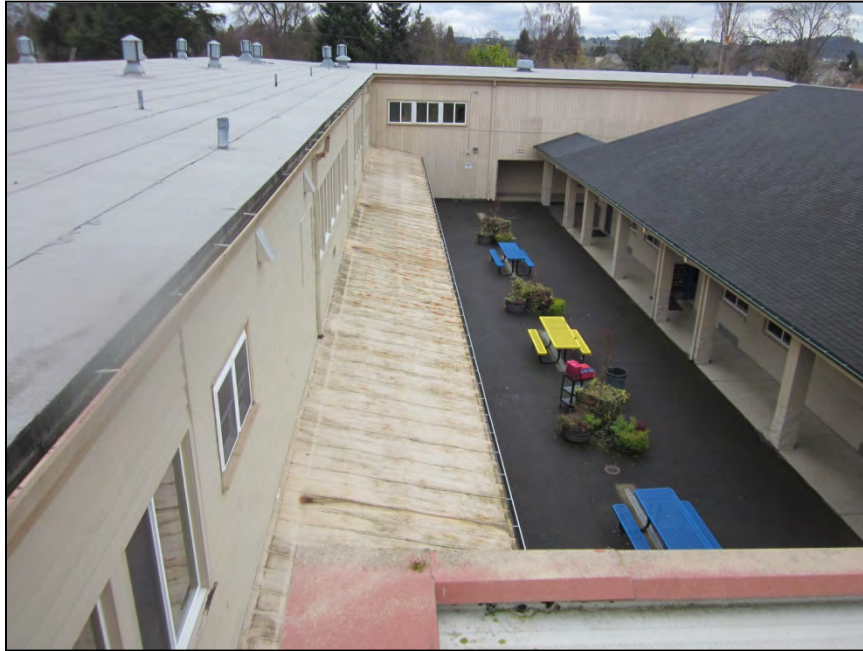
Sec. 1.29 – Roof L: View to north across the roof field. Roof A is at left and Roof M is at right.

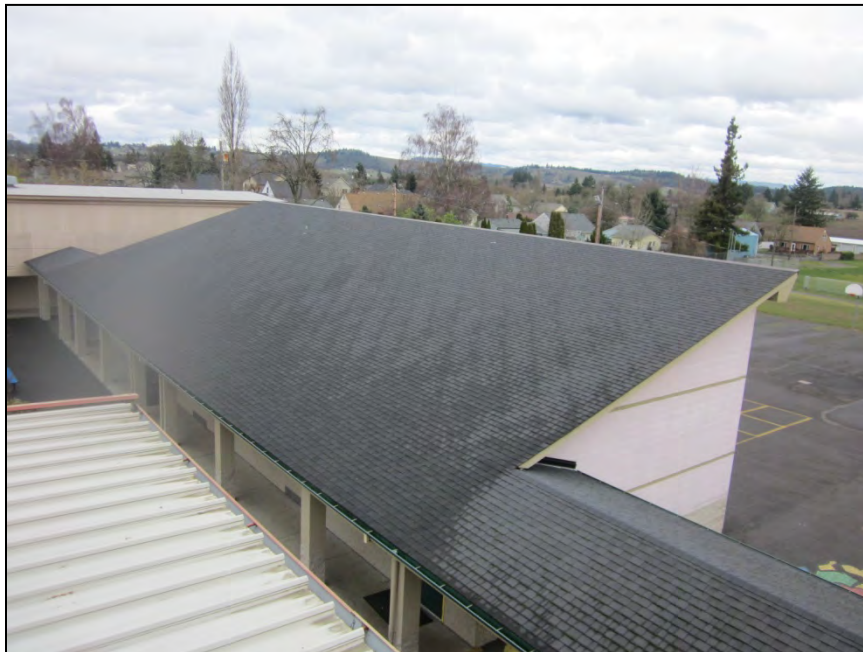
Sec. 1.30 – Roof M: View to northeast across the roof field. Roof N is at bottom of photo.

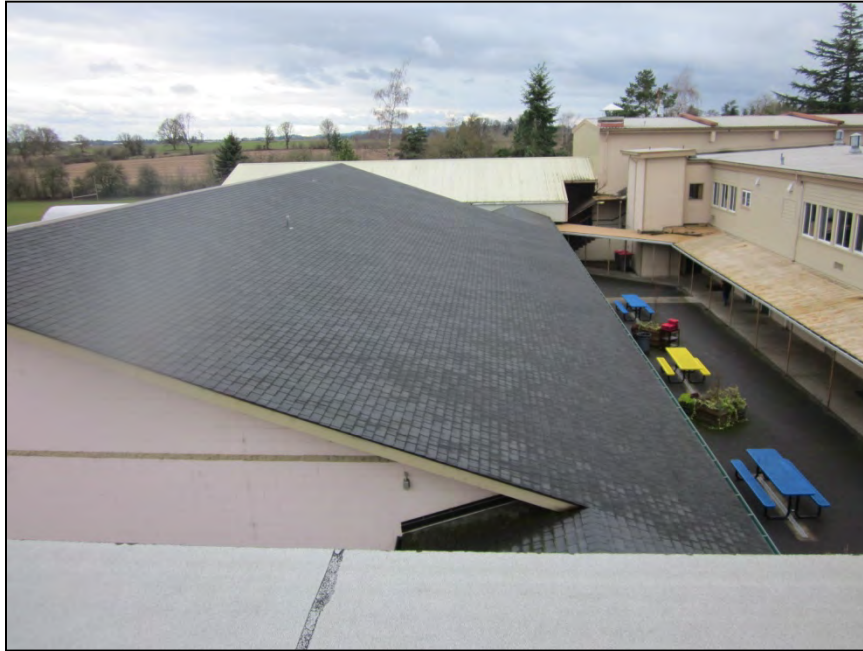
Sec. 1.31 – Roof M: View to south across the roof field.

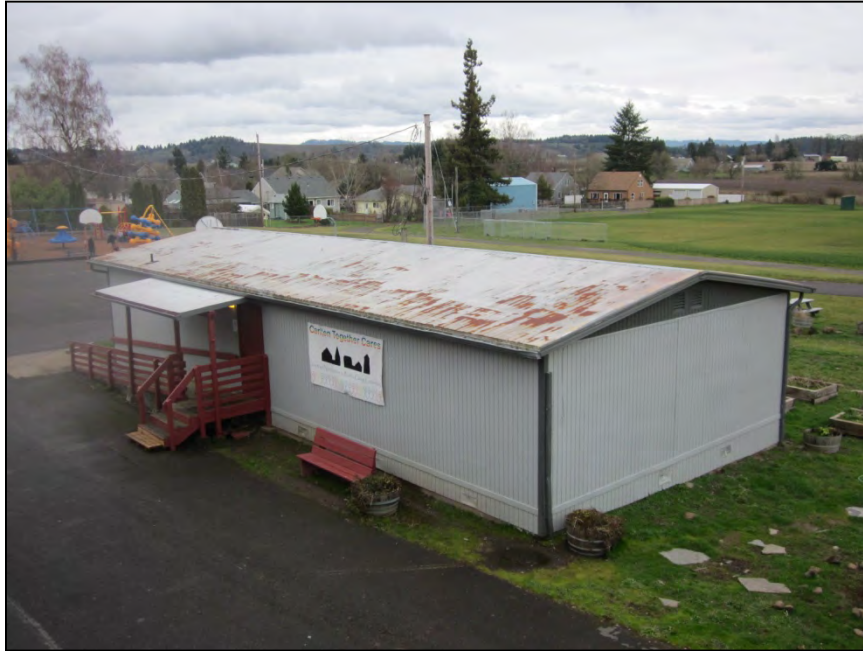
Sec. 1.33 – Roof T: View to northeast across roof field. Roof U is at left.

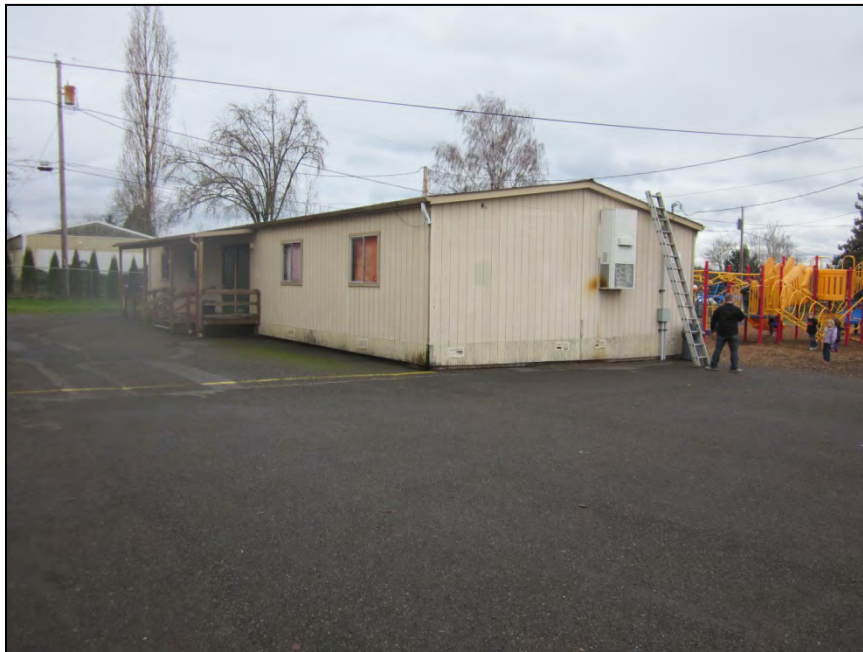
Sec. 1.34 – Roof V: View to north of west elevation at left and south elevation at right.

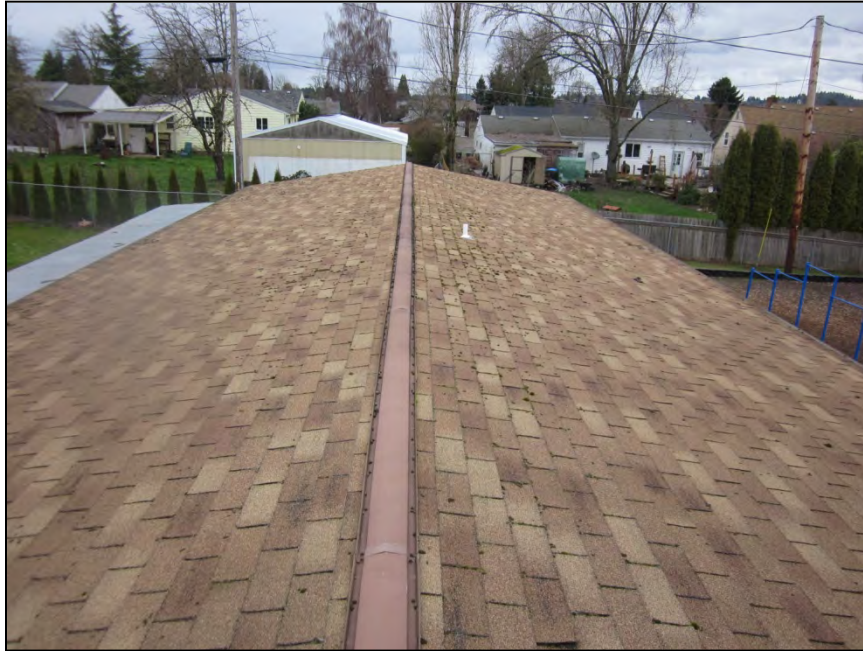
Sec. 1.35 – Roof V: View to north across the roof field.
